LETTER OF NOTIFICATION

BATH-TREBEIN 138 kV RECONDUCTOR PROJECT

PUCO Case No. 19-1631-EL-BLN

Submitted by: The Dayton Power and Light Company 1900 Dryden Road Moraine, Ohio 45439

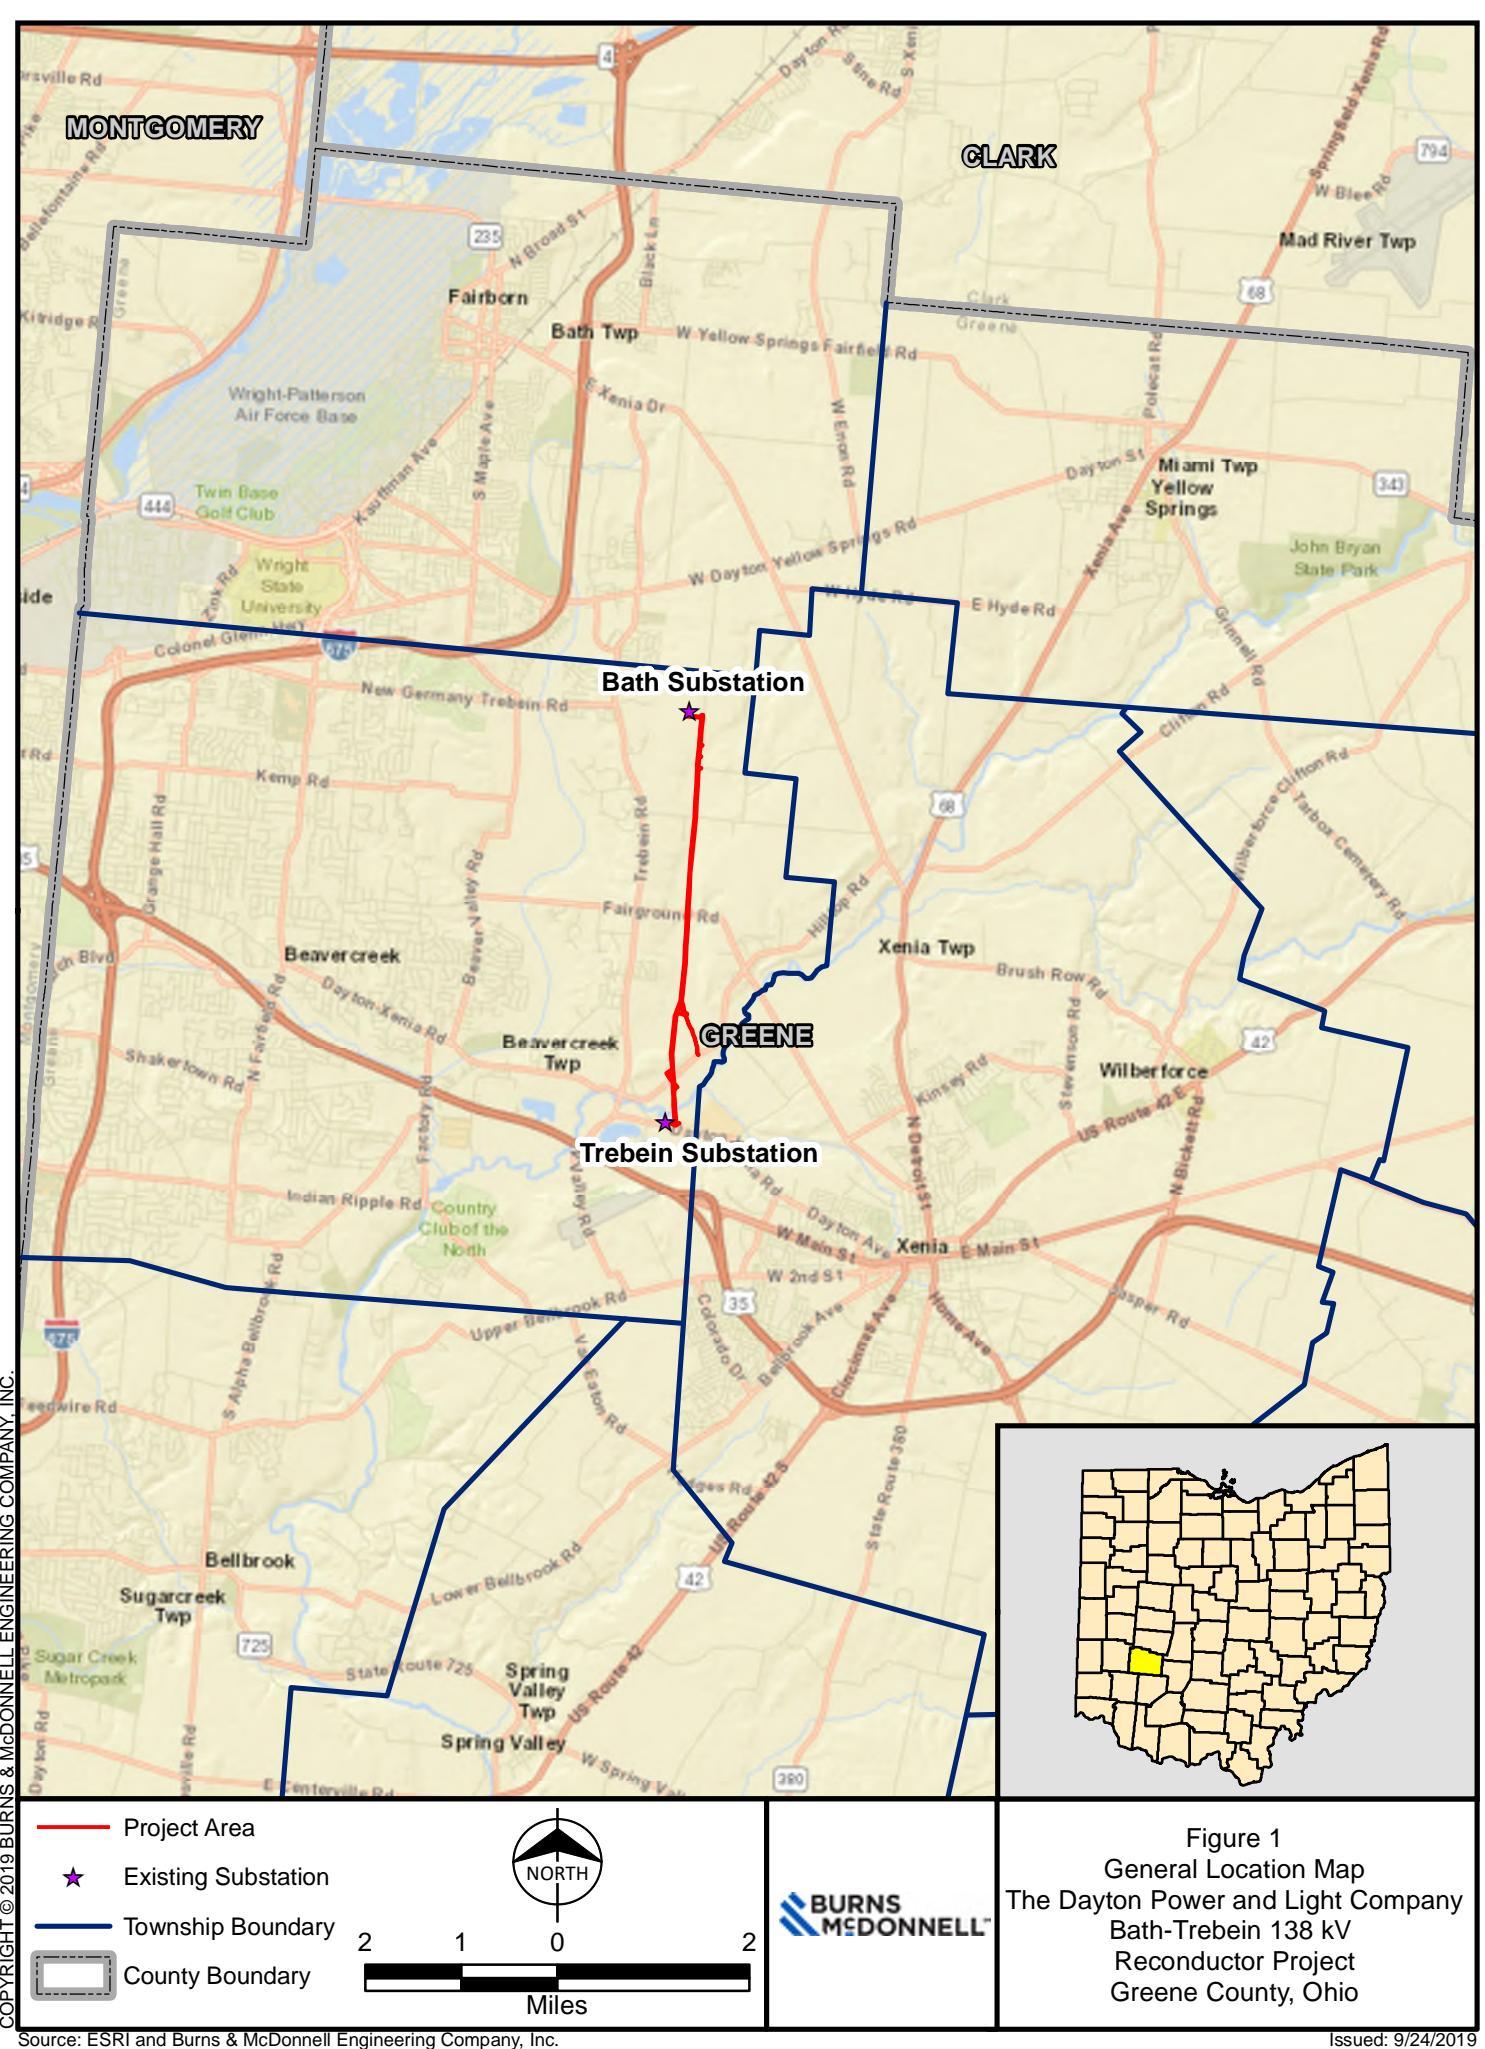
The location of the Project is shown on Figure 1 in Attachment A. This figure shows the approximate Project area and substations in relation to the county and township boundaries. Figure 2 in Attachment A shows the Project area, including the approximate existing Bath-Trebein 138 kV ROW, potential off ROW access, existing structures and poles, new pole location, existing substations, existing transmission lines, and parcel boundaries within the general Project vicinity.

DP&L proposes the Bath-Trebein 138 kilovolt (kV) Reconductor Project (Project), located in Beavercreek Township, Greene County, Ohio (Attachment A, Figure 1). The purpose of this Project is to reconductor an existing 138 kV overhead electrical transmission line connecting the existing Bath 138 kV Substation to the existing Trebein 138 kV Substation. The transmission line is approximately 4.6 miles in length and located within an existing 100-foot-wide right-of-way (ROW). The Project also includes the replacement of four wood poles; a direct embed steel monopole is replacing one wood pole and three other wood poles will be replaced with new wood poles in the same location. The remaining existing transmission line towers/pole will remain in their current locations and will not be moved.

Attachment A, Figure 1 depicts the location of the Project. To locate and view the Project area from Columbus, take Interstate-70 (I-70) West to I-675 South, then head south on I-675 for about 3.5 miles

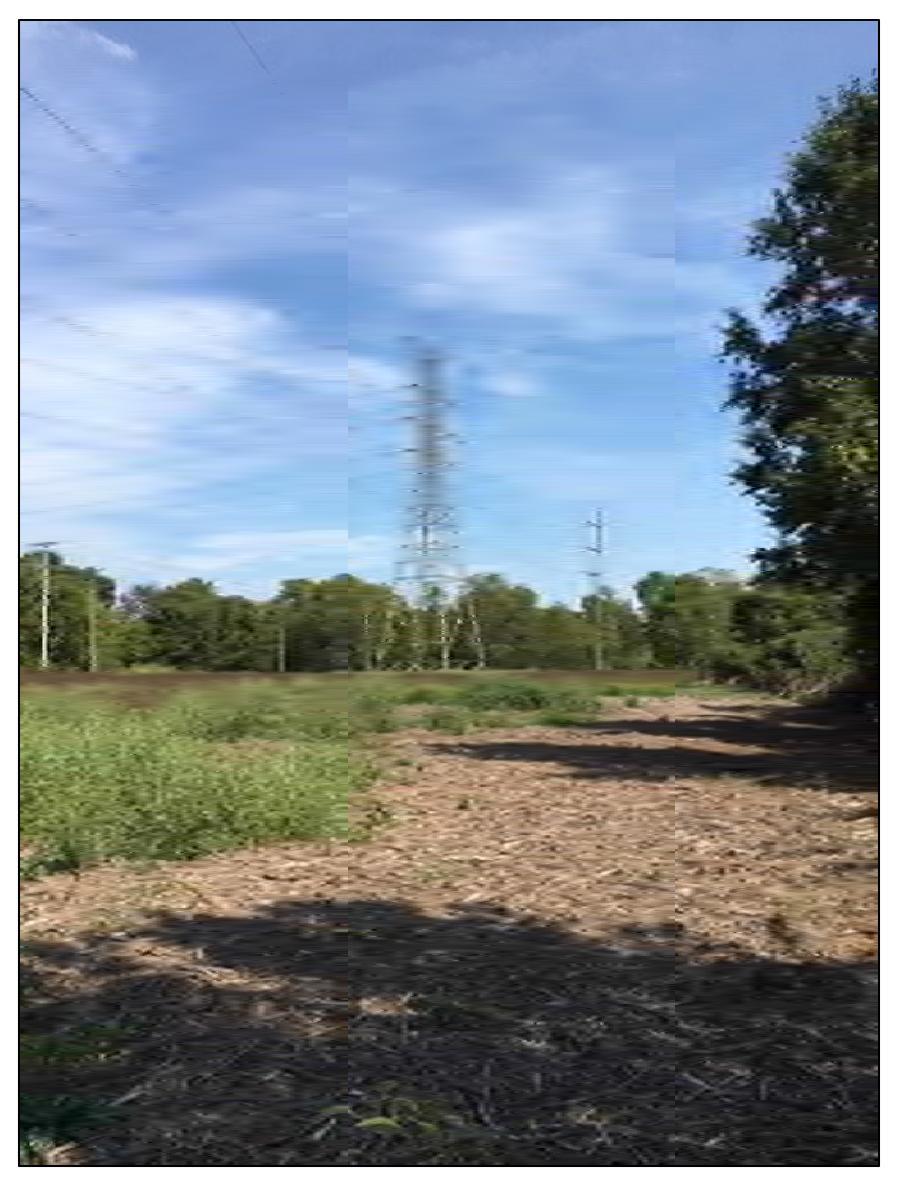
Figure 2-2: Project Overview, Facing Northeast. Pole to be Replaced right of Tower.

| Figure 1-1: | General Location Map | . 1-2 |
|---|---|---|
| Figure 2-2: | Project Overview, Facing Northeast. Pole to be Replaced right of Tower | . 2-4 |
