Scioto Ridge Wind Farm, Ohio Wetland and Stream Field Delineation Surveys Photolog July 2014

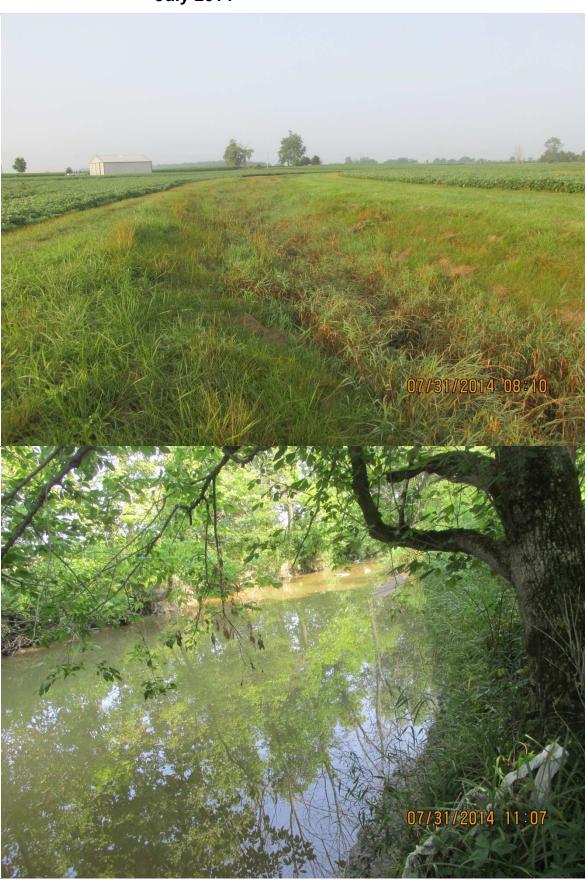
Photo: SOH-AD03

Description: Photo of SOH-AD03, a Modified Class II stream located between two active agricultural fields.

Description: Photo of SOH-AD05, a Class III PHWH stream with forested banks.

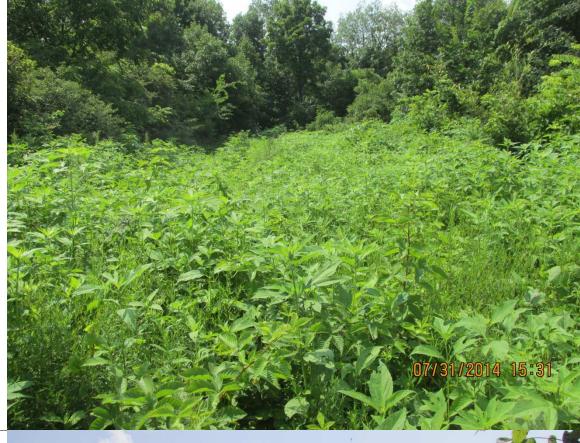
Photo: WOH-AD01

Description: Photo of WOH-AD01, the only wetland in the new Project Corridor. Interior shot of the PEM component of the wetland, dominated by Great Ragweed (Ambrosia trifida).

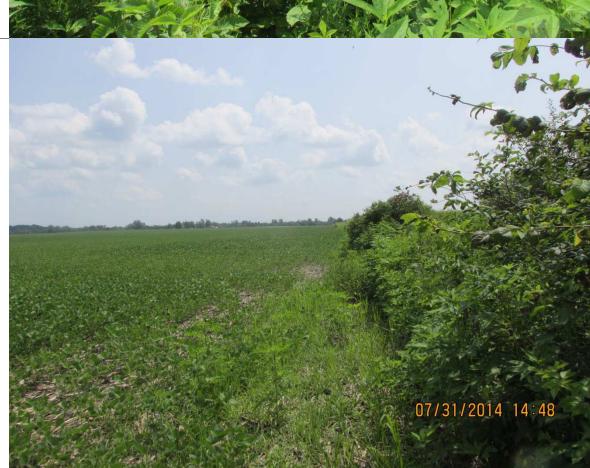
Photo: WOH-AD01

Description: Photo of crop area bordering WOH-AD01, showing the lack of significant buffer
