Subject: Against the Emerson Creek Wind, Seneca Wind & Republic Wind Projects

- Ground Water Inducted Flooding in the Bellevue Ohio Spring and Summer 2008 (final report)
- The Advertiser-Tribune: Wind turbine misconceptions
- The Advertiser-Tribune: Points of View: Wind Turbines- among tallest structures in Ohio
- The Advertiser-Tribune: Wind power just doesn't add up

On March 18, 2008 ground water levels rose to 40-year-high levels in the Bellevue, Ohio area. Sinkholes, rounded depressions in the landscape formed by solution of bedrock or collapse of an underlying cavity, which typically accept surface water, were acting as springs. Flooding of fields, roadways and homes occurred because of the lack of a defined surface drainage. The purpose of this report is to outline the geologic, hydrologic, and meteorological conditions that led to the flooding experienced in the vicinity of Bellevue, Ohio in the spring and summer of 2008. Figure 1 is a map showing the areas that experienced flooding. A combination of geologic conditions present at the surface and near-surface, and unique increases in precipitation, created a situation where a rising ground water table breached the ground s

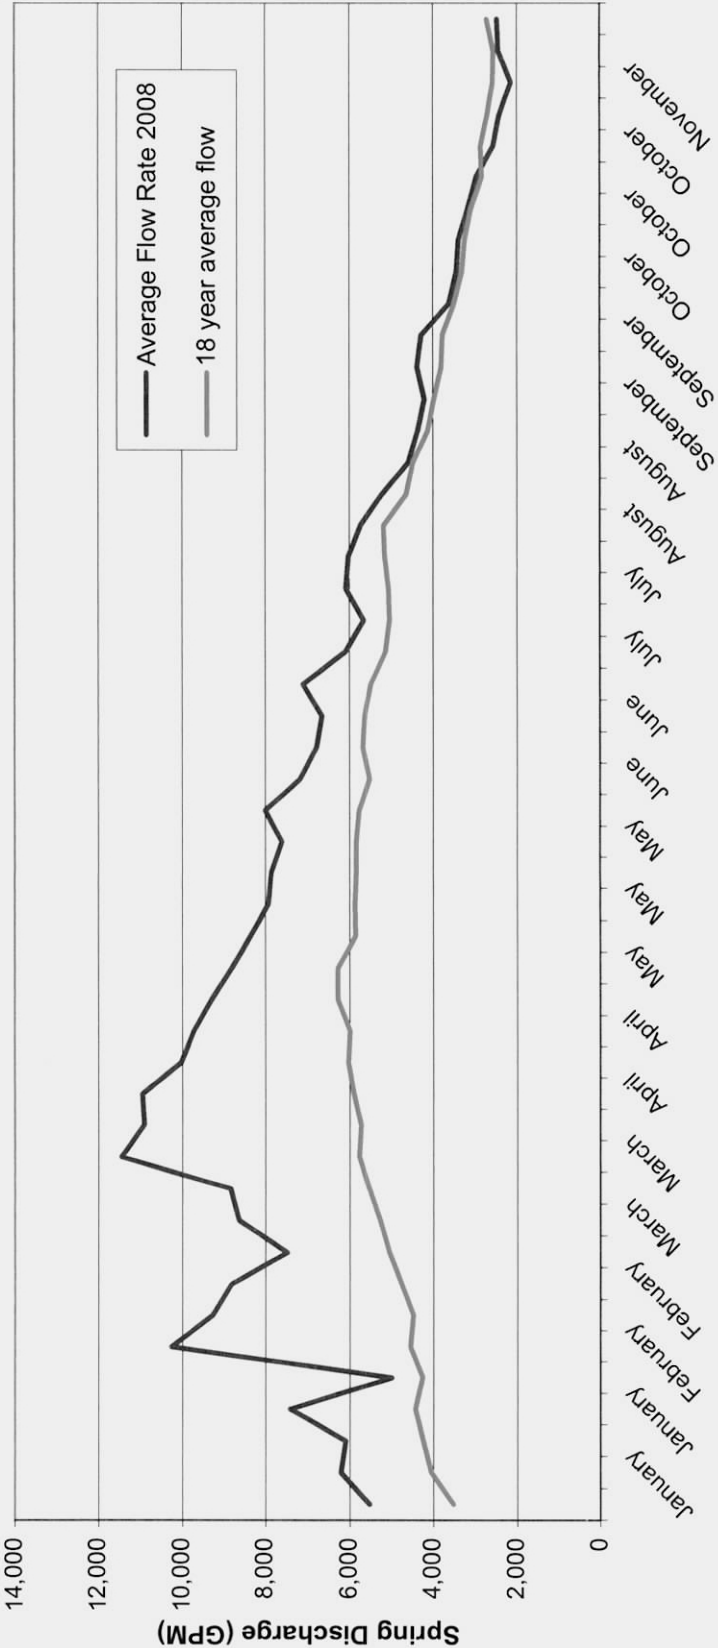
Figure 5.—Spring discharge from Rockwell Springs Trout Club

Spring discharge data has been collected by personnel at the Rockwell Springs Trout Club. This spring is located near the intersection of County Roads 310 and 247 in Sandusky County and is down-gradient of the flooded areas. Data for the past 18 years was sent to the DOW. This spring is very responsive to precipitation events, which indicates that it is connected to the shallow ground water flow system. Data for 2007 and 2008 shows that the spring discharge was slightly above normal starting in December 2007, but then peaked the third week of March, more than doubling the average flow for that time period (see Figure 5). Spring discharge stayed above average until the third week of August.
