**A Report by the Staff of the
Public Utilities Commission of Ohio**

In the Matter of the investigation of Dominion Energy Ohio
relative to compliance with the Natural Gas Pipeline safety
standards

Case No. 19-2140-GA-GPS
February 28, 2020

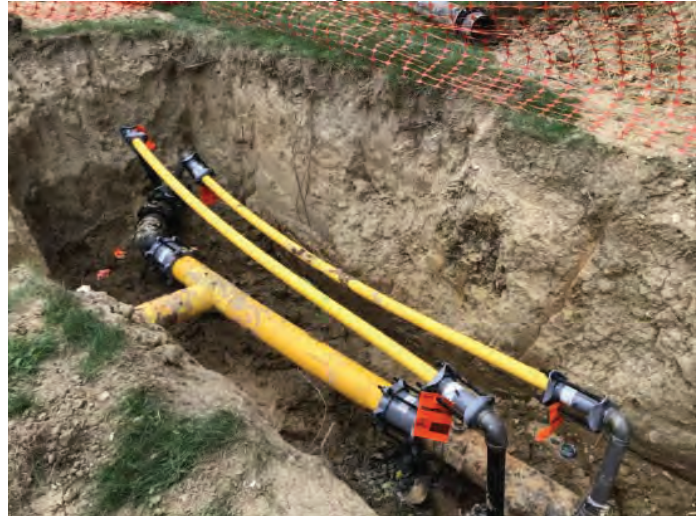
The tie-in at Brainard and Belgrave.

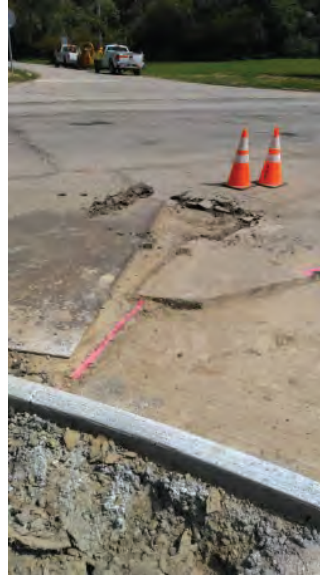
Damage done by DRS Crew member.

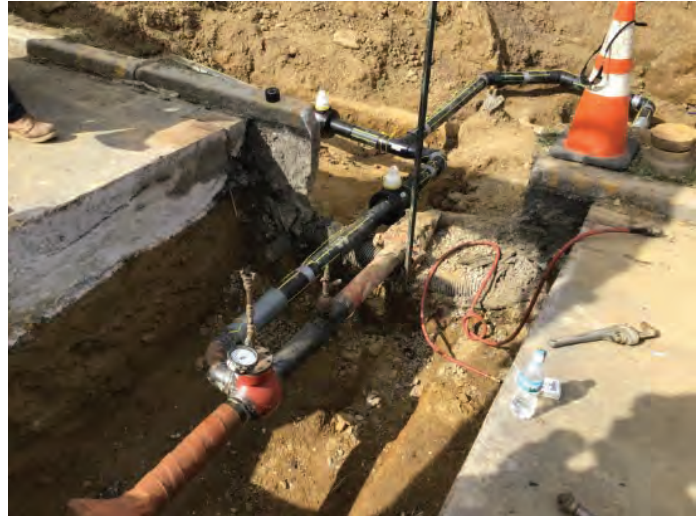
The tie-in at the east end of the circle.

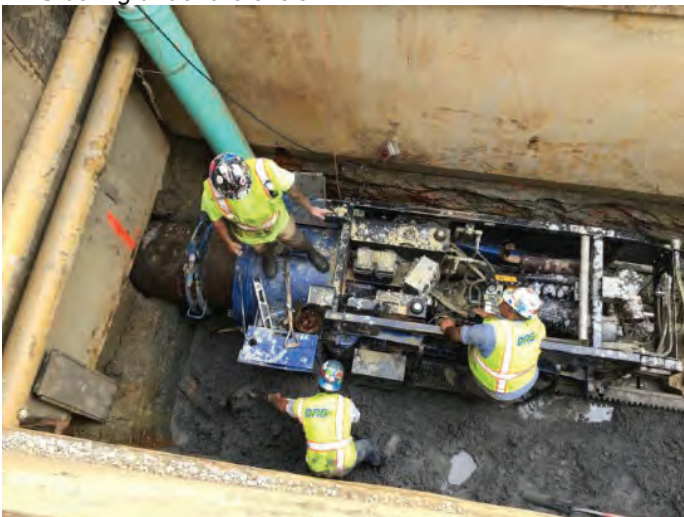
DRS boring under the circle.

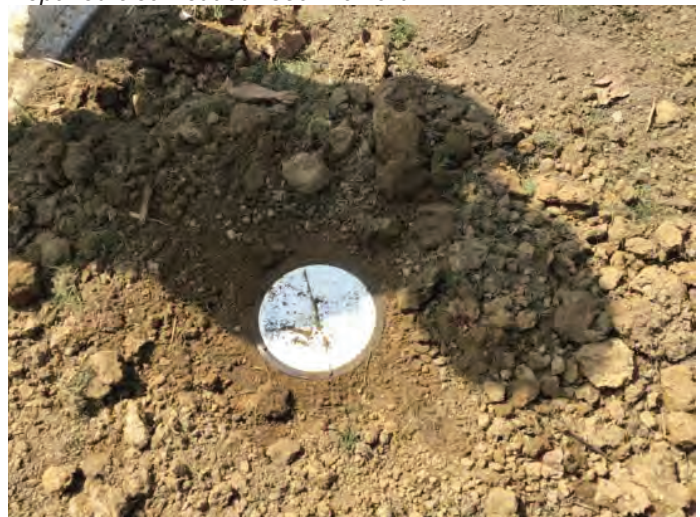
Repaired clean-out at 2850 Brainard.

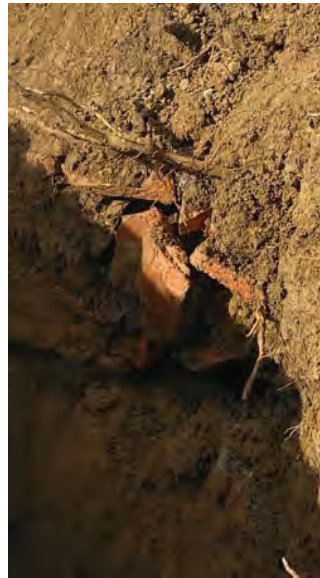
Previously broken storm drain from daylight to curb drain on Brainard.

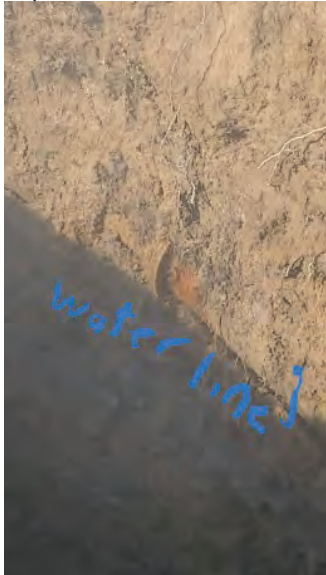
Exposed water line with existing rust by joint.

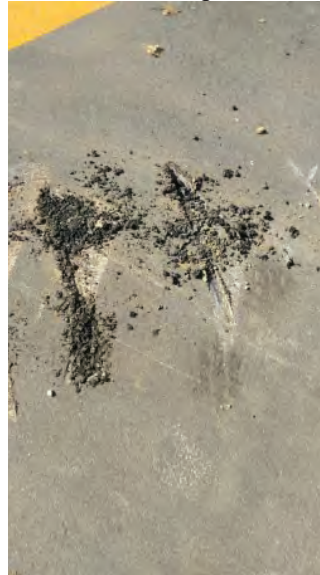
Some road damage from the excavator. Road was sweep

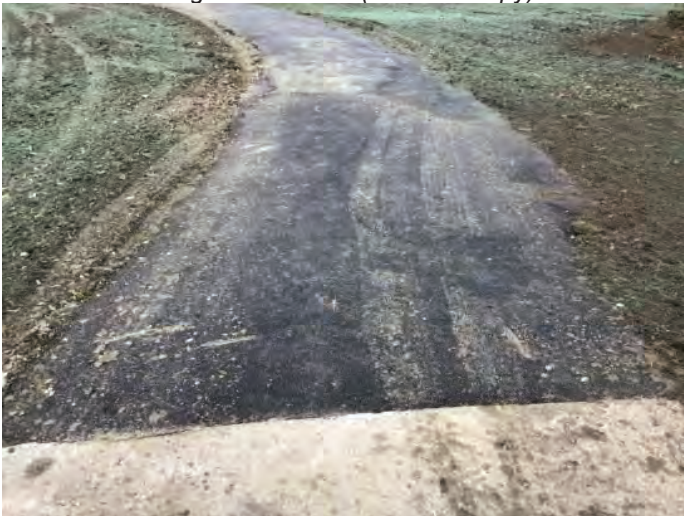
Inside the circle on the site the sidewalk $9 \times 78 = 702$ sf / 9 = 78 Sy, 3 inches depth. In front of Brainard Rd The Asphalt Pavement not in good condition (road is bumpy)

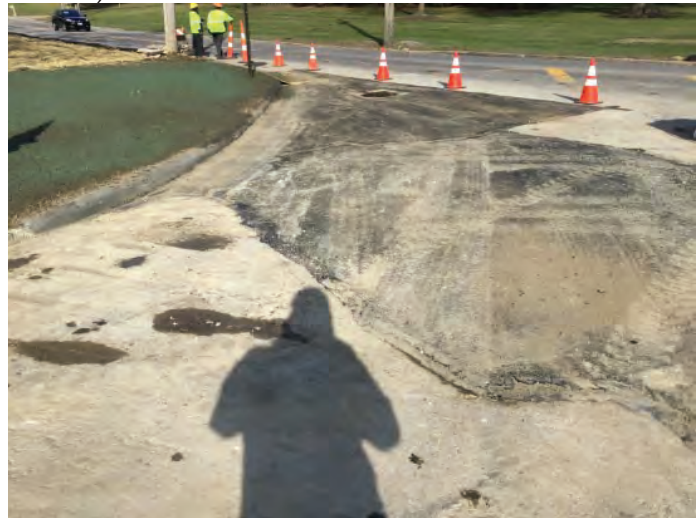
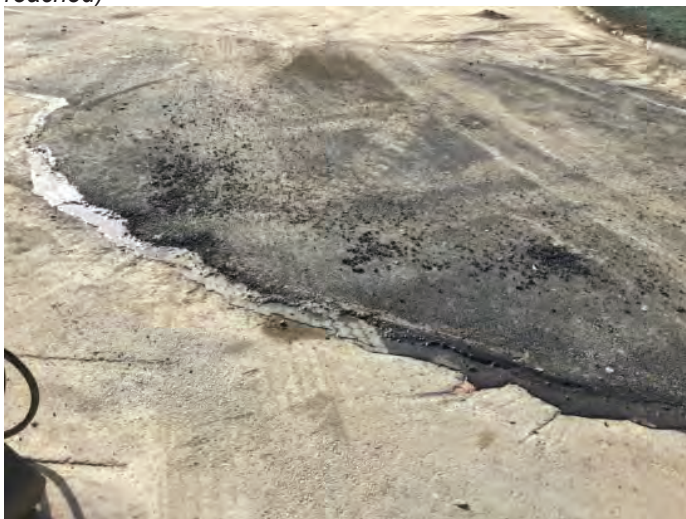
Note- The Asphalt work was not neat. (Expectations weren't reached)

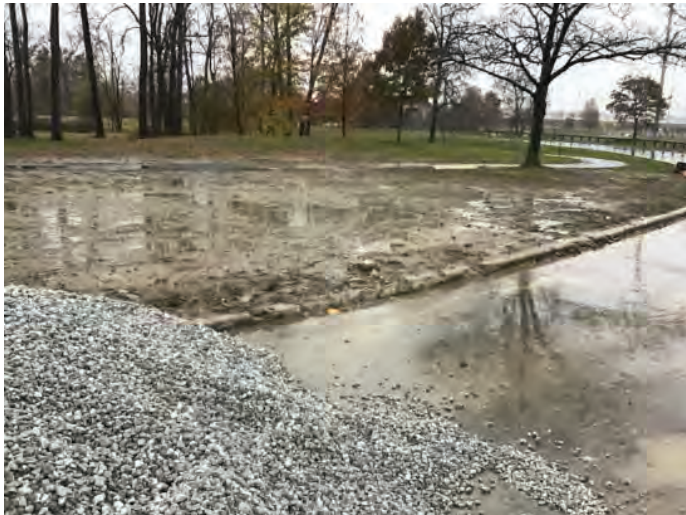
Curb broken in the circle

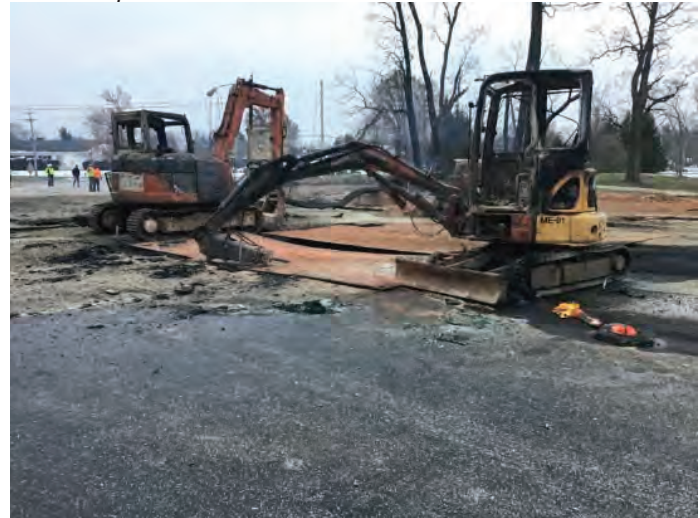
Gas-Pipeline explosion-shut downs roads in Pepper Pike, on Brainard Circle between Gates Mills Blvd SW - Brainard Rd - & W Shaker Blvd. on the opposite side to the Pepper Pike Police Department
