## **2973 Garford, Shawnee Twp, Ohio – Excavation Damage Summary**

### **Background**

### **Damage Description**

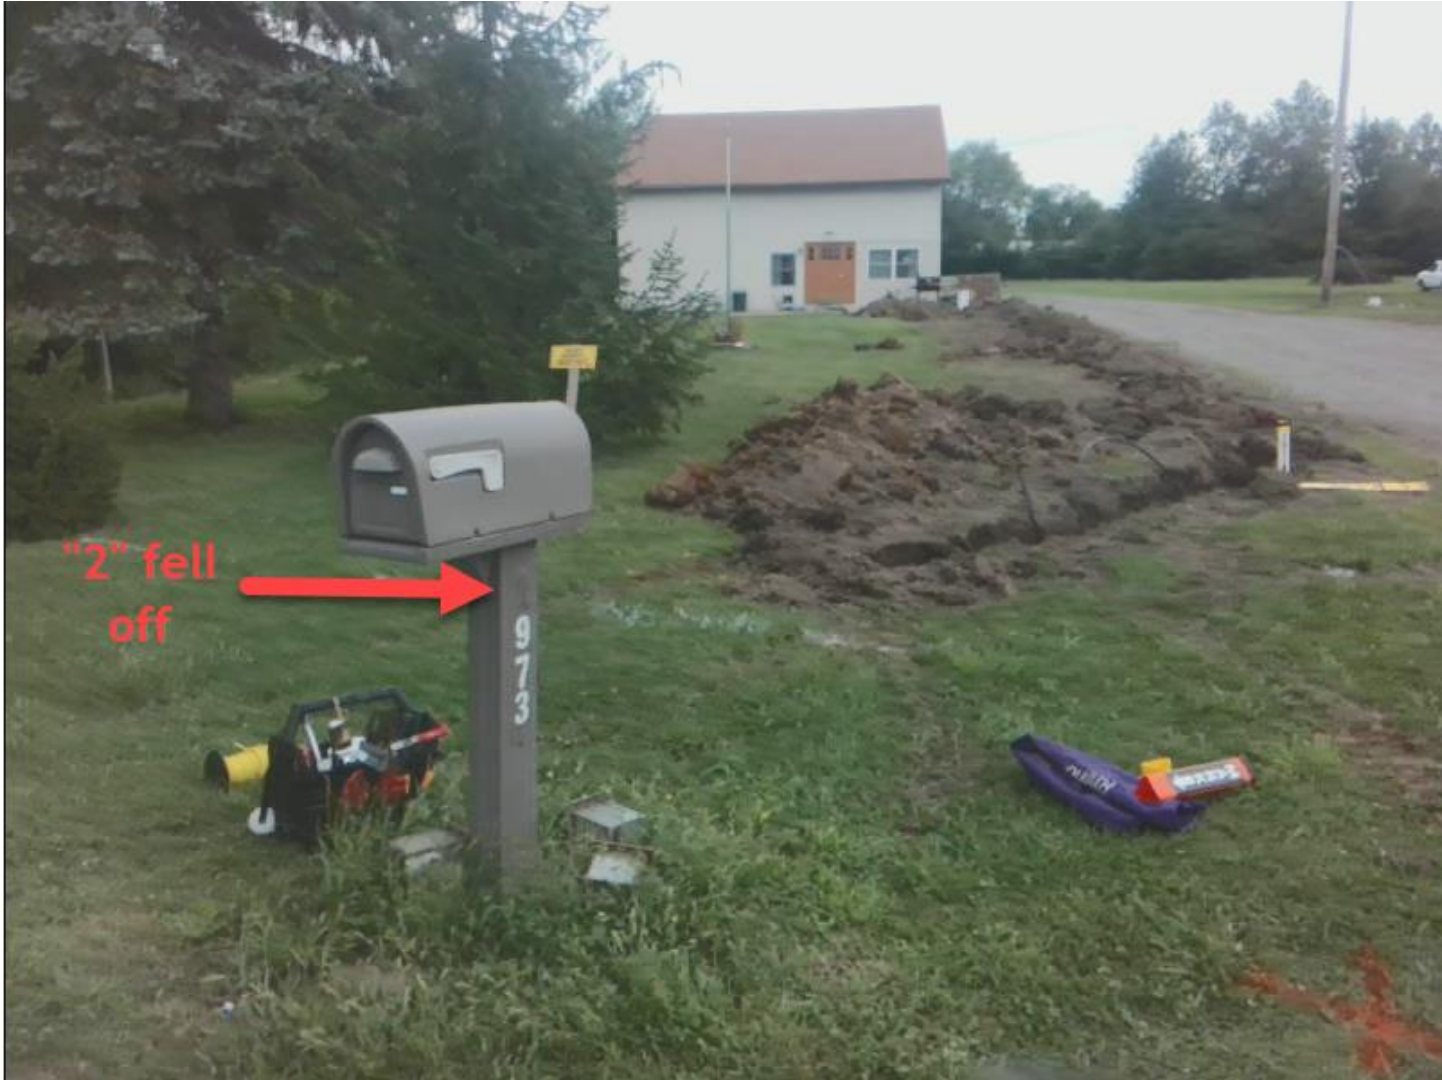
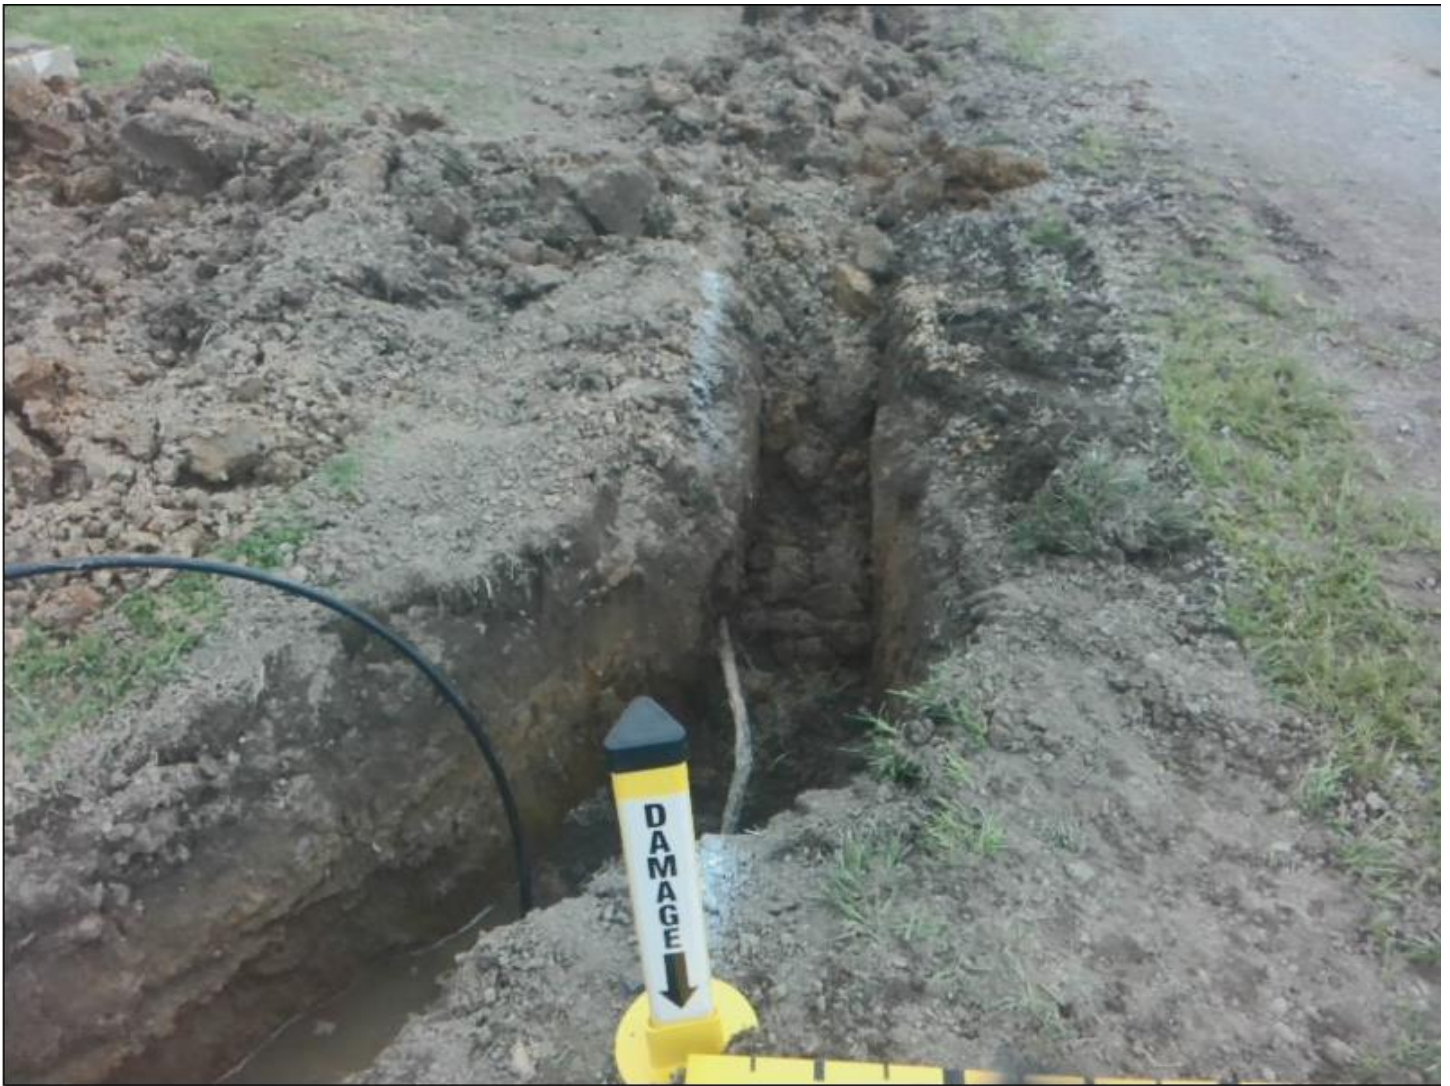
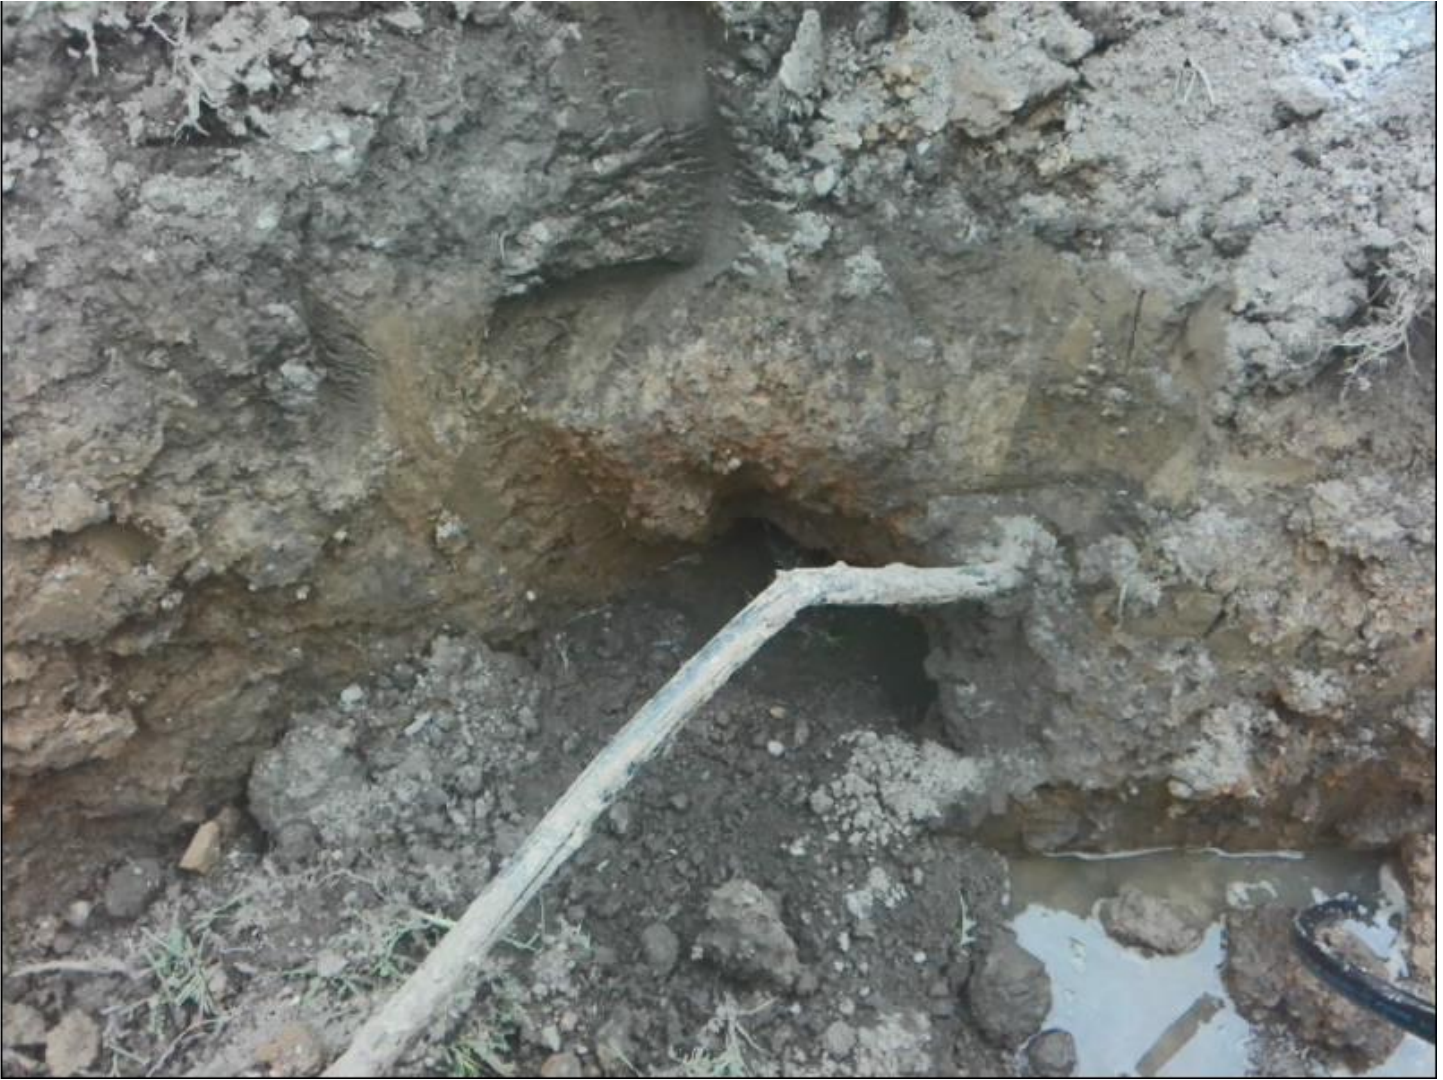
DEO generated an emergency excavation notice (A123702398) at 2:04 PM on 8/25/021 and responded to the reported address to investigate. Upon arrival, DEO found an unmarked damaged one (1) inch service line and initiated the repair.

The pictures below detail the damaged service line along the driveway at 2973 Garford Street in Shawnee Twp, Ohio.

Cornerstone Basement Solution failed to generate an excavation one call ticket and wait the required 48 hours prior to excavating, as required by section 3781.28 of the Ohio Revised Code (below). This failure resulted in an unmarked service line being damaged.

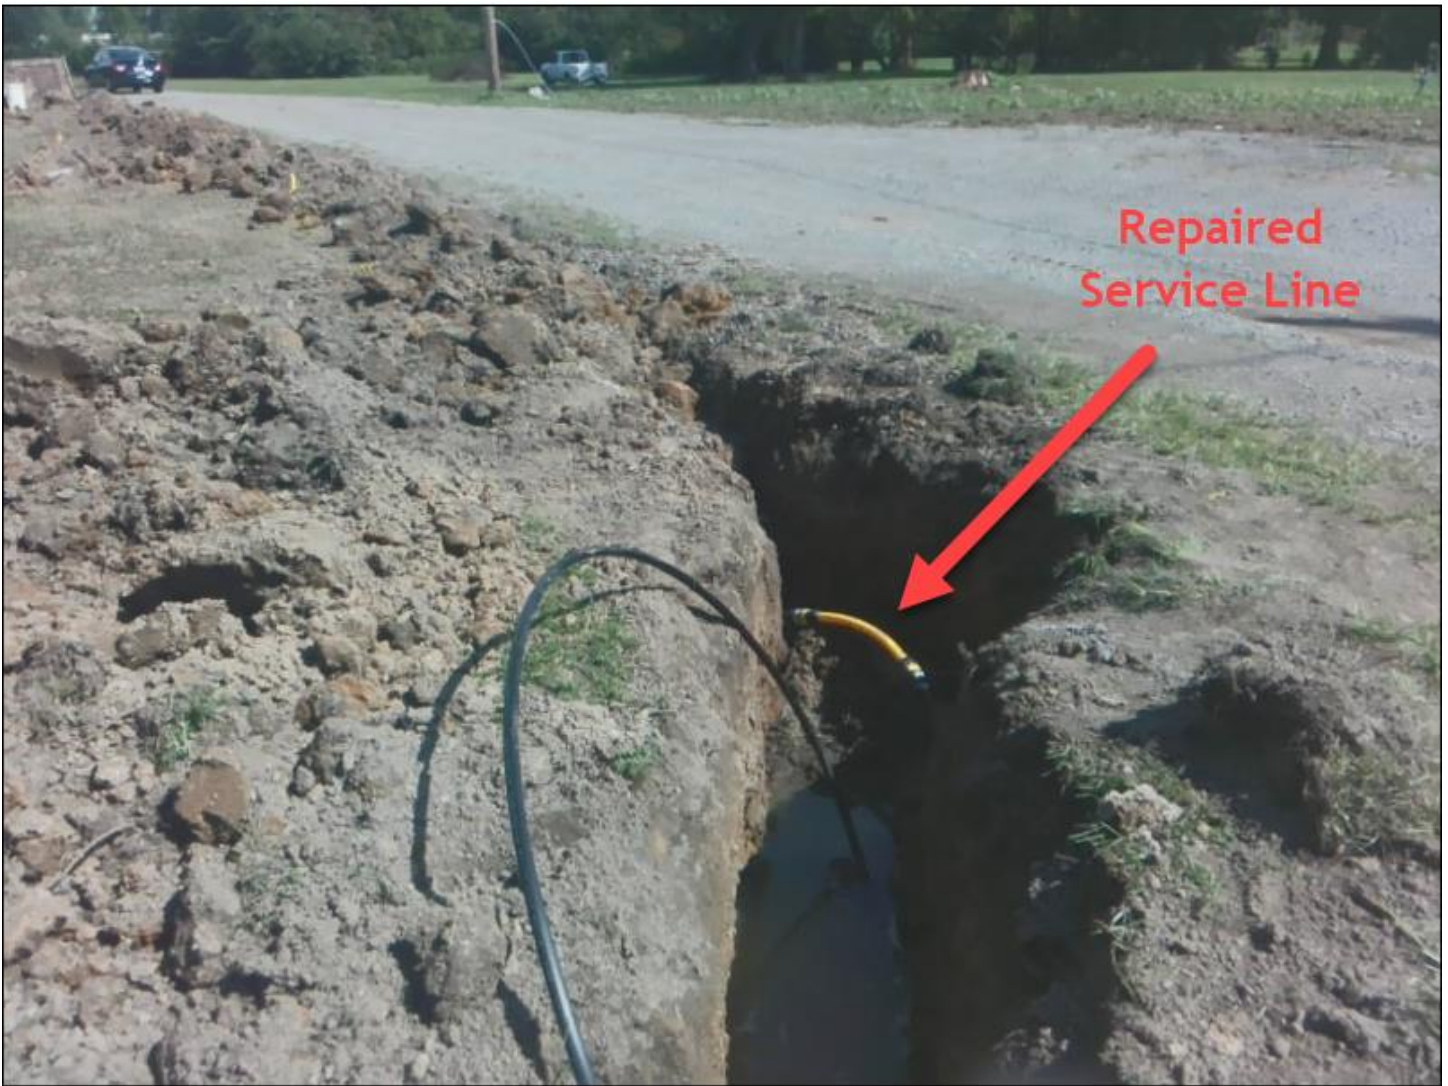
The picture below details the repaired service line 2973 Garford Av, Shawnee Twp, Ohio on 8/25/2021.
