## 1035 N Main Street, Lima Ohio - Excavation Damage Summary

#### **Background**

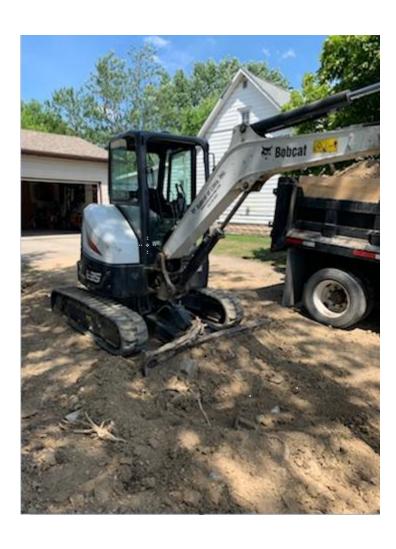
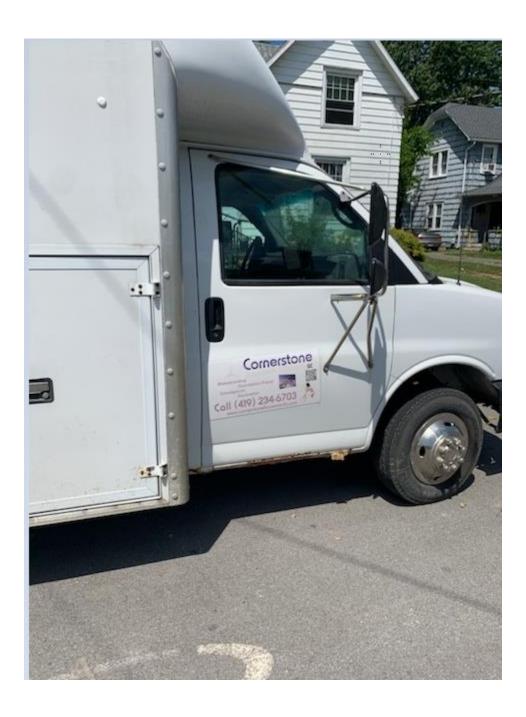
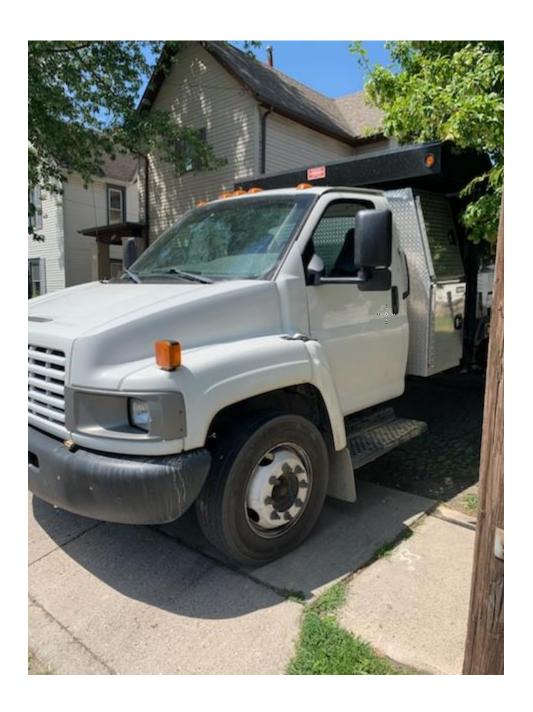
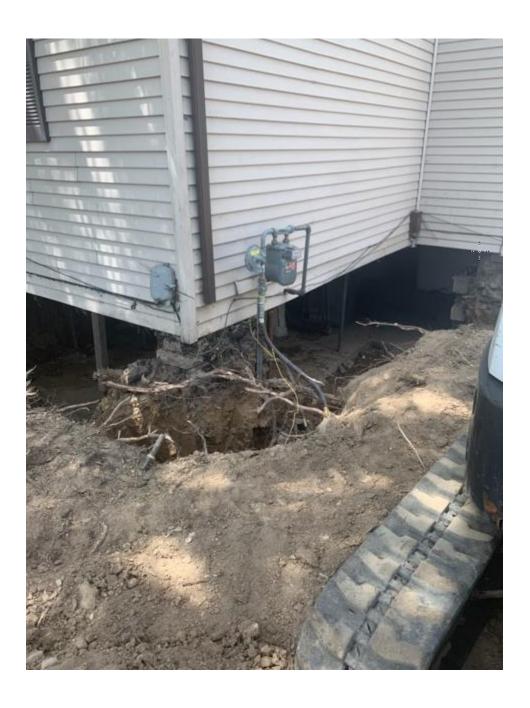
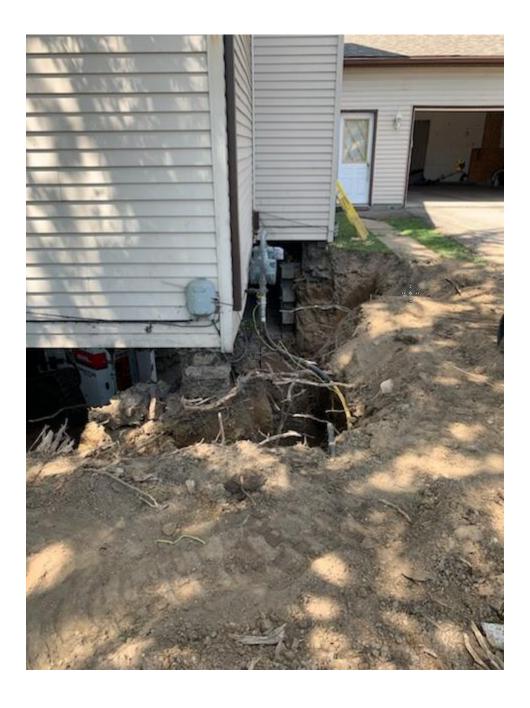
This was reported to the DEO C&M supervisor who immediately went to the site at approximately 11:55 AM on 7/15//2020 and found Cornerstone Basement Solution employees, who had just completed a significant excavation around and under the foundation of the house. The natural gas service line had been exposed and approximately 8 feet was suspended in the air. The meter was still being supported by the support stake in the remaining soil along the foundation of the building.

The picture(s) below detail the Cornerstone Basement Solution vehicles on site on 7/15/2020 and the exposed service line along the side house wall at 1035 N. Main Street, Lima, Ohio.
