Re: PUCO Case Number: 12-2198-RR-RCP
Rail Crossing: (473-711A) State Street

Per the Public Utilities Commission request, this letter has been generated to acknowledge and accept a temporary change to the railroad warning light at grade crossing 473-711A, located on State Street in Fremont Ohio.

City of Fremont Ohio
Rail Crossing 473-711A – State Street

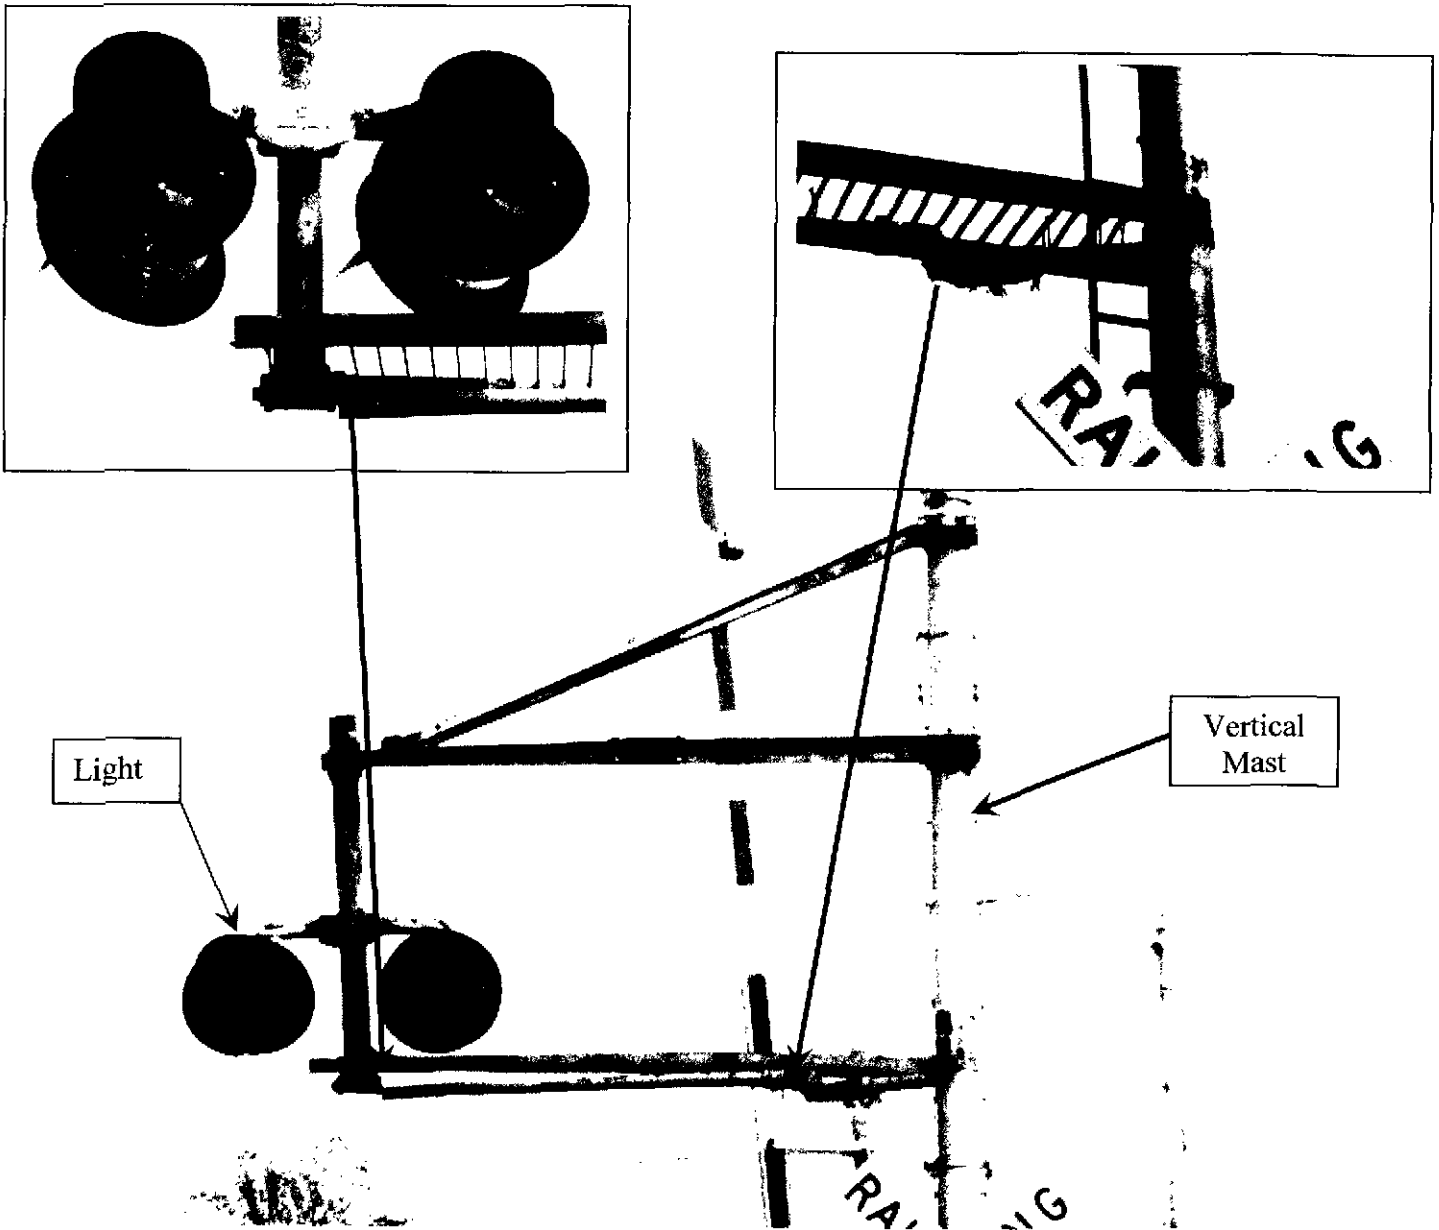
1. This warning device has been damaged and thereby structurally unsound (see photograph below and note unconnected members).
2. Damaged structural elements will be removed from the vertical mast (the vertical mast is shown on the right side of the photograph below).
3. The light shall be located on the vertical mast under these temporary conditions.

Photograph of Damaged Cantilever
State Street Crossing – (473-711A)
