# **LETTER OF NOTIFICATION FOR Dilles Bottom-FE Corridor 138 kV Transmission Line Project**

PUCO Case No. 18-0603-EL-BLN

### AEP Ohio Transmission Company, Inc.'s Dilles Bottom-FE Corridor 138 kV Transmission Line Project

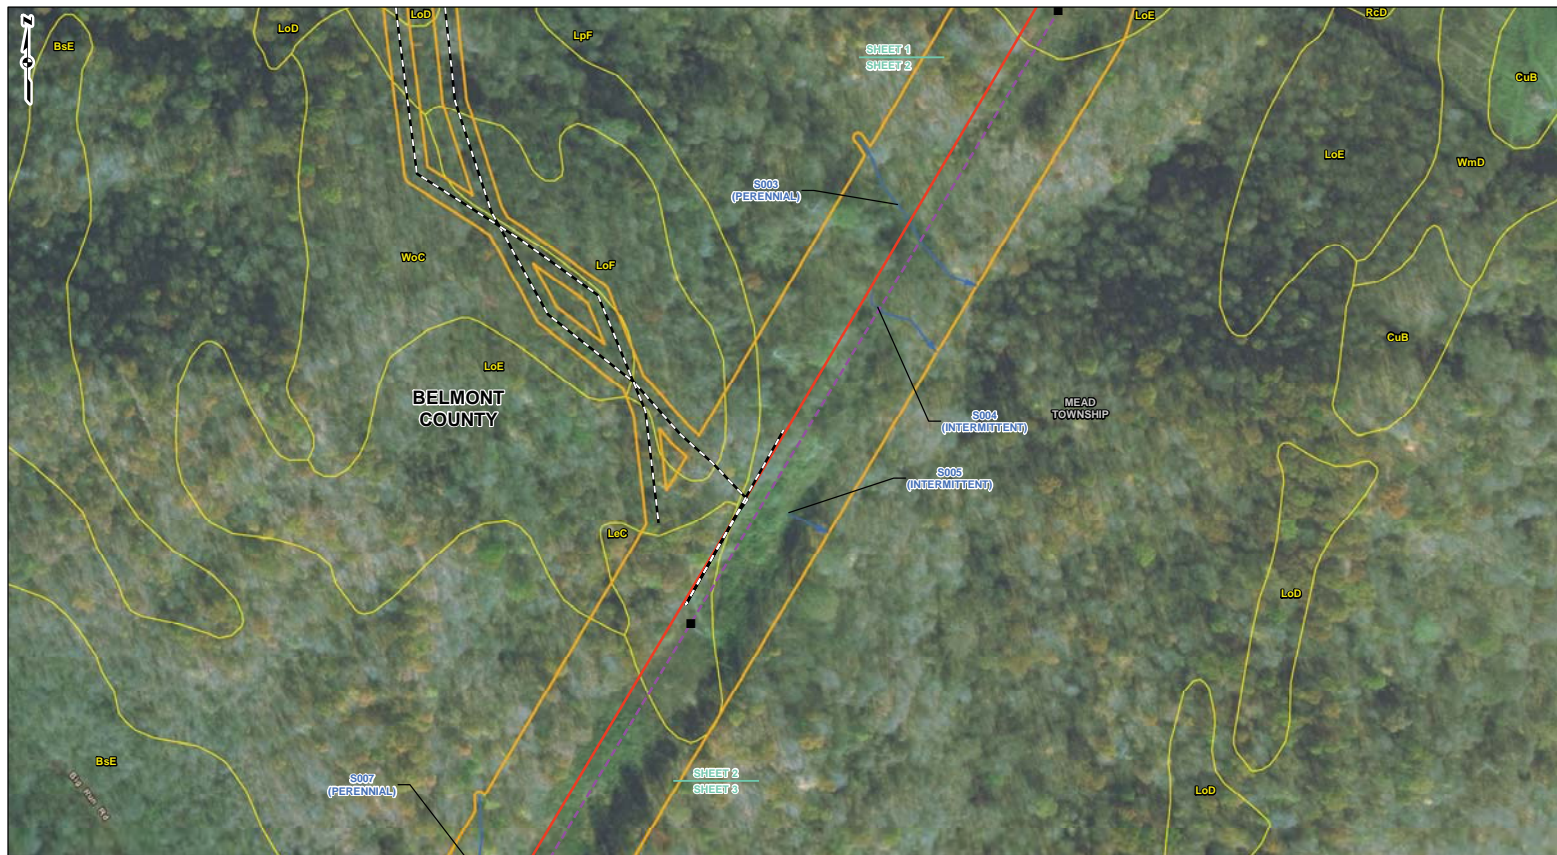
FIGURE 2 RESOURCE LOCATION MAP SHEET 2 OF 5	
<b>DILLES BOTTOM</b> <b>138kV LINE REBUILD PROJECT</b> <b>AMERICAN ELECTRIC POWER</b>	
DRAWN BY: JTH CHECKED: REZ	DATE: 5/17/2018 APPROVED:

LEGEND	
■ Proposed Structure	- - - Proposed Transmission Line
● Culvert	— Existing Transmission Line
▲ Upland Data Point	- - - Access Road
▼ Wetland Data Point	— Stream
▲ Soil Test Pit	..... Open-Ended Boundary
□ Study Area	0 100 200 400 Feet
□ Soil Type Boundary	□ Township Boundary
□ ODNr Land	□ County Boundary
□ NWI Wetland	□ Wetland Type:
□ 100-Year Floodplain	□ PFO
□ FEMA Floodway

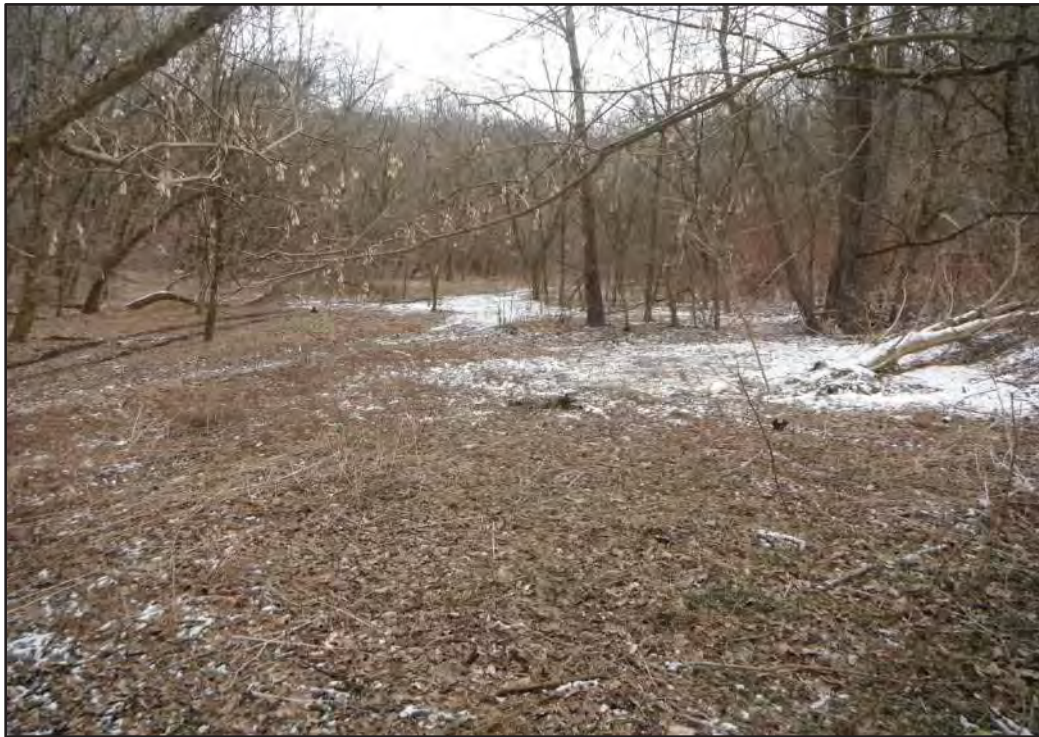
**Photograph 1. Wetland W001-PFO-CATMOD2, Facing South**

Two (2) PFO wetlands were identified and delineated within the Project study area. In order to document site conditions, USACE Data Forms were completed for each wetland and upland reference. Information on the delineated wetlands can be found in Table 1 and photographs of the wetlands are included in Appendix A.

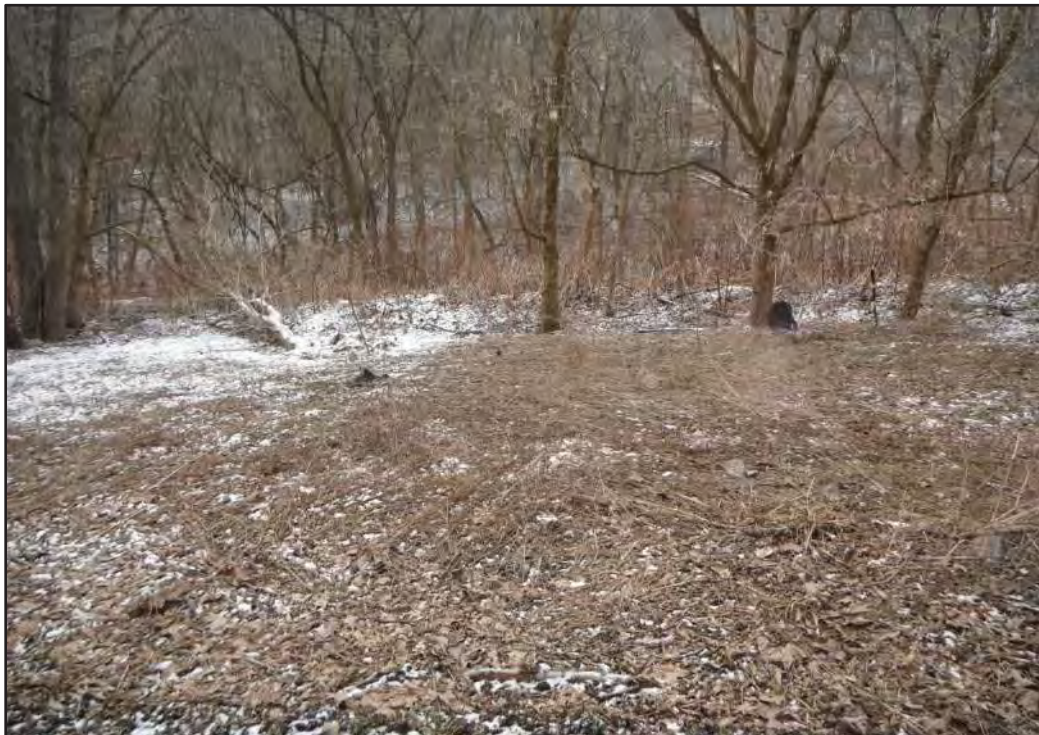
**Photograph 2. Wetland W001-PFO-CATMOD2, Facing West**

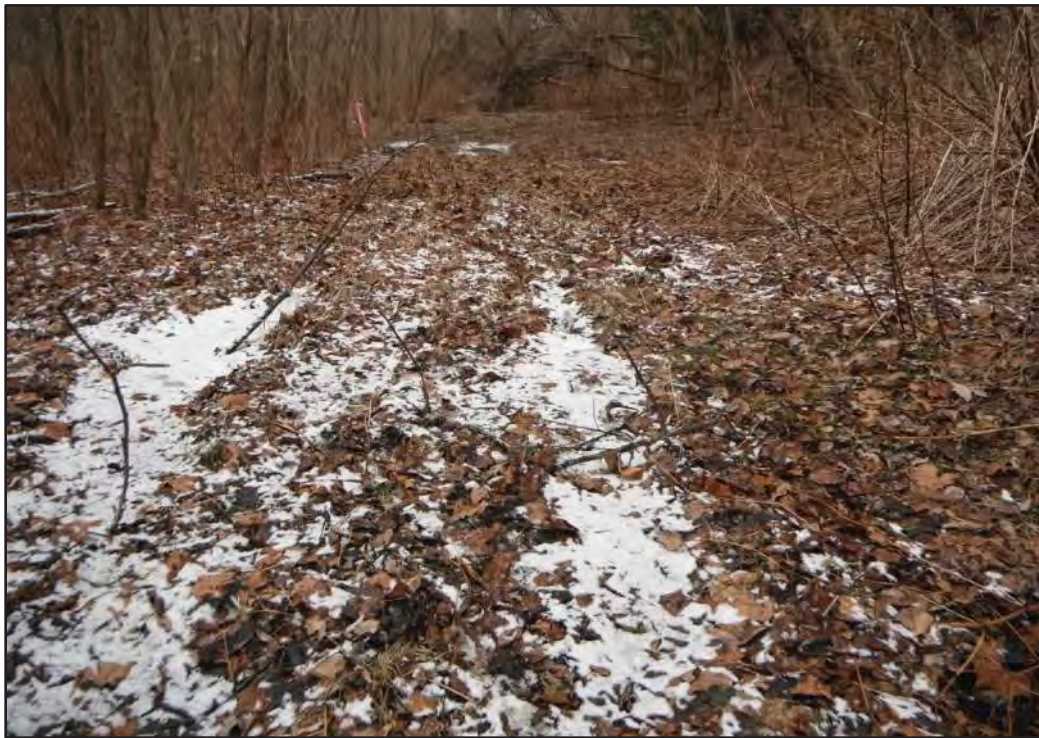
**Photograph 3. Wetland W002-PFO-CATMOD2, Facing North**

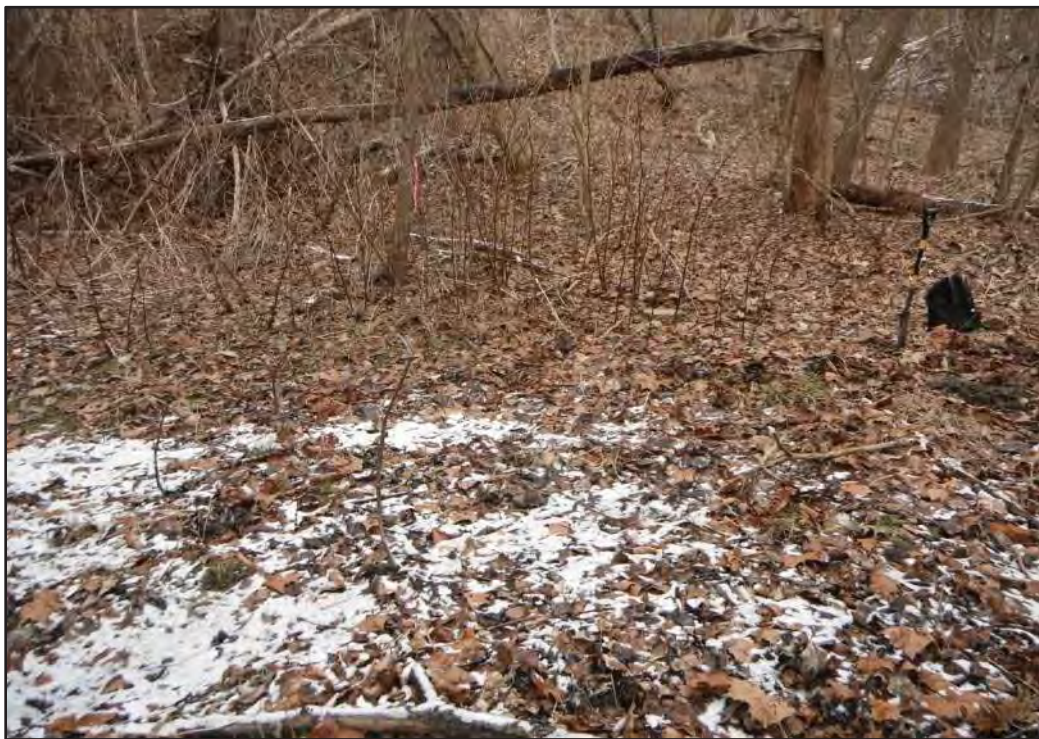
**Photograph 4. Wetland W002-PFO-CATMOD2, Facing East**

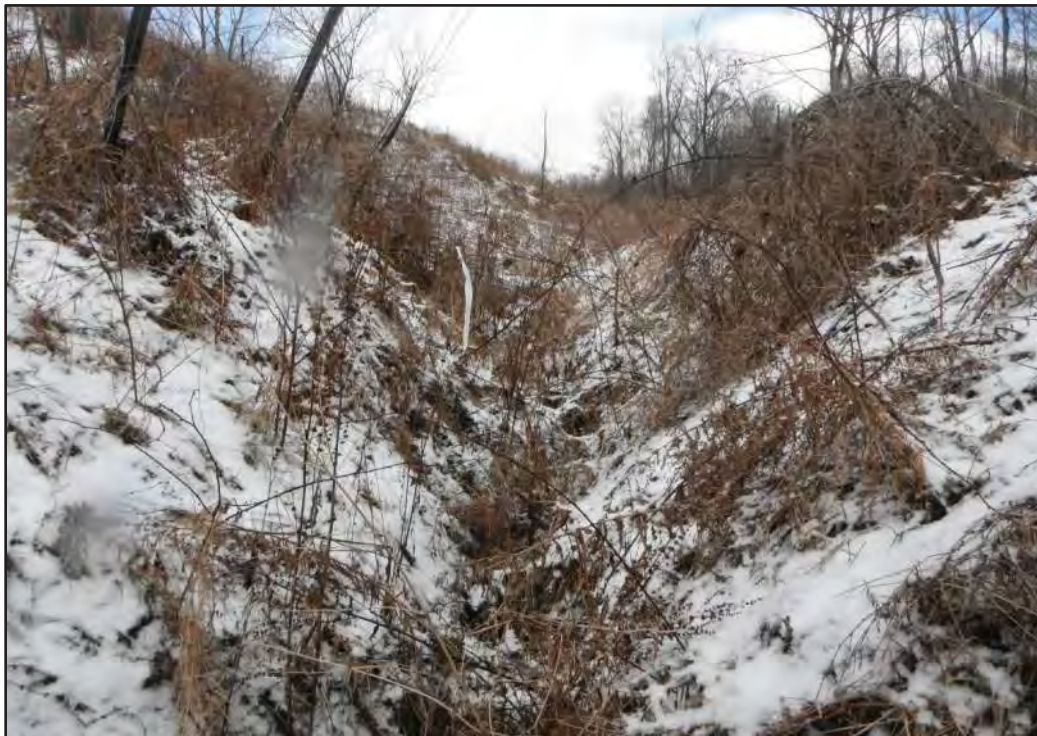
**Photograph 5. Stream S001, Upstream, Facing East**

Eleven (11) stream segments were identified and delineated within the Project study area. Five (5) streams were classified as having a perennial flow regime, two (2) were classified as intermittent and four (4) were classified as ephemeral. Information on the delineated waterbodies and their classifications can be found in Table 2, and photographs of the identified streams are included in Appendix A.

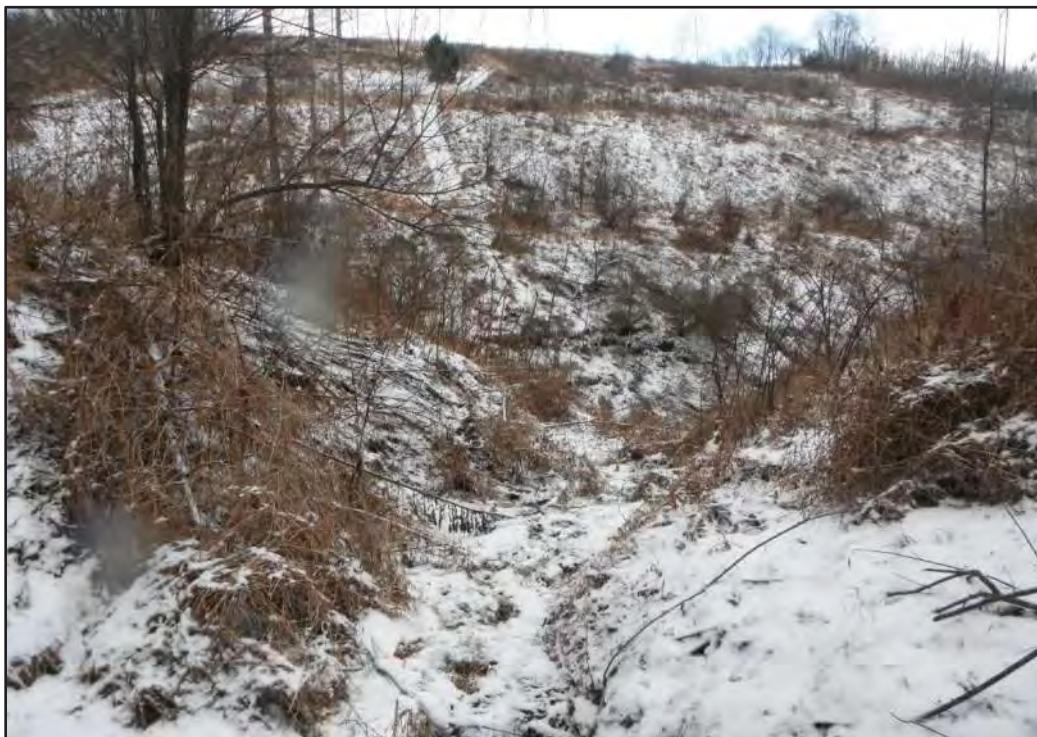
**Photograph 6. Stream S001, Downstream, Facing West**

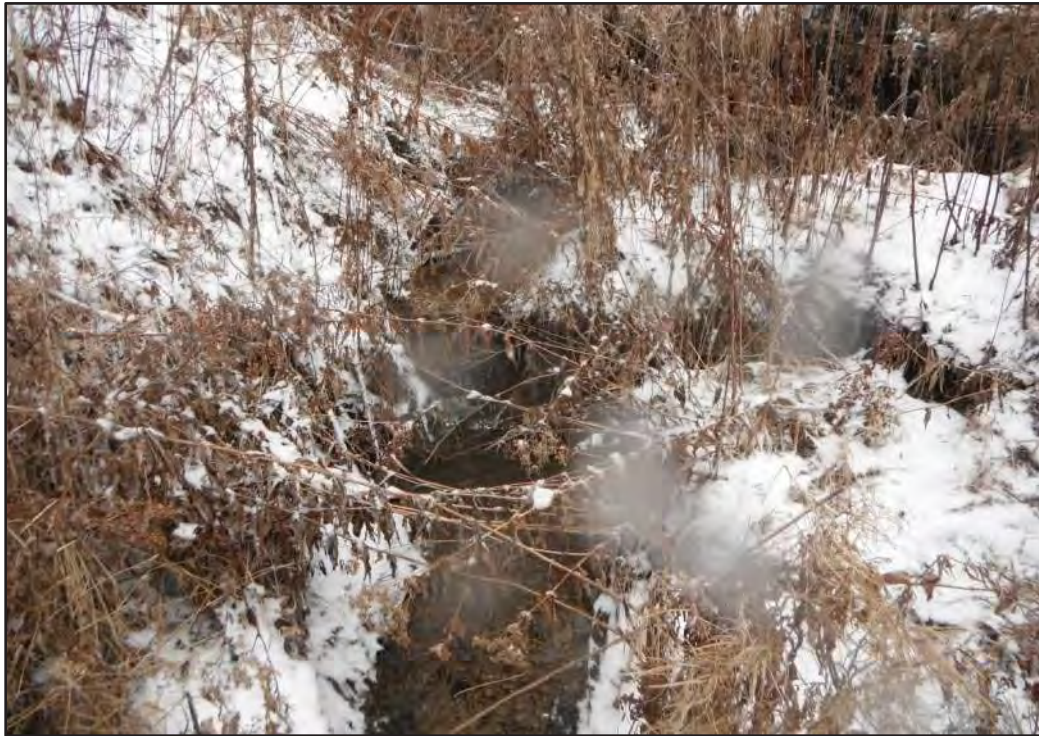
**Photograph 7. Stream S002, Upstream, Facing North**

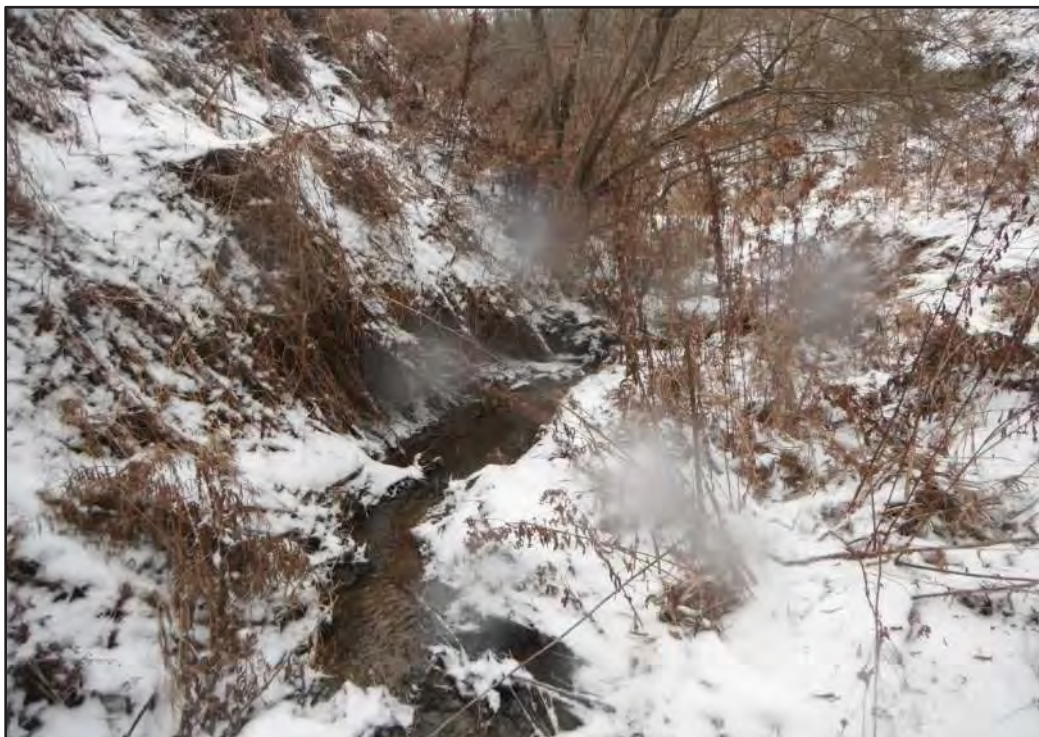
**Photograph 8. Stream S002, Downstream, Facing South**
