**Re:** PUCO Case No. 16-1413-RR-FED- In the Matter of the Authorization of Norfolk Southern Railway to Install Active Warning Devices at a Grade Crossing in Fulton County.

# Norfolk Southern Variance Request

## Case #16-1413-RR-FED

### Staff Response

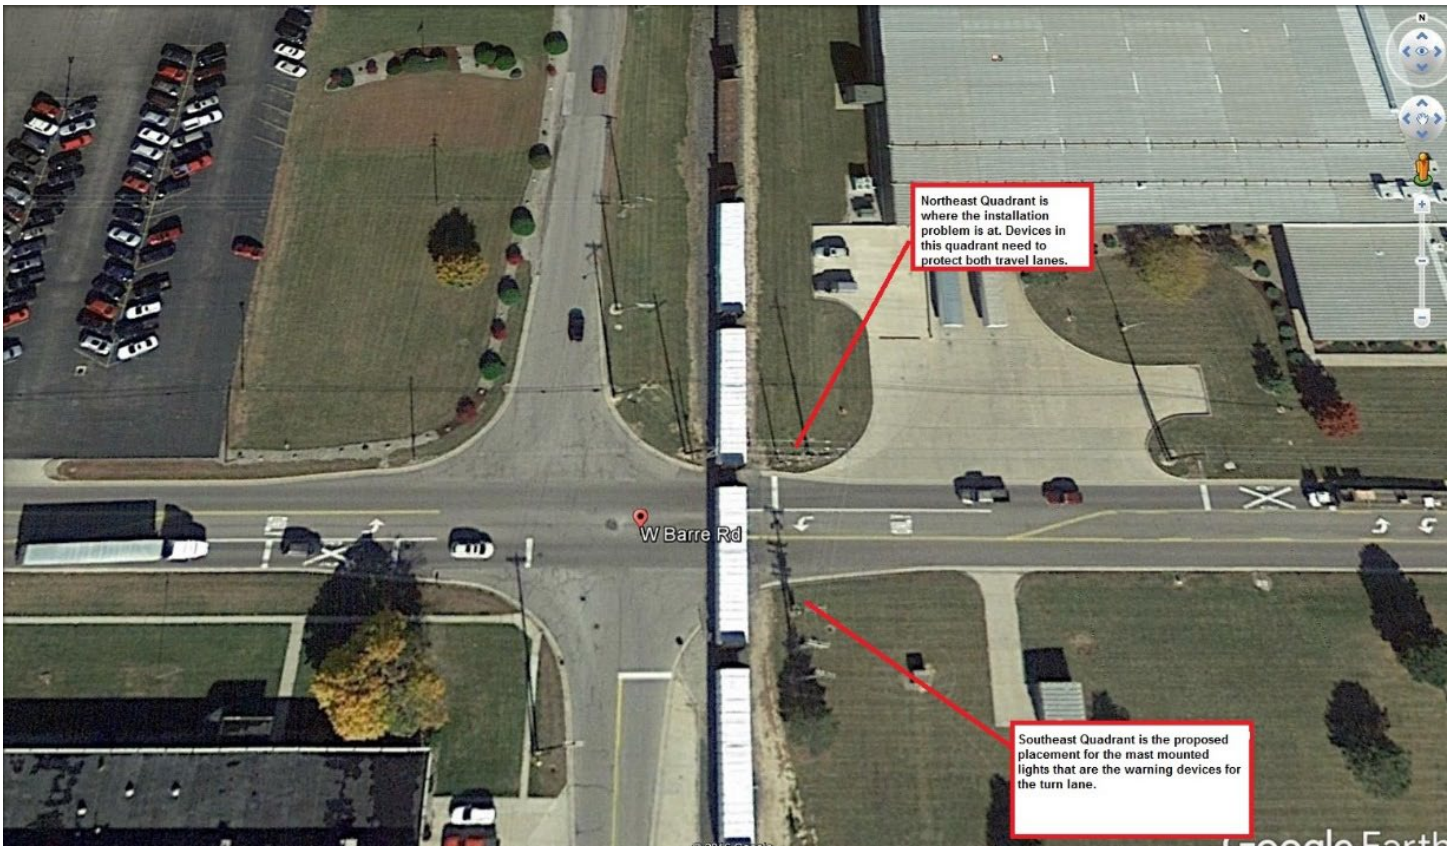
## Exhibit A

Overview of the W. Barre Street Crossing

The remaining issue to resolve, and the subject matter of the variance request, concerns the two westbound traffic lanes located east of the tracks at the intersection of the railroad with Myers Road and W. Barre Road. The active warning devices in the northeast quadrant will need to protect two westbound traffic lanes at the crossing. The standard method to protect both traffic lanes is to install a cantilever device that would have flashing lights specific to both travel lanes and would put the flashing lights for second lane (the turn lane) over the traveled way so that approaching traffic would see the devices.<sup>2</sup>

<sup>1</sup> See Exhibit A for a photograph and overview of the crossing.

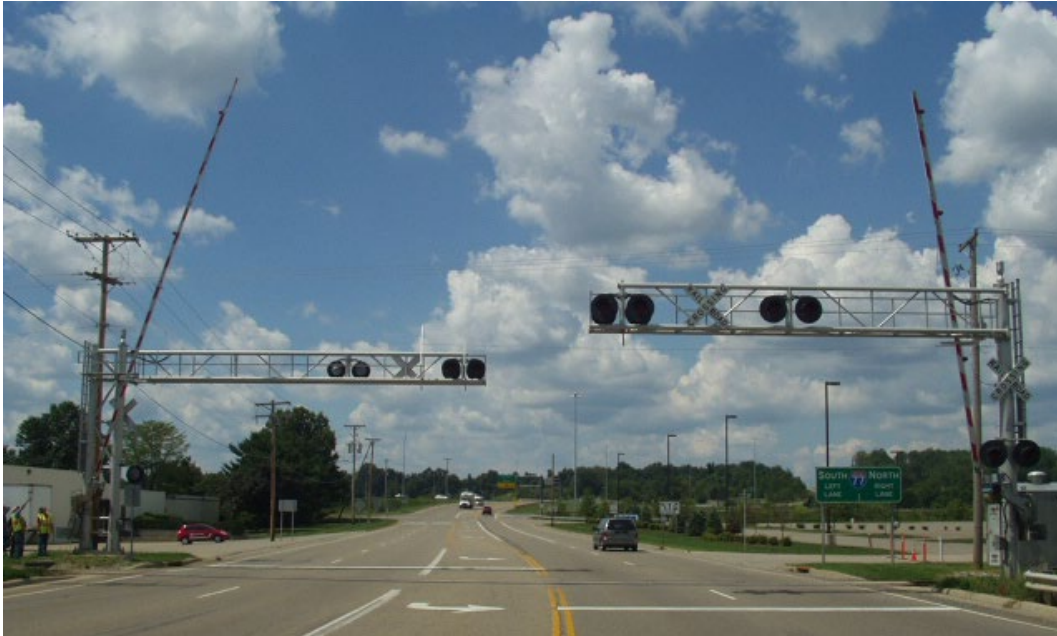
DOT#142-894G: Shuffel Drive Canton

Multiple Travel Lanes in each direction.

<sup>2</sup> See Exhibit B for examples of active warning devices over multiple traffic lanes at similarly configured crossings.

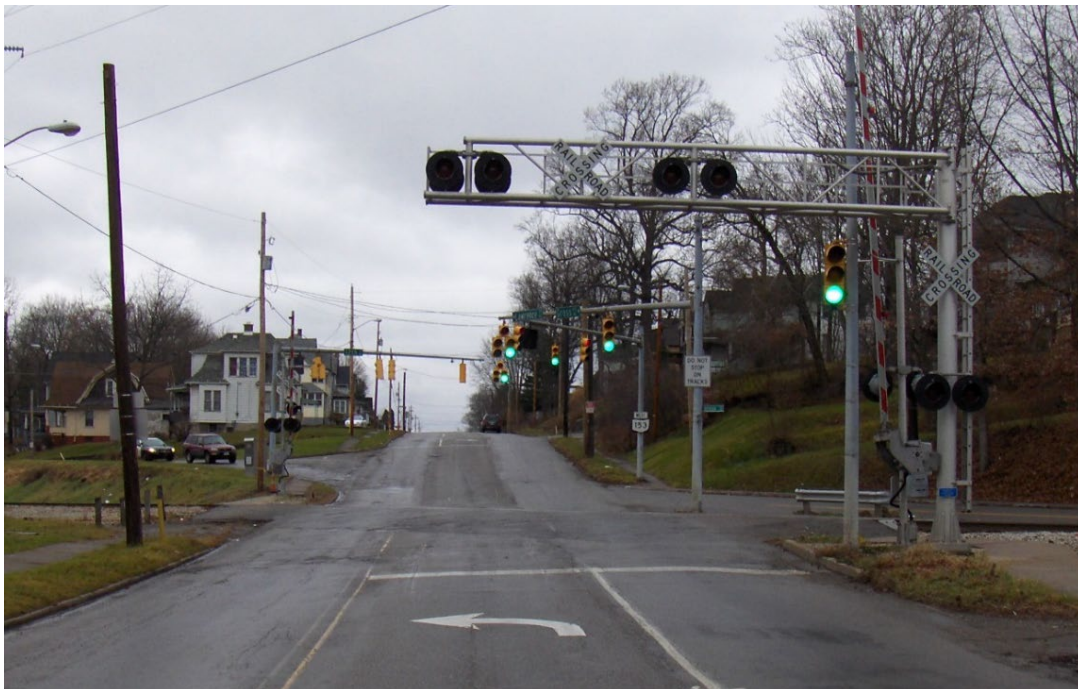
DOT# 474-399K:12<sup>th</sup> Street NE Canton

Multiple Travel Lanes in one direction.

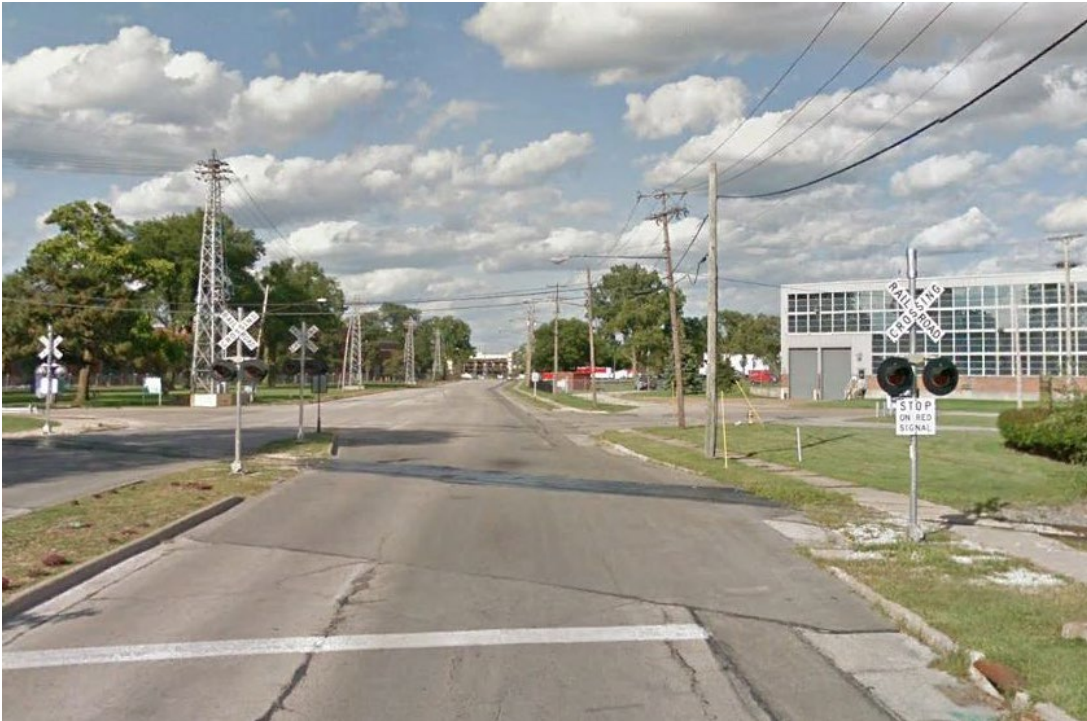
DOT#851-575V Superior Street Rossford

Multiple Travel Lanes in both directions with median.
