Exhibit K
Drain Tile Mitigation Plan

Drain Tile Mitigation Plan

Pleasant Prairie Solar Energy Project

January 2021, Draft

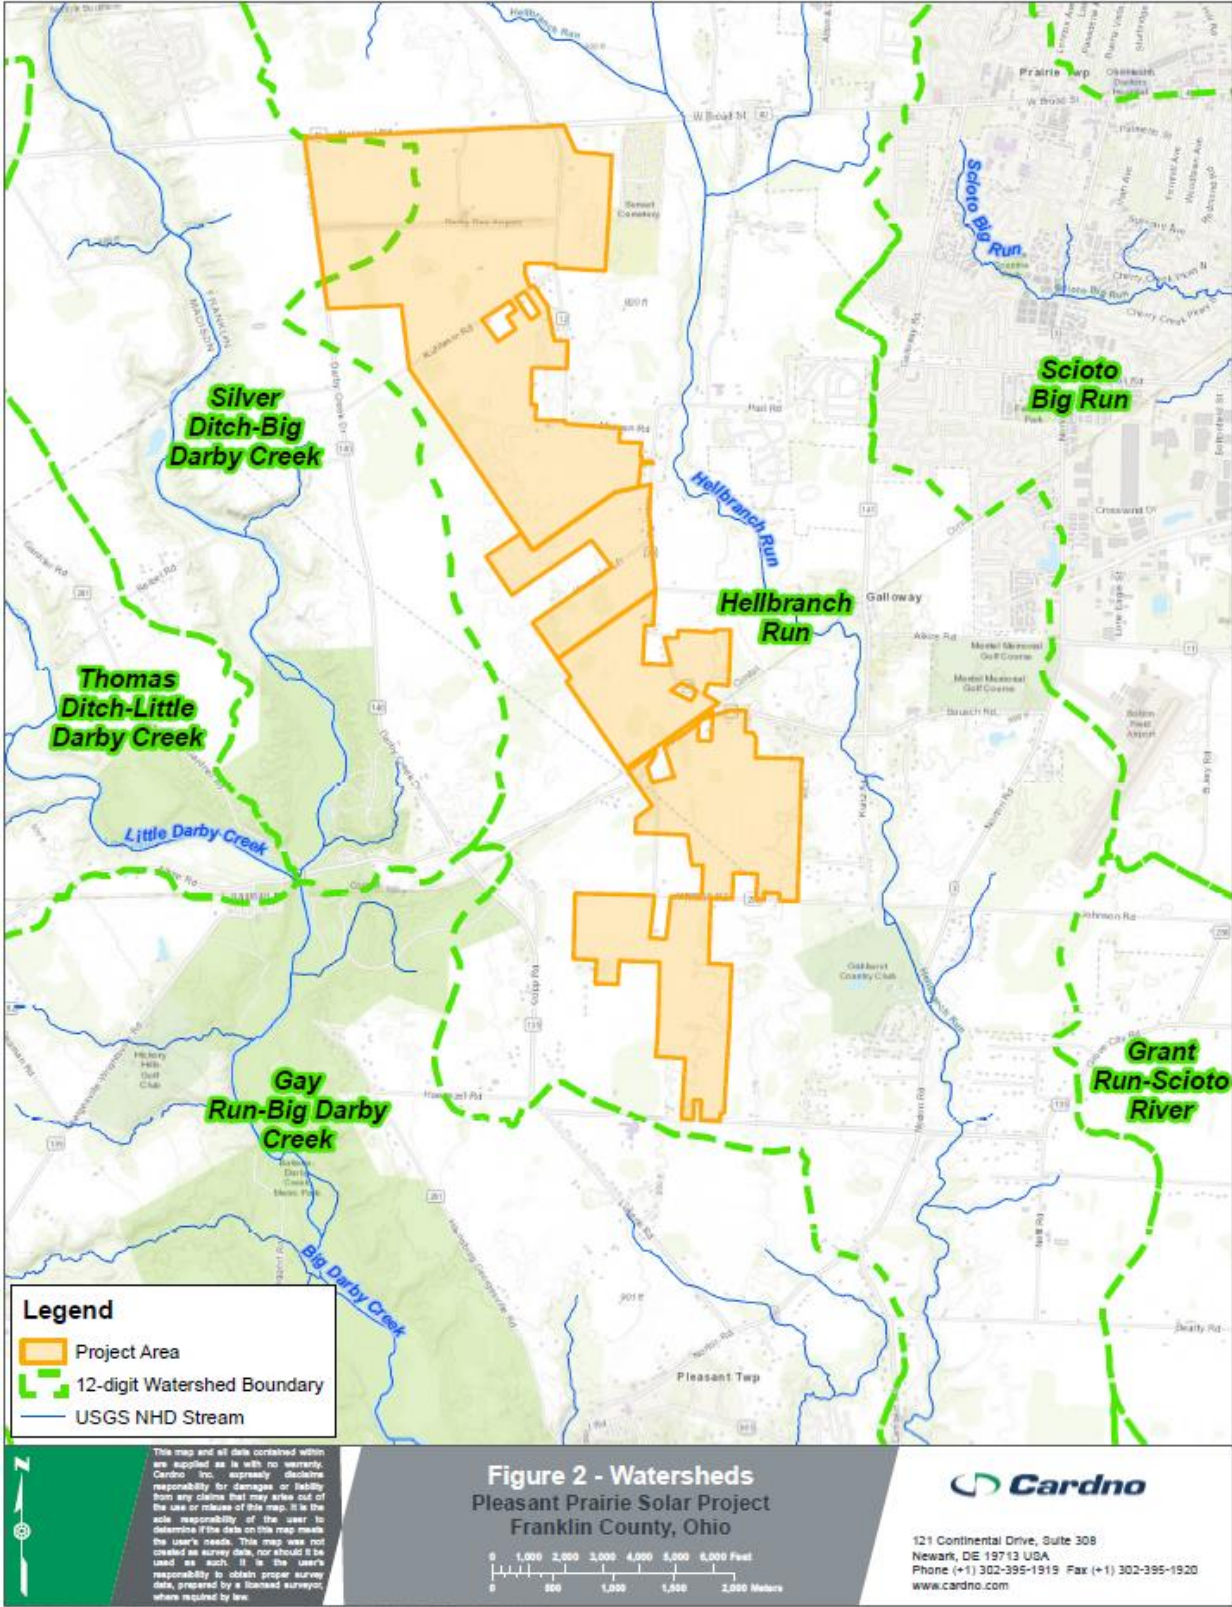
Figure 2. Pleasant Prairie Solar Project Watersheds in Franklin County, Ohio

The Facility lies entirely within the drainage of Big Darby Creek Watershed which flows south into the Scioto River and then to the Ohio River. More specifically, the site drains predominantly east to the Hellbranch Run drainage before flowing south into Big Darby Creek (Figure 2).

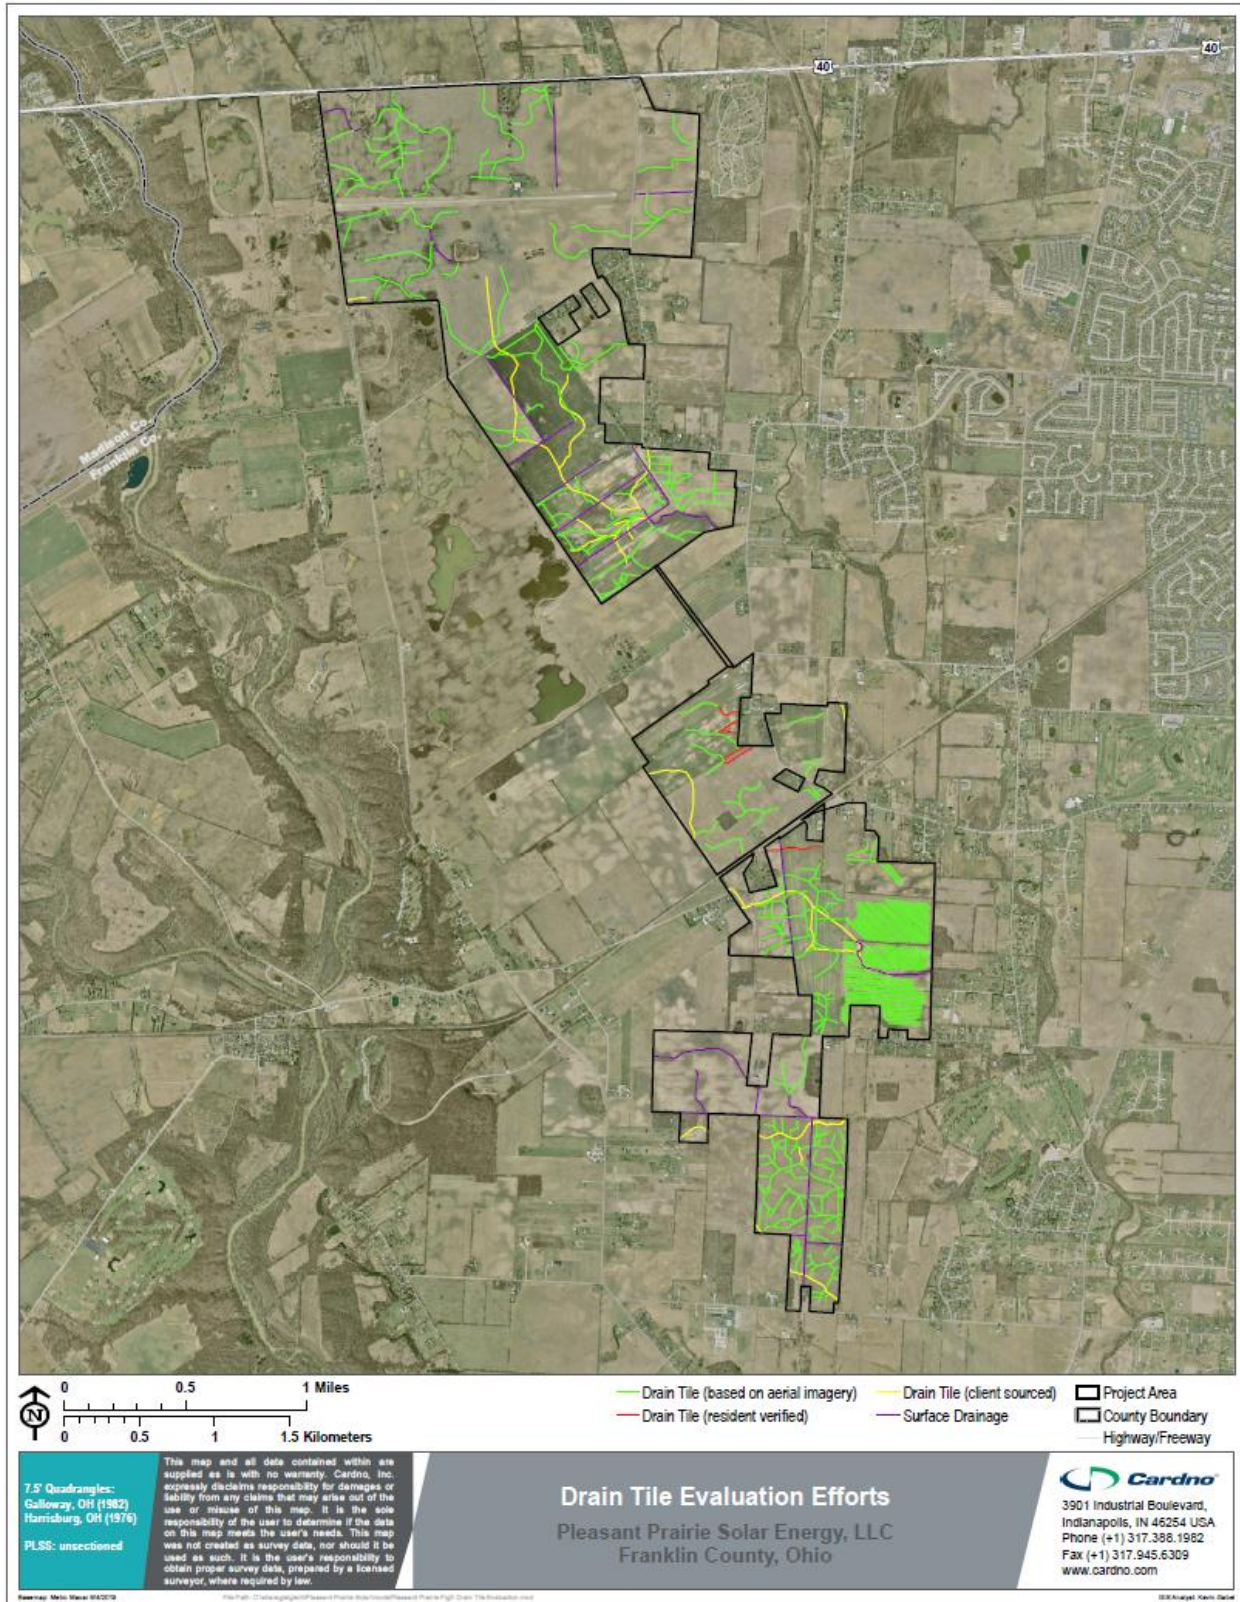
Figure 3. Drain Tile Evaluation

The drainage tiles appear to be limited to natural drainages or non-existent on the majority of the parcels within the Project with the exception of the eastern parcels south of Alkire Rd and north of Johnson Road as well as the southern portion parcel just north of Kropp Rd (Figure 3: Drain Tile Evaluation). When a lateral tile is discovered during excavation work, other tiles should be assumed present and contractors shall be vigilant in identifying lines that have been intercepted by construction work.

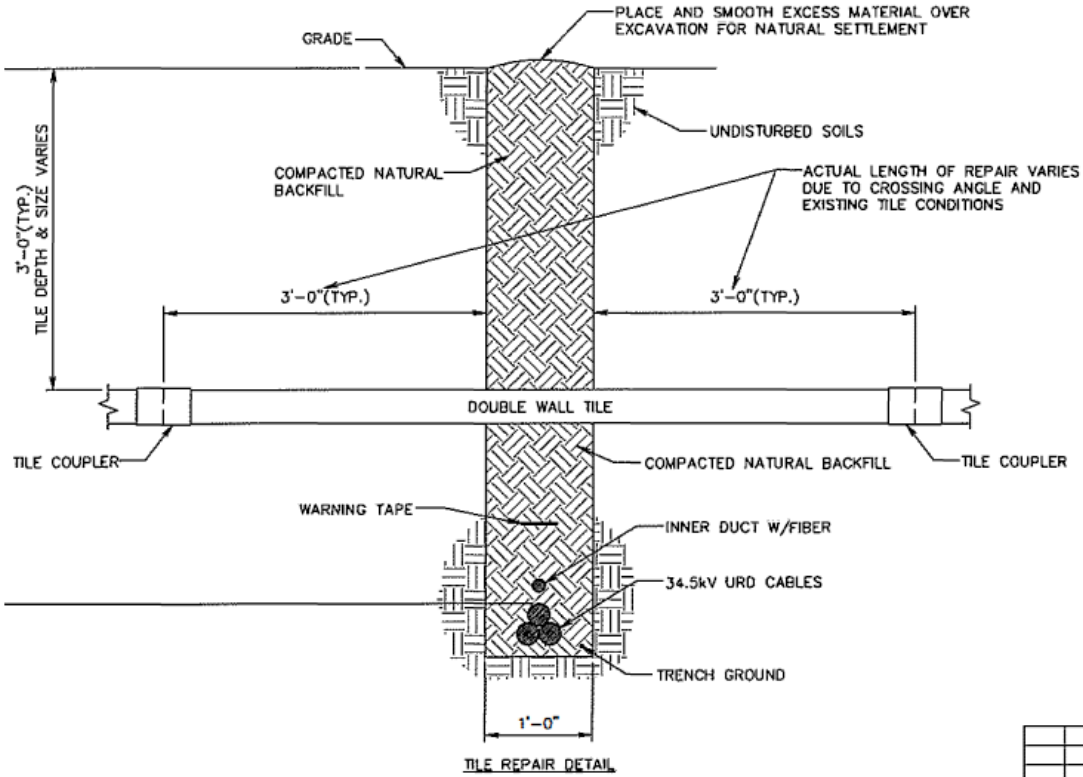
Figure 4. Drainage Tile Repair Schematic

- a) Repairs to drain tile lines shall follow the typical drawing below (Figure 5);
 - b) All subsurface drainage tile main lines shall be repaired;
 - c) Alternatively, new drainage tile lines of comparable or improved materials and similar or greater diameter, will be installed at the appropriate depth and slope to maintain the drainage that was present prior to construction activities on the property;

- d) Subsurface drain tile repair or replacement shall maintain the original alignment, gradient, and water flow to the greatest extent practical.
