Re: Case No. 20-1605-EL-BGN

In the Matter of the Application of Birch Solar 1, LLC for a Certificate of Environmental Compatibility and Public Need to Construct a Solar-Powered Electric Generation Facility in Allen and Auglaize Counties, Ohio.

Supplement to Application – USFWS Coordination and History/Architecture Reconnaissance Survey Report

History/Architecture Reconnaissance Survey for the Proposed Birch Solar Project in Portions of Shawnee Township, Allen County and Logan Township Auglaize County, Ohio

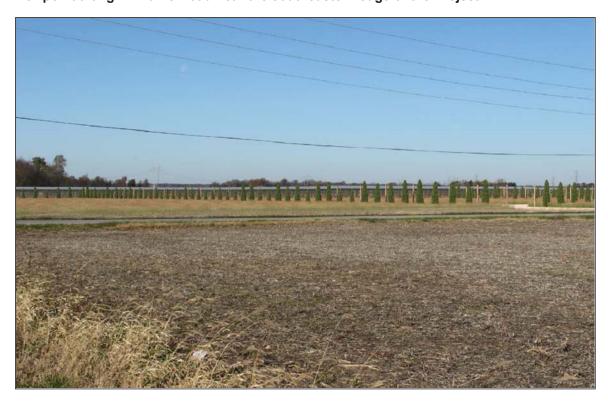
Figure 2. Simulated view of the vegetative screening at full height and cedar post farm fencing at a viewpoint along W. Hume Road near the southeastern edge of the Project

Based on the architectural locations identified in the attached report as potentially eligible for listing on the National Register of Historic Places, Birch Solar is committed to vegetative screening, similar to the screening already being proposed on the Project, that would further limit views of the Project from these potentially eligible resources.

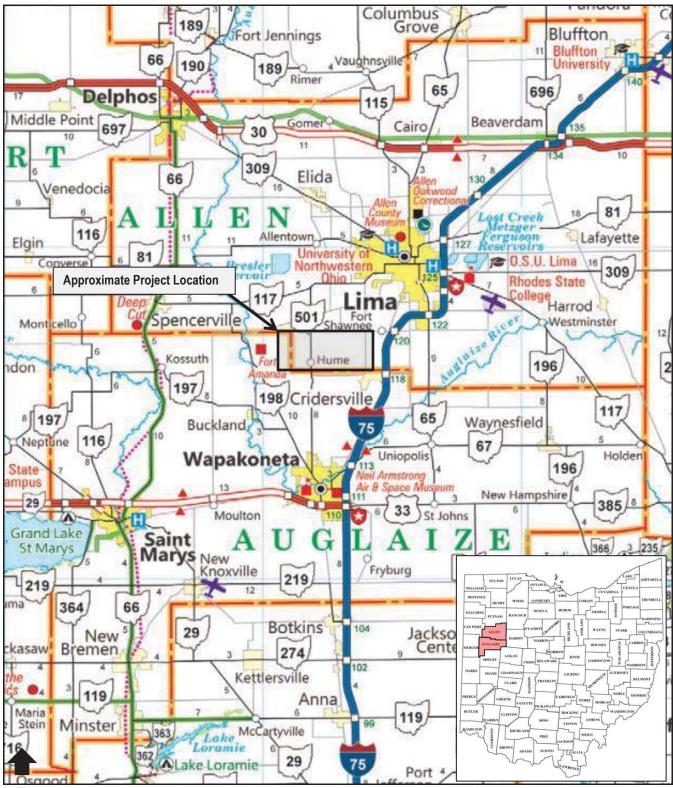
Figure 1: Showing the approximate project location within Allen County and Auglaize County, Ohio of the proposed Birch Lima Solar Panel Farm (Inset showing the location of Allen County and Auglaize County within the State of Ohio)

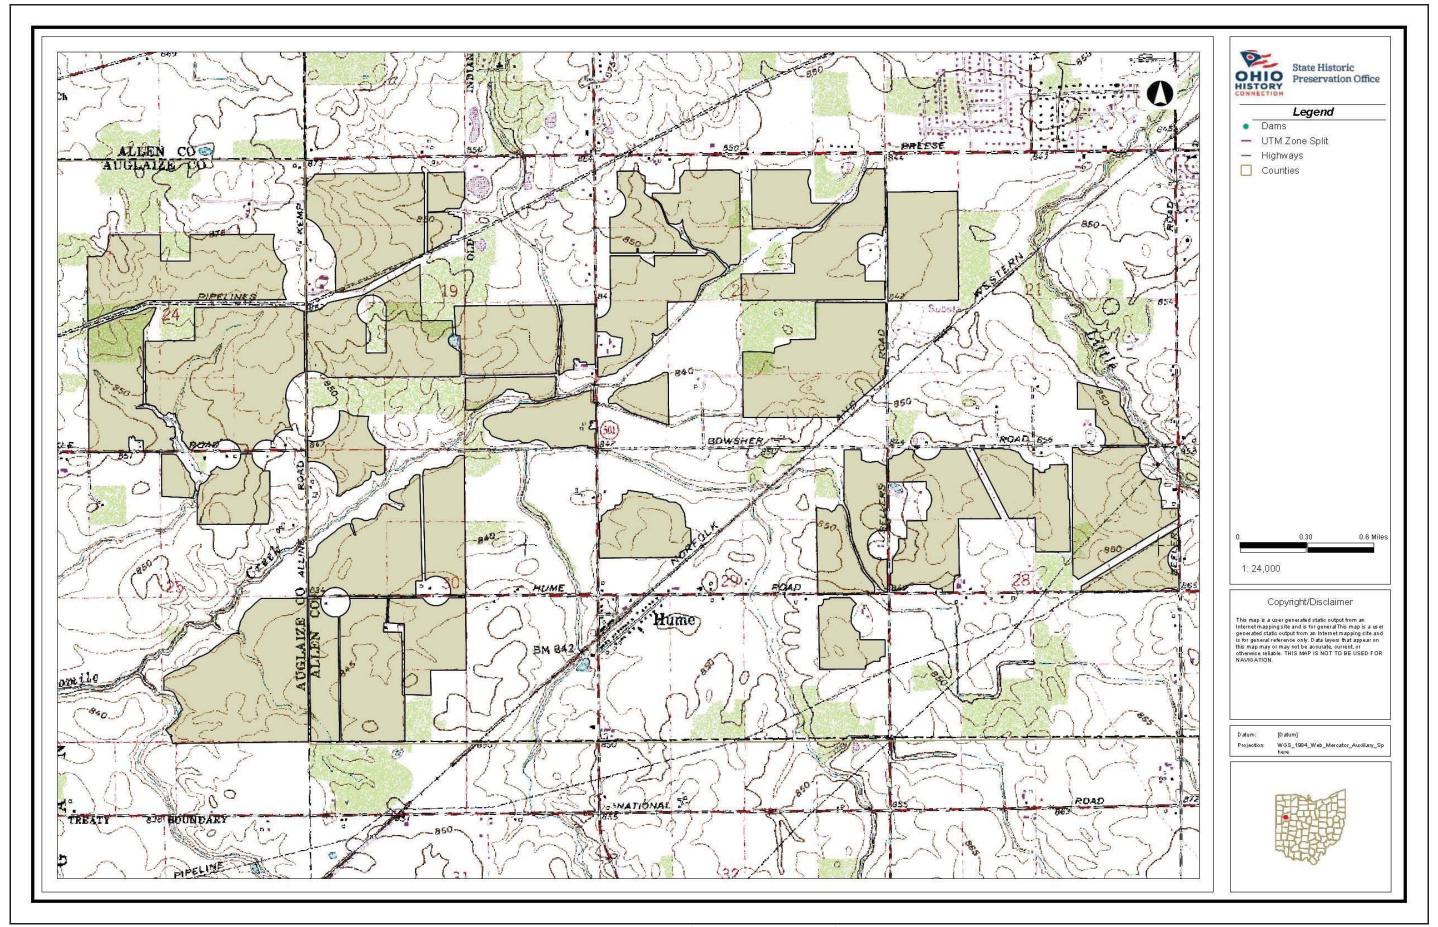
Figure 2: Portion of the USGS 7.5-Minute Series (Topographic) Cridersville, Ohio Quadrangle (1961, Photo-Revised 1983) highlighting construction areas for the proposed Birch Lima Solar Panel Farm

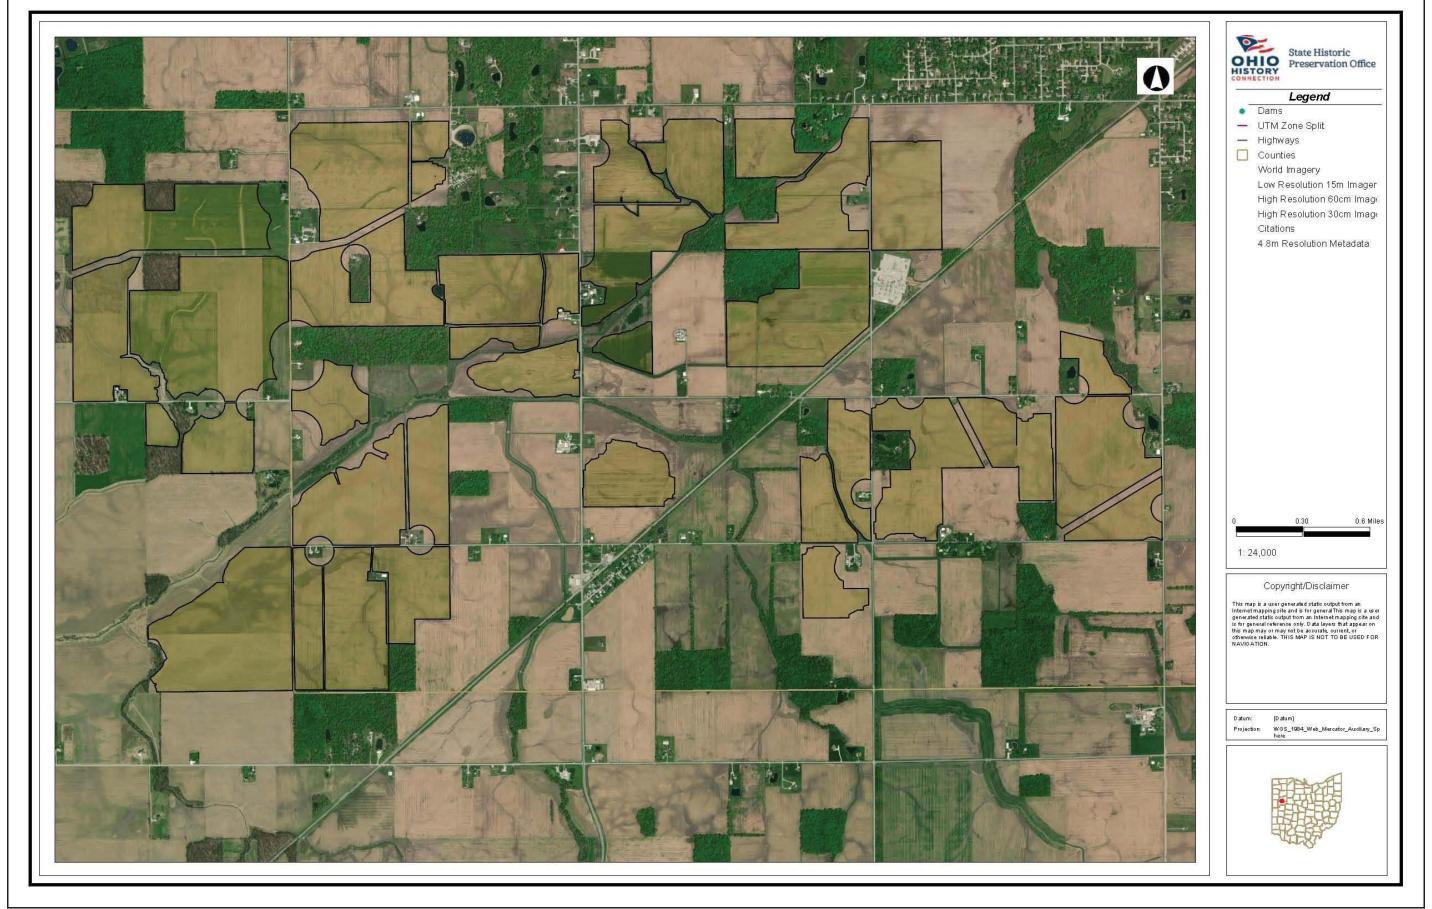
Figure 3: Aerial image highlighting construction areas for the proposed Birch Lima Solar Panel Farm

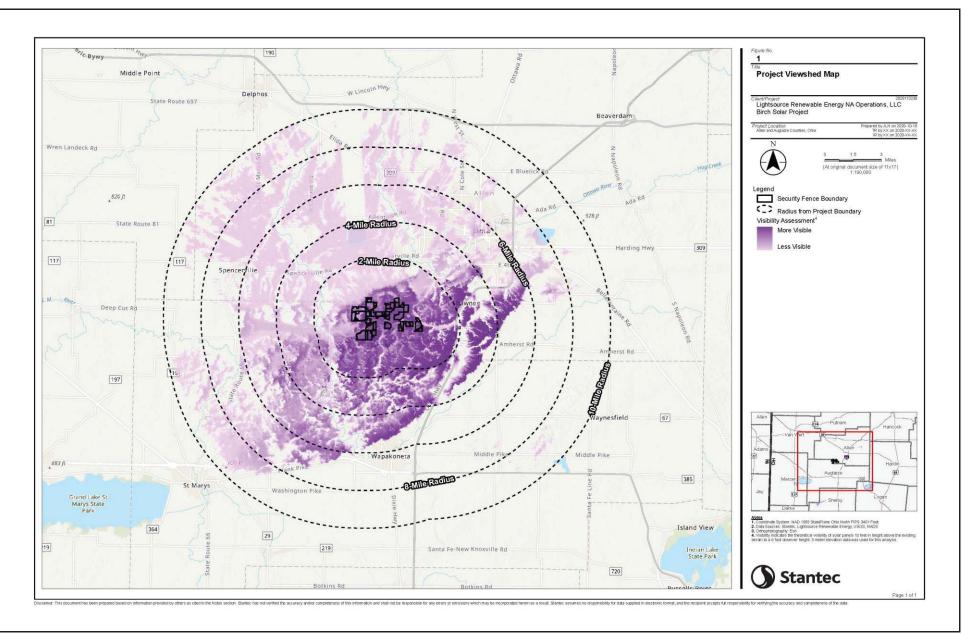
Figure 7: View shed map for the proposed Birch Lima Solar Panel Farm

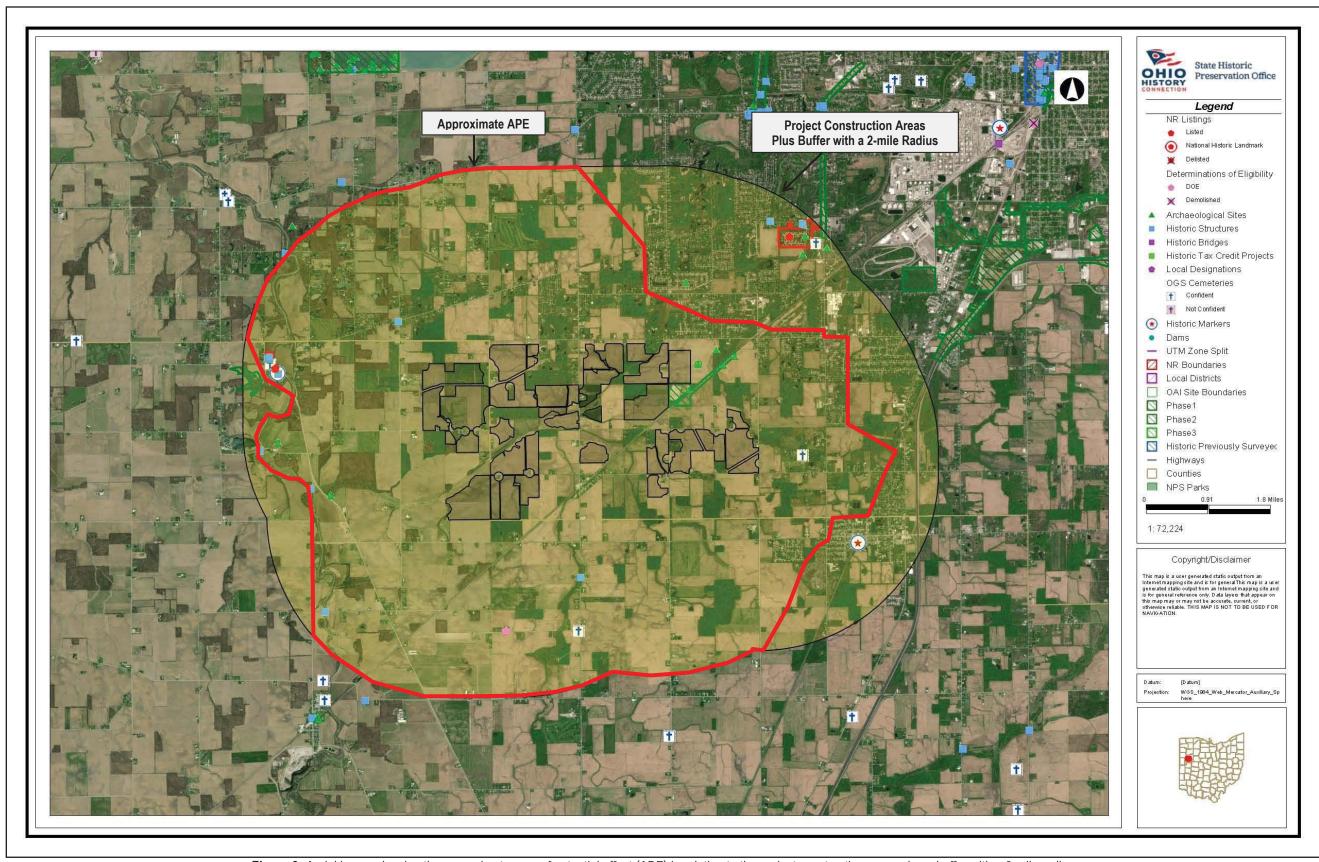
Figure 8: Aerial image showing the approximate area of potential effect (APE) in relation to the project construction areas plus a buffer with a 2-mile radius

As noted in Section 4.1.1 above, the area of potential effect (APE) was expected to extend approximately 2-miles beyond the project limits. It was anticipated that the APE may be reduced to the northeast and southeast where the 2-mile radius encroached upon the communities of Fort Shawnee and Cridersville, and that the APE would be slightly reduced to the west where the 2-mile radius stretched west of the Auglaize River. During field investigations, the APE was in fact reduced to less than a 2-mile radius in the vicinity of Fort Shawnee, Cridersville, and the Auglaize River as shown on Appendix A: Figure 8.

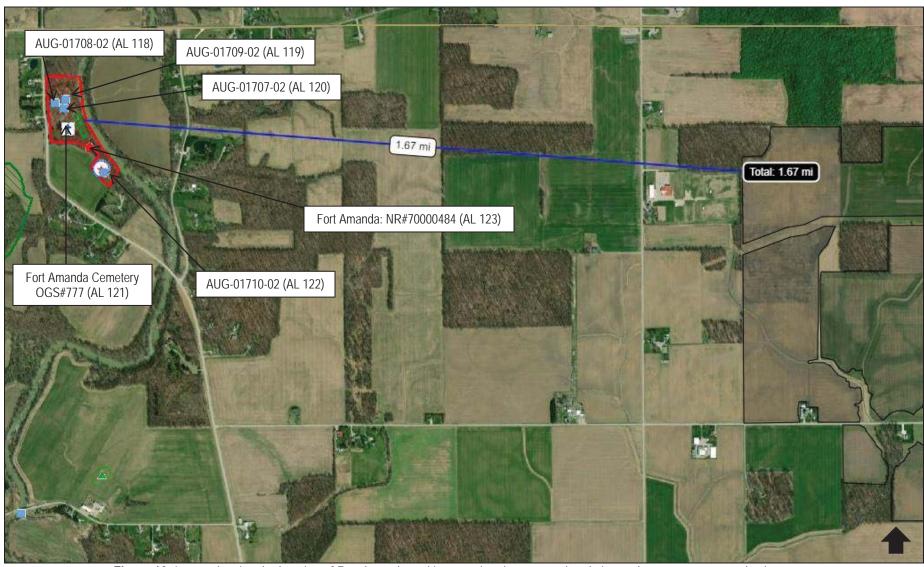
Figure 16: Image showing the location of Fort Amanda and its associated resources in relation to the nearest proposed solar arrays

- AUG-01707-02 (AL 120) is the Fort Amanda Large Picnic Shelter. The building is extant and is in good condition. AUG-01707-02 is situated within the forested area of Fort Amanda Memorial Park and is located about 1.67-miles east of the nearest proposed solar arrays. Due to the distance and the existing, dense vegetation lining the Auglaize River, there will be no view of the proposed solar arrays from AUG-01707-02 (Appendix A: Figure 16)

- AUG-01708-02 (AL 118) is the Fort Amanda Toilet Building. The building is extant and is in good condition. AUG-01708-02 is situated within the forested area of Fort Amanda Memorial Park and is located about 1.67-miles east of the nearest proposed solar arrays. Due to the distance and the existing, dense vegetation lining the Auglaize River, there will be no view of the proposed solar arrays from AUG-01708-02 (Appendix A: Figure 16).

- AUG-01709-02 (AL 119) is the Fort Amanda Grill Shelter. The building is extant and is in good condition. AUG-01709-02 is situated within the forested area of Fort Amanda Memorial Park and is located about 1.67-miles east of the nearest proposed solar arrays. Due to the distance and the existing, dense vegetation lining the Auglaize River, there will be no view of the proposed solar arrays from AUG-01709-02 (Appendix A: Figure 16).

- AUG-01710-02 (AL 122) is the Fort Amanda Monument. The object is extant and in excellent condition. AUG-01710-02 is situated within Fort Amanda Memorial Park and is located about 1.67-miles east of the nearest proposed solar arrays. Due to the distance and the existing, dense vegetation lining the Auglaize River, there will be no view of the proposed solar arrays from AUG-01710-02 (Appendix A: Figure 16).

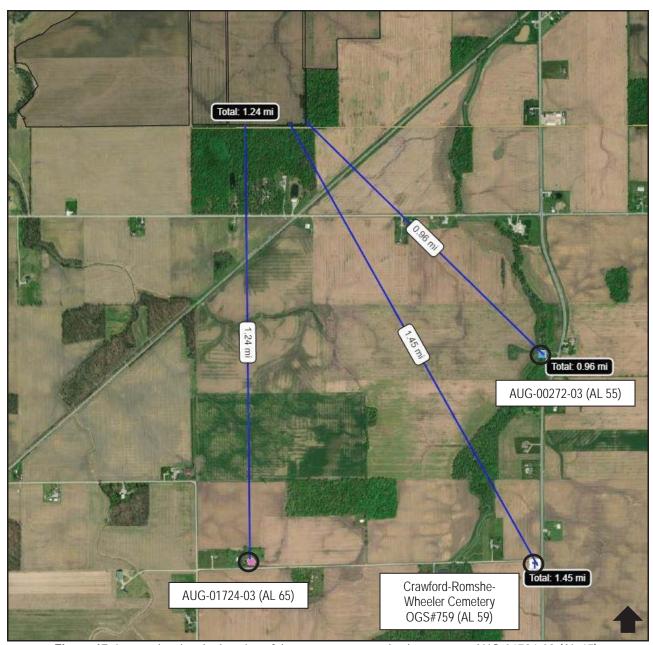
Figure 17: Image showing the location of the nearest proposed solar arrays to AUG-01724-03 (AL 65), AUG-00272-03 (AL 55) and the OGS #759 Crawford-Romshe-Wheeler Cemetery (AL 59)

AUG-00272-03 (AL **55):** AUG-00272-03 is a bowstring bridge which was constructed in 1874 and moved to its current location in the 1920s. AUG-00272-03 is a single span of a three span bridge that once spanned the nearby Auglaize River. When the bridge over the Auglaize River was replaced in the early 1920s, AUG-00272-03 was saved and moved to its current location for use on a private farm lane over Two Mile Creek. According to the Ohio Bridge Association, AUG-00272-03 is a rare example of David H. Morrison's 1867 patent (reissued in 1871); there is only one other bridge of this design remaining in Ohio. Although in fair condition, AUG-00272-03 retains integrity of materials, design, and workmanship. Despite AUG-00272-03 being moved from its original location, the bridge has been at its current location for about 100 years. AUG-00272-03 retains integrity of setting, feeling, and association as it remains functioning as a bridge over a waterway. AUG-00272-03 is recommended eligible for the NRHP under Criterion C as a surviving example of the Morrison Patent Wrought Iron Arch Truss Bridge type built by Dayton's Columbia Bridge Works

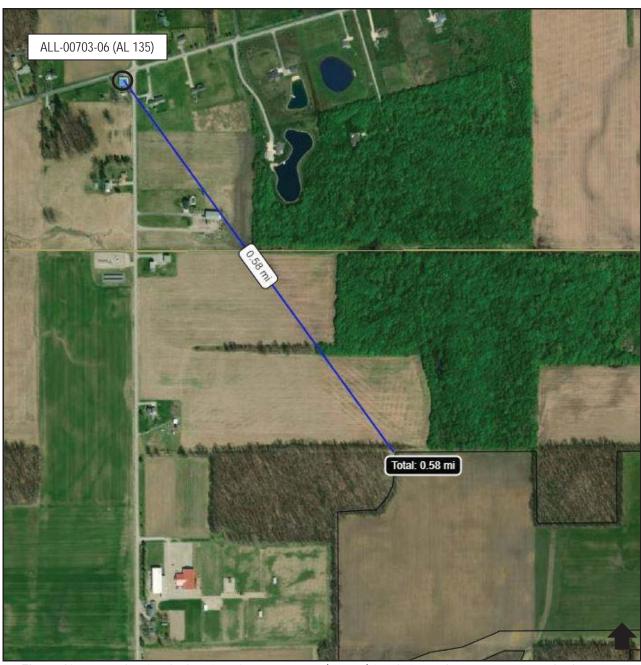
Figure 18: Image showing the location of ALL-00703-06 (AL 135) in relation to the nearest proposed solar arrays

ALL-00703-06 (AL 135): Constructed circa 1887, ALL-00703-06 is a wood-framed, rural church building which now serves as a single-family residence. The exterior of the building retains integrity of materials, design, and workmanship. The only addition is a 1-story, screened porch attached to the rear of the building. Despite vinyl siding applied to the exterior, the original wood trim and details remain exposed. The church's steeple with original bell is intact. ALL-00703-06 has its original lancet windows with stained glass. A new door has been installed in the front entry, but it has not altered the size or configuration of the original entryway; the entryway trim and lancet window are intact. ALL-00703-06 is potentially eligible for the NRHP under Criterion C as a significant example of a relatively unaltered late-1800s rural church with Gothic Revival elements.

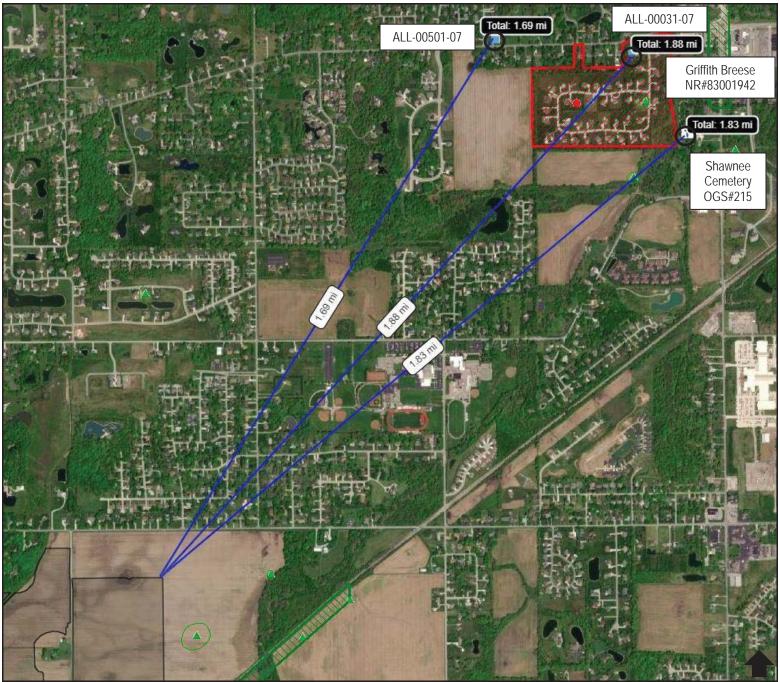
Figure 19: Image showing the location of the nearest proposed solar arrays to the NRHP Griffith Breese Farm, AUG-00031-07, ALL-00501-07, and the OGS #215 Shawnee Cemetery

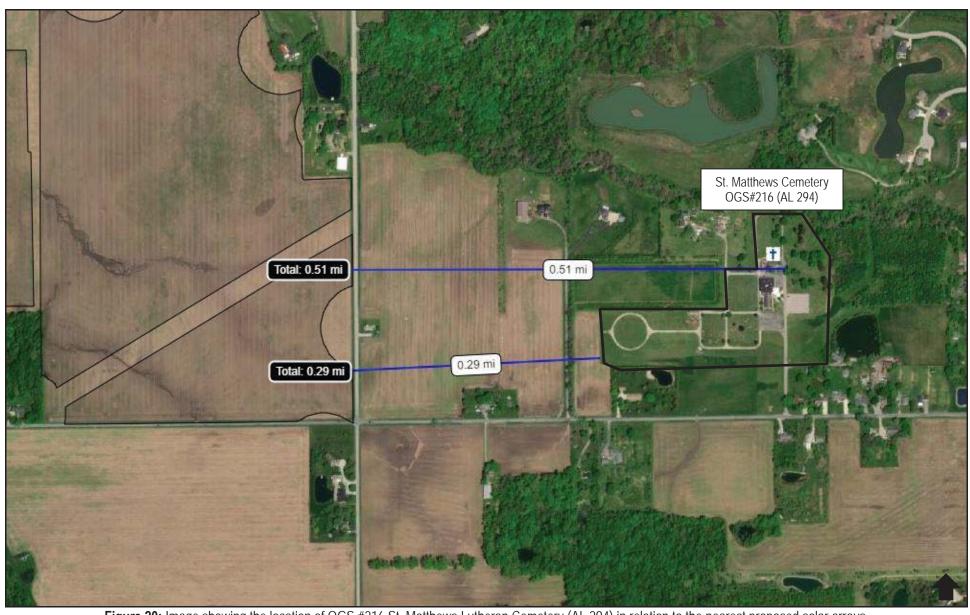
Figure 20: Image showing the location of OGS #216 St. Matthews Lutheran Cemetery (AL 294) in relation to the nearest proposed solar arrays

As indicated in Table 3, the St. Matthews Evangelical Lutheran Cemetery (OGS #216) lies within the APE near the intersection of Shawnee Road and W. Hume Road. According to the church's website (St. Matthews Lutheran Church 2020), burials within St. Matthews Cemetery range from 1837 to the present; and, many of the founding members of the church are buried in the cemetery. The cemetery contains family members of early settlers with the surnames of DeLong, Mowery, Shappell, Bowsher, Reichelderfer, Brandt, Lower, Moyer, Crider, Spyker, Sellers, and Meffley.

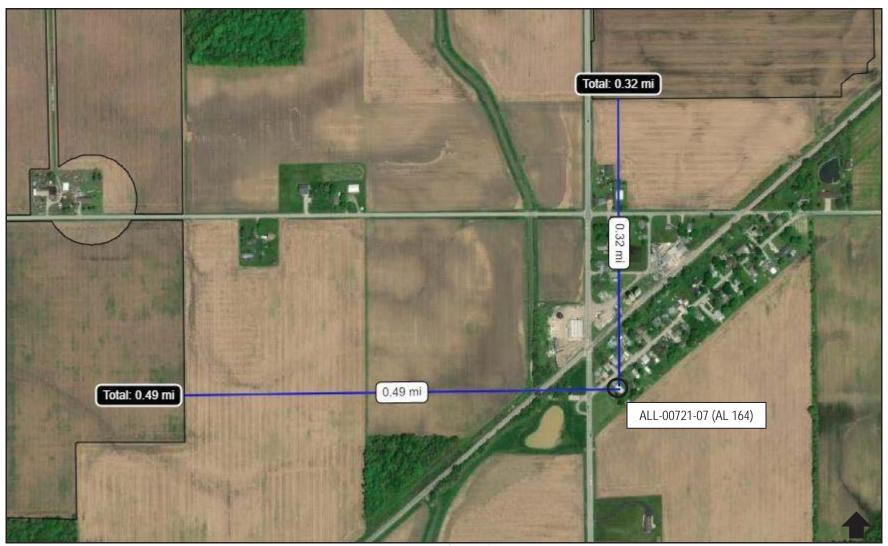
Figure 21: Image showing the location of ALL-00721-07 (AL 164) in relation to the nearest proposed solar arrays

- ALL-00721-07 (AL 164): The nearest proposed solar arrays are about 1,600-feet north of ALL-00721-07; however, views of the solar arrays to the north shall be blocked by existing, intervening residences. But, additional solar arrays are proposed about 2,400-feet west of ALL-00721-07. There are no intervening buildings to block views of these solar arrays west of ALL-00721-07 (Appendix A: Figure 21).

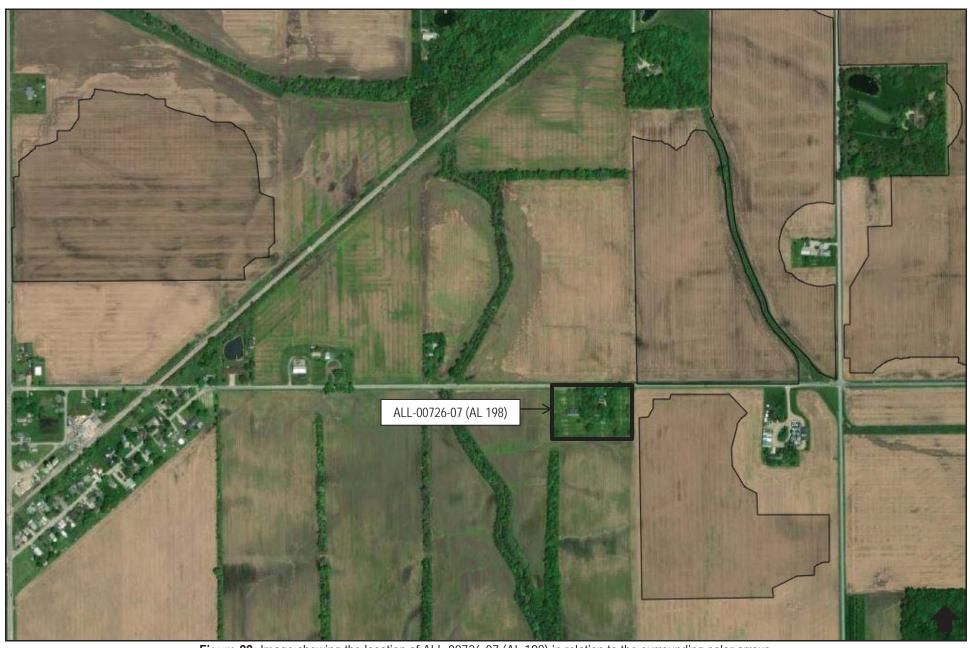
Figure 22: Image showing the location of ALL-00726-07 (AL 198) in relation to the surrounding solar arrays

ALL-00726-07 (AL 198): ALL-00726-07 is a farmstead with a Colonial Revival style residence and a Three Bay Barn. A building appears in this location on the 1880 atlas upon the property of Mary C. Bowsher. The Allen County Auditor provides a generic construction date of 1920 for the existing building on this property. The Colonial Revival style did not become popular until about 1895 and remains a popular style even today. Consequently, it is unclear whether the existing residence replaced a previous building on this location, or whether an original building at this located was altered to the existing Colonial Revival style. Regardless of a specific age, as existing, ALL-00726-07 is a significant example of the Colonial Revival style. ALL-00726-07 has the characteristic elaborate portico, a 2-story wrap-around porch, a porte cochere, large double hung windows with shutters, Palladian windows, and fanlights. The 2-story, Gabled Ell type building has a T-shaped plan. The exterior walls are clad in vinyl siding and the roof is clad in asphalt shingles. On the east elevation is an exterior, brick chimney. The associated Three Bay Barn has only one, small, shed roofed addition; otherwise, the barn maintains integrity of materials, design, and workmanship. Also associated with ALL-00726-07 are two, detached garages. View of the garages are limited from the right-of-way; although, the buildings appear to be in good condition. Compared to other farmsteads in the APE, ALL-00726-07 has a house, barn, and garages in good condition with a high degree of integrity. Materials, design, workmanship, setting, feeling, association, and location are all preserved. Therefore,

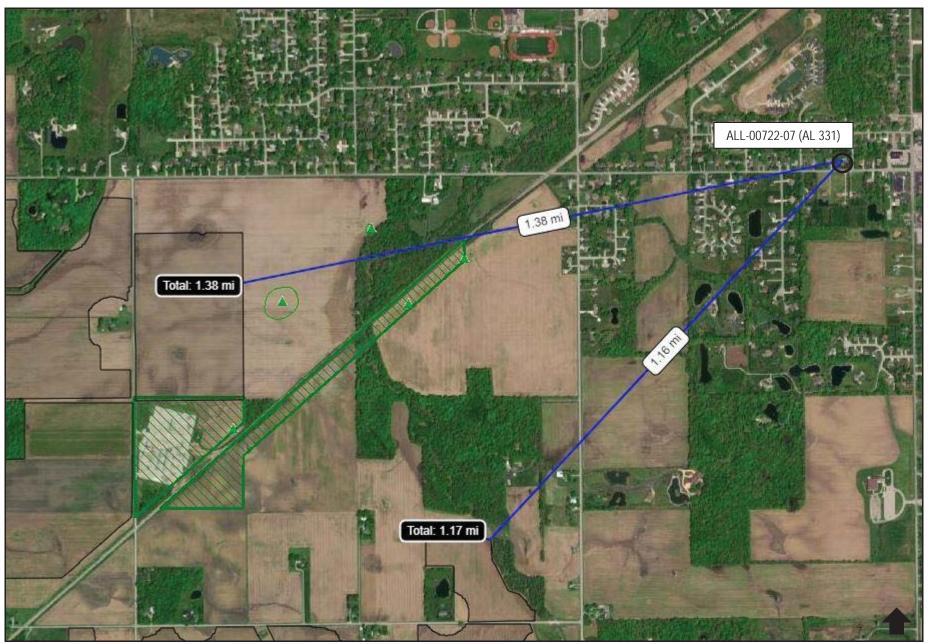
Figure 23: Image showing the location of ALL-00722-07 (AL 331) in relation to the nearest proposed solar arrays

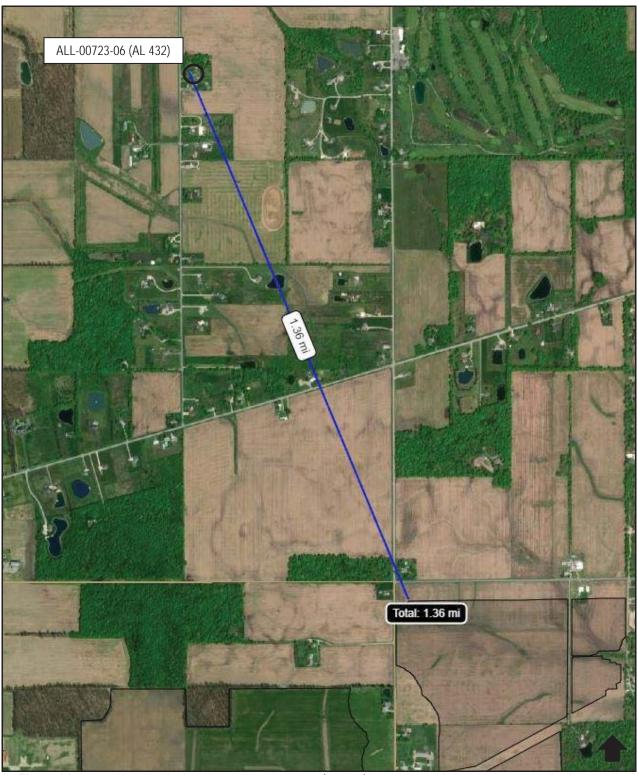
Figure 24: Image showing the location of ALL-00723-06 (AL 432) in relation to the nearest proposed solar arrays

ALL-00723-06 (AL 432): ALL-00723-06 is a Gabled Ell type house constructed circa 1860s-1880s. The building, which has a cross-shaped plan, is two stories in height. The building has a stone foundation and brick exterior walls laid in a running bond pattern. The window openings contain replacement windows but the openings maintain their original size. The window openings also retain their original sandstone sills and lintels with stone brackets. The eaves retain their original wood molding. There are two, open porches. There is a front porch in the southwest corner of the building and a rear porch in the southeast corner of the building. Across the rear, east side of the building is a one-story, wood-framed addition. There is a brick chimney, off-center within the roof slope. Overall, the building is in good condition and maintains integrity of materials, design, and workmanship. The property has lost some integrity of setting with the demolition of various outbuildings, but the house retains integrity of feeling and association as it remains located on a large parcel in a rural setting. Compared to other buildings of similar age and type within the APE, ALL-00723-06 is remarkably unchanged. ALL-00723-06 is potentially eligible for the NRHP under Criterion C as a significant example of a vernacular style, Gabled Ell type farmhouse from the late 1800s.

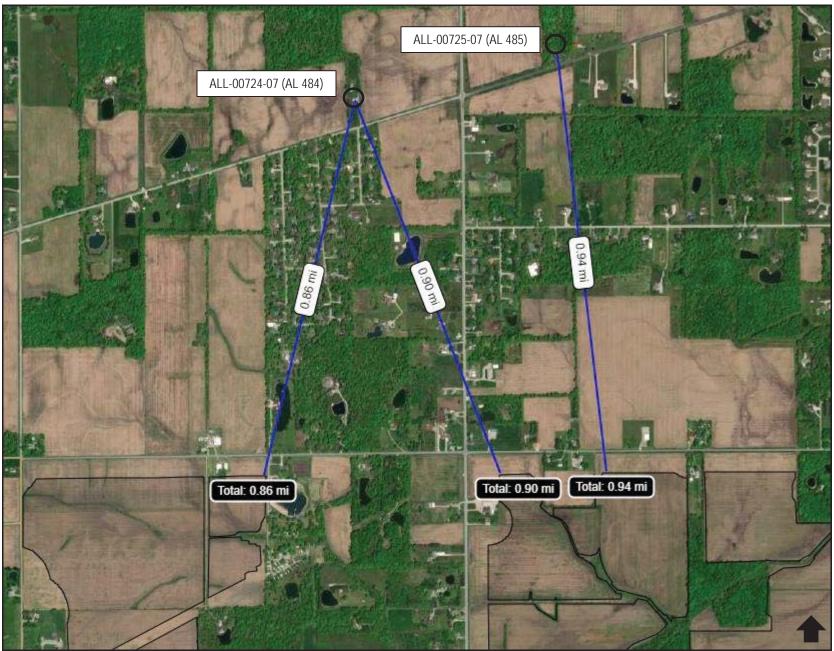
Figure 25: Image showing the nearest proposed solar arrays to ALL-00724-07 (AL 484) and ALL-00725-07 (AL 485)

ALL-00724-07 (AL 484): ALL-00724-07 includes a Craftsman style, Dormer Front Bungalow type residence. According to the Allen County Auditor and available mapping, the house was constructed in 1926. The front of the home faces east towards the driveway rather than south towards Fort Amanda Road. The house is 1.5-stories and has a rock-faced concrete block foundation. From a distance, the exterior siding appears to be vinyl and the windows are 1/1. Across the east façade is a full-width porch with brick columns and an enclosed brick rail. The east-facing, front-gabled dormer contains three 1/1 windows. The house has overhanging eaves with wooden knee brackets. Associated with the house is a two-car garage designed with a pyramidal, hipped roof and a front-gabled dormer that contains two, 1/1 windows. Also on the property is a Three Bay Barn designed with a gambrel roof clad in asphalt shingles. The barn is minimally altered. The original center entry doors and original windows remain intact. And, the exterior walls are clad in the original, vertical wood siding. The only addition is a 1-story, side-gabled, open-bay section at the north end of the barn. Compared to other farmsteads in the APE, ALL-00724-07 has a house, barn, and garage in good condition with a high degree of integrity. Materials, design, workmanship, setting, feeling, association, and location are all preserved. Therefore, ALL-00724-07 is potentially eligible to the NRHP under Criterion C as a significant example of a rural farmstead with a Craftsman style, Dormer Front Bungalow and Three Bay Barn.

ALL-00725-07 (AL 485): According to the Allen County Auditor and available mapping, this house was constructed in 1925. The house has a rectangular plan, a non-discernable building type, and an eclectic design mixing Craftsman and Colonial Revival style elements from the 1920s with the older style of Greek Revival. The building is 1.5-stories, with a concrete foundation, exterior walls clad in aluminum siding, and a side-gabled roof clad in asphalt shingles. Centered on the south façade is a 1-story, 1-bay wide, front-gabled porch with paired, round columns. Both the main roof and the porch roof feature corner returns. The south façade has an original center entry door with original sidelights. Flanking the center entry are symmetrical, three-part, original windows which have a center 10/1 window flanked by 6/1 windows. Associated with the house is a detached garage. Although only partially visible from the right-of-way, the garage appears to be constructed at the same time and with the same elements as the house. Located at the rear of the property is a chicken coop which retains its original design and materials including its 6/6 windows. The majority of buildings in the APE lack stylistic details and many have lost integrity of materials, design, and workmanship due to alterations and additions. By comparison, ALL-00725-07 is a unique example of relatively unaltered buildings with a mix of stylistic elements. Therefore, ALL-00725-07 is recommended potentially eligible for the NRHP under Criterion C.

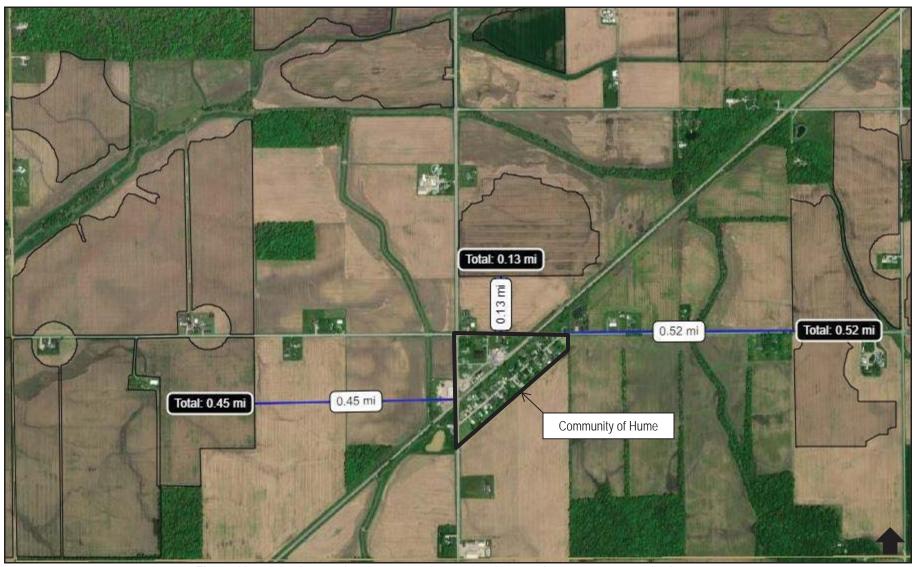
Figure 28: Image showing the community of Hume in relation to the nearest proposed solar arrays

- Potential District, Community of Hume (AL 157-158 and AL 164 through AL 193): Regardless of specifically identified boundaries, any identified historic district within the limits of Hume will have views of proposed solar arrays (Appendix A: Figure 28). Solar arrays are proposed in agricultural fields about 0.45-mile west of Hume, 0.13-mile north of Hume, and 0.52-mile east of Hume.

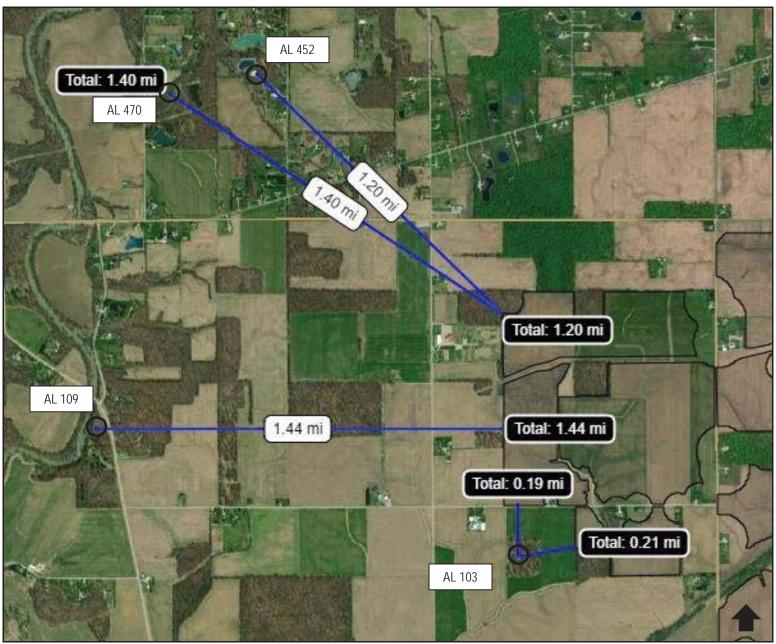
Figure 29: Image showing the unevaluated architectural locations (AL 103, 109, 452 & 470) in relation to the nearest proposed solar arrays

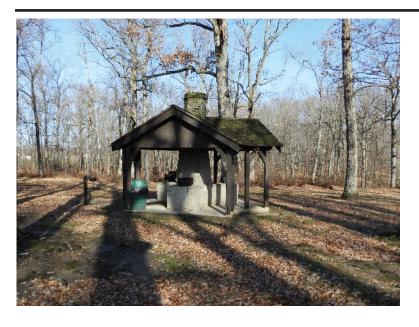
1. No. AUG-01708-02	4. Present Name(s) Fort Amanda Grill Shelter	AUG-0 8-02
2. County Auglaize	5. Historic or Other Name(s) Fort Amanda Grill Shelter)170

13. Part of Established Hist. Dist?	NO	26. Property Acreage 2.75	No chimney observed	=
15. Other Designation (NR or Local)	NO	27. Other Surveys	41. Distance from & Frontage on Road 719'

28. No. of Stories	51. Condition of Property: Good/Fair	
16. Thematic Associations: Funerary		20 P	52. Historic Outbuildings & Dependencies	┨
War of 1812		29. Basement? 30. Foundation Material	Structure Type

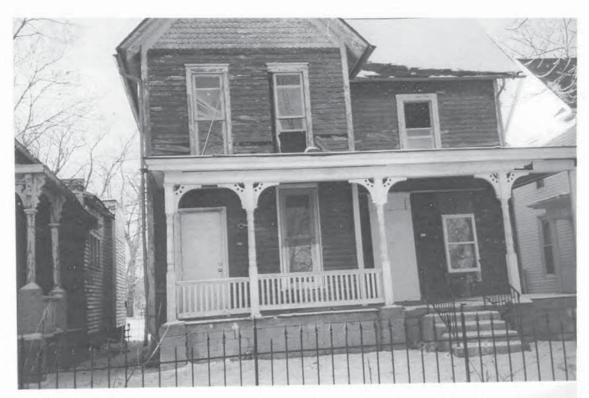
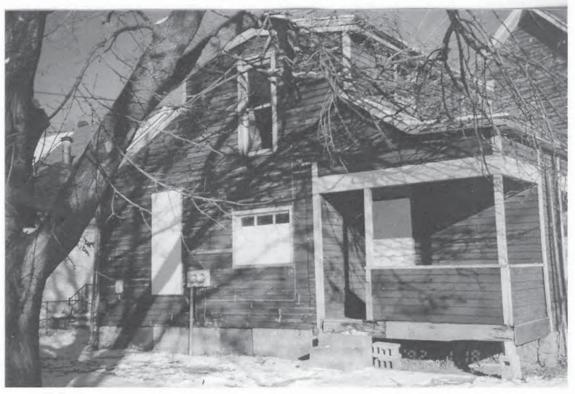
ALL-249-8
Feb. 2006
PROPERTY OF OHPO

756 South Main Street Lima, Ohio

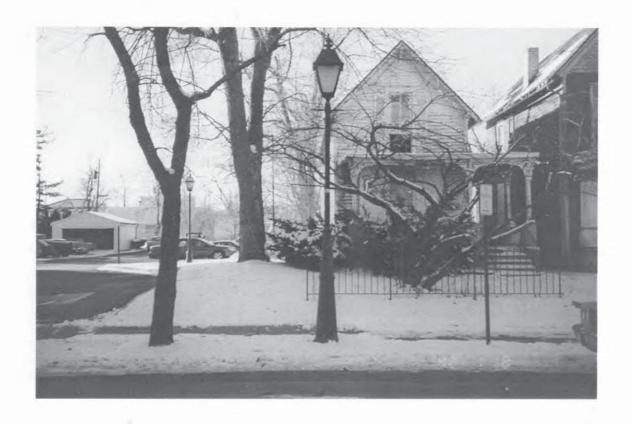
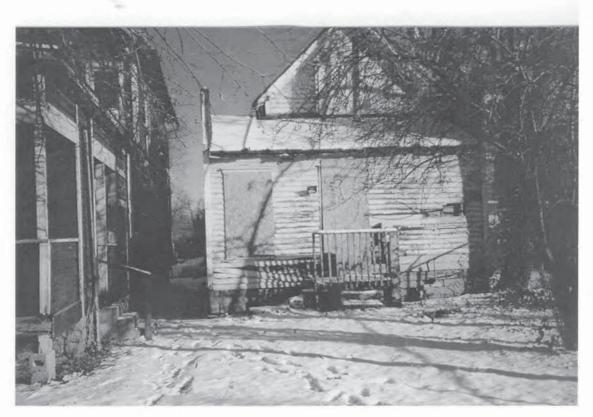
ALL-250-8 Feb. 2006 PROPERTY OF OHPO

758 South Main Street Lima, Ohio
