Historic Resources Survey
October 2020
Environmental Design & Research
(Submitted to State Historic Preservation Office
January 5, 2021)

RE: Emerson Creek Wind Farm

Our office has reviewed the revised Historic Resources Survey Report, Emerson Creek Wind Farm, Groton and Oxford Townships, Erie County, Ohio, Lyme, Ridgefield, Sherman, Norwich, and Richmond Townships, Huron County, Ohio, prepared by Environmental Design and Research (EDR) in October 2020. The project is a 297.66-megawatt wind energy facility consisting of up to 87 wind turbine generators and associated infrastructure.

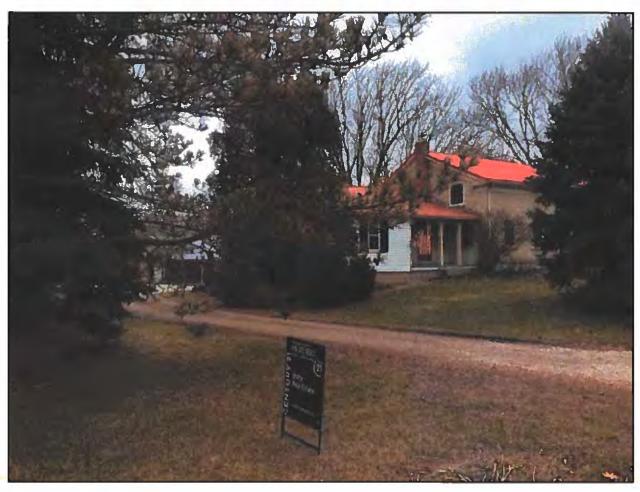
Inset 4. 9519 State Route 99 N

This is a one-and-one-half-story, side-gable house constructed of locally quarried limestone (Inset 4). It is five-bays wide with a center entry, metal roof, and replacement six-over-six-windows. A one-story, vinyl clad wing extends to the south. The massing and partial cornice return indicate a mid-nineteenth century construction date with Greek Revival influences. This is consistent with the construction date of 1835 provided on the property record (Erie County, 2020). A large, modern, pole-barn and four wood-frame sheds are located west of the house. The barn is sided in metal and appears to date to circa 2000. The four sheds are sided in wood, with asphalt roofs, and are site on poured concrete foundations. There is also a small limestone outbuilding directly behind the house. At just under six acres, the property is significantly smaller than it was historically. It appears on the 1874 Combination Atlas Map of Erie County, by Stewart and Page as consisting of 268 acres, and on the 1896 Illustrated Atlas and Directory of Erie County, Ohio by the Atlas Publishing Co. as 285 acres (Stewart and Page, 1874; Atlas Publishing Company, 1896). This house is a good example of the use of limestone construction common to Erie County and it retains a moderately high degree of integrity of location, materials, workmanship, and design. Coniferous limestone is noted as the most important geological feature in Erie County. The upper portion of the limestone, which is formed in layers, is blue in color and known as "Sandusky stone" and was popularly used for building and paving. The lower layer is lighter in color, composed largely of fossils and decomposing organic matter. Quarries and limekilns were prevalent in the city of Sandusky and the islands in Lake Erie during the nineteenth century. Many facilities are still in operation as limestone and crushed stone quarried in Erie County continue to be used for construction of buildings and roadways (Peeke, 1916; Sandusky History, 2015).

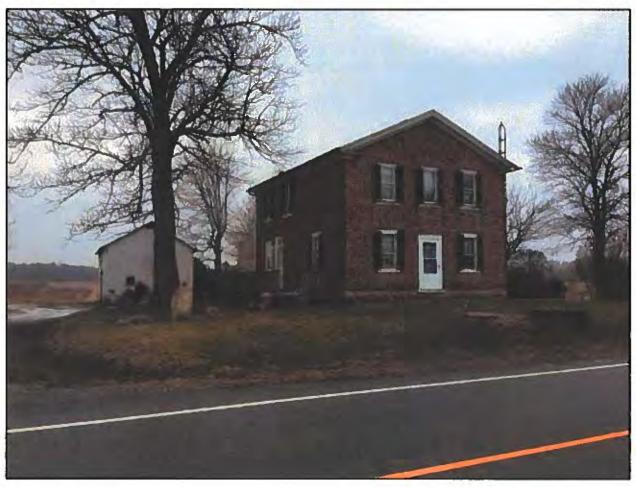
Inset 5, 8901 State Route 113

This is a two-story, front-gable, brick house with a two-story, side-gable wing projecting to the west (Inset 5). The principal block is three-bays wide with a center entry, asphalt roof, and wood six-over-six windows framed by wood shutters. The wing is wood framed, sided in clapboard and has a farm porch running the width. The massing and partial comice return indicate Greek Revival influences, which is consistent with the construction date of 1820 provided on the property record and construction materials (Erie County, 2020). A wood-frame, gable-roofed barn is located south of the house. A second barn, located across the road and within a stand of trees, is in very poor condition and near collapse. The house, and a barn that is no longer extant, are included on the 1874 *Combination Atlas Map of Erie County*, by Stewart and Page, shown within a 112-acre parcel that closely reflects the modern boundaries (Stewart and Page, 1874). The property is notable as a vernacular example of the Greek Revival style. The house is in fair condition, but retains a high degree of integrity of materials, location, setting, and design. Retaining the majority of its original acreage and agricultural setting, the property is also a good example of a nineteenth-century rural farmstead grouping consisting of a house and outbuildings association with the agricultural development of northern Ohio.

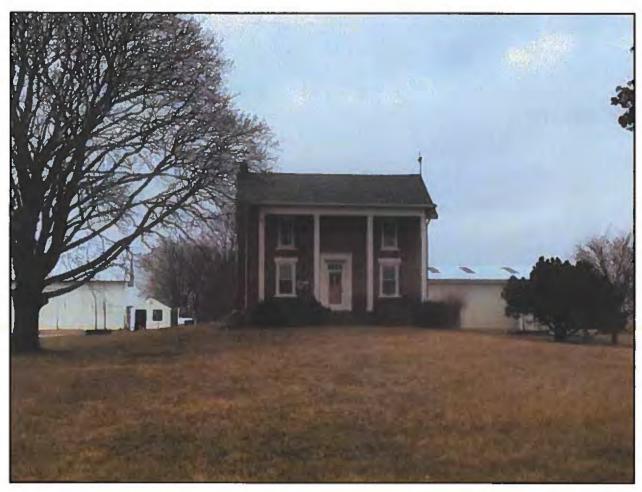
Inset 6. 8401 State Route 113

This is a two-story, side-gable, brick house with a full-height portico spanning the façade (Inset 6). The house is three-bays wide with a center entry topped by a transom light. The entry is flanked by double-hung windows each with a similar window aligned above; there is no window in the center on the second floor. All windows appear to be vinyl and have painted stone lintels. The property record provides a date of construction of 1875 (Erie County, 2020) which is plausible based on historic mapping and architectural influences. The house is on a separate parcel from the outbuildings and land, but they are under the same ownership. The two parcels total 192 acres. Compared to historic mapping this appears to be the result of two adjacent parcels, each consisting of approximately 150 acres, being combined then the northern section was lost to a right-of-way for the railroad (Stewart and Page, 1874; Atlas Publishing Company, 1896). Sited behind the house are four barns. Visibility from the road is limited but it appears that the easternmost barn is a modern pole barn with metal siding, while the remaining four are wood frame and likely dating to the early nineteenth century. From at least 1860-1880 the property was owned by Philip Bath, a farmer and English

immigrant (USCB, 1860; 1870; 1880). The property is notable as an example of a mid-nineteenth century farmstead that retains a high degree of integrity of location, setting, design, and feeling. In addition, though vernacular interpretations of Greek Revival were common during this period in northern Ohio, the full-height portico sets this house apart. As a rural farmstead grouping consisting of a house, outbuildings, and acreage, it is also important for its association with the agricultural development of northern Ohio.

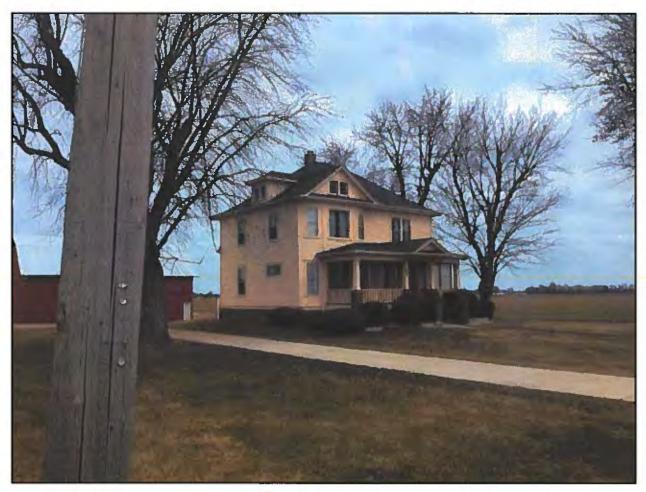
Inset 7. 1819 Fox Road

This is a two-story, wood-frame, Foursquare derivative house with a hipped roof (Inset 7). Approximately one-half of the façade is composed of a projecting two-story bay with a gable-roofed dormer above. A hipped-roofed dormer is centered on each side roof plane. A one-story, screened porch spans nearly the full width of the façade; it is supported by flared wood columns on cast-stone piers. Windows appear to be wood, one-over-one, siding is clapboard, the roof is asphalt, and the foundation is concrete block. Also on the property, which consists of 116 acres, are two barns, a shed, and a metal grain silo located north of the house. One of the barns appears to be wood frame with a gambrel

roof and the other is a metal sided pole barn. The property record provides a date of construction of 1916, which is consistent with architectural influences. However, a house is present at this location on the 1896 *Illustrated Atlas and Directory of Erie County*, which, combined with the use of cast-stone for the foundation indicates a mid-1890s construction date (Atlas Publishing Company, 1896; Erie County, 2020). The house is an excellent example of Foursquare type house with Colonial Revival influences retaining a high degree of integrity of location, setting, design, and materials. It is also notable as an example of a nineteenth-century rural farmstead grouping consisting of a house and outbuildings and for its association with the agricultural development of northern Ohio.

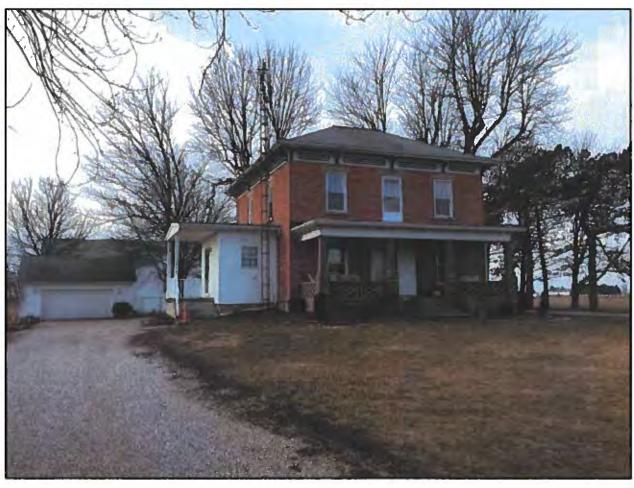
Inset 8. 8309 Willard West Road

This is a two-story, three-bay, brick house with a hipped roof and a full-width, one-story porch on the façade (Inset 8). It appears to have two side-by-side front doors, one of which is blocked by shutters. Another door is centered on the second floor over the porch. Windows appear to be vinyl six-over-six, double-hung units and feature stone sills and lintels. A wide fascia board with racetrack motifs separated by single brackets encircles the building. The porch is supported by cast stone columns and piers, with cast stone block railing. Modillions underscore the porch roof eave. A modern, one-story addition with an open porch project from the center of the east elevation. Property records indicate the house was built in 1875, which is consistent with architectural influences, though the porch is an early twentieth century addition (Huron County, 2020). A building first appears at this location on the 1873 Atlas of Huron County as part of a 101-acre farm belonging to P. Koder (Lake, 1873). Directly south of the house are a one-car garage and a wood-frame, L-shaped, gable-roof barn. The property is an excellent example of a house type very common to north-central Ohio, a hipped-roof house on a square footprint, with a full-width porch. This example, executed in brick with Italianate-style influences, retains a high degree of integrity of location, design, materials, and workmanship. The use of cast stone for porch columns and railings is a common turn-of-the-century feature on rural homes in north central Ohio.

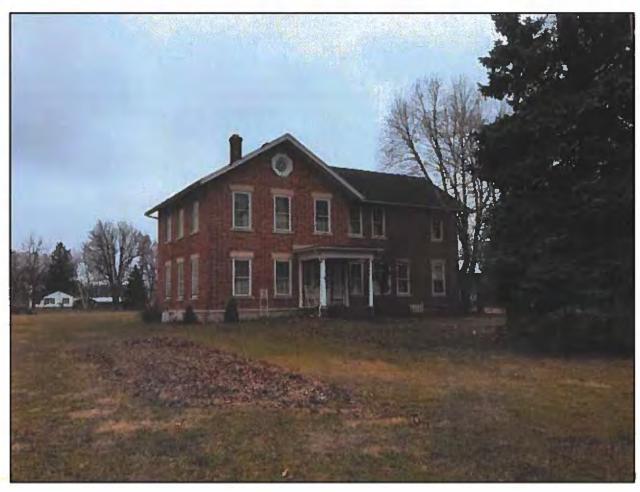
Inset 9, 6157 State Route 113

This is a two-story, front-gable, brick house with a two-story, side-gable wing extending to the east (Inset 9). The principal block is three bays wide with the main entry positioned in the right-hand bay; the wing is four bays wide. The roof is asphalt shingles, and windows appear to be a combination of wood, six-over-six and vinyl one-over-one with stone lintels. A hexagonal window is located under the gable on the façade. The entry features sidelights and a transom and is protected by a flat-roofed portico supported by smooth Doric columns and pilasters. Based on historic maps, settlement trends, and architectural influences the house was likely constructed mid-nineteenth century. Three pole barns all constructed between 1987 and 1998 are located southwest of the house. Historically the property extended north of State Route 113, encompassing approximately 41 acres, whereas it is presently 5.5 acres (Mesnard, 1891; Huron County, 2020). The property is notable as an example of a mid-nineteenth century vernacular Greek Revival residence that retains a high degree of integrity of location, design, workmanship, and materials.

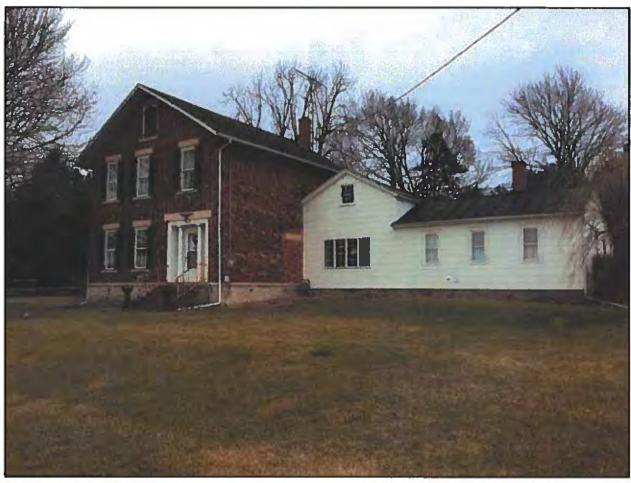
Inset 10, 5679 State Route 113

This is a two-story, front-gable, brick house on a raised, limestone foundation (Inset 10). The house is three-bays wide and the entry is set in the right-hand bay flanked by smooth, Doric columns within a recessed doorway. Windows appear to be wood, six-over-six with stone lintels and sills framed by wooden shutters. A wood-frame addition extending to the east is composed of a one-and-one-half-story, front-gable front section nearest the principal block, and a one-story, side-gable section attached to that. The wing is sided in asbestos shingles. The property record provides a date of construction of 1846, which is consistent with architectural influences and historic maps (Huron County, 2020). A house appears to be present at this location as early at 1859 on the *Map of Huron County Ohio* (Nunan, 1859). Two early twentieth century wood-frame garages, and a modern, metal sided pole barn are located south of the house. The property is notable as an example of a mid-nineteenth century vernacular Greek Revival-style residence that retains a high degree of integrity of location, design, workmanship, and materials.

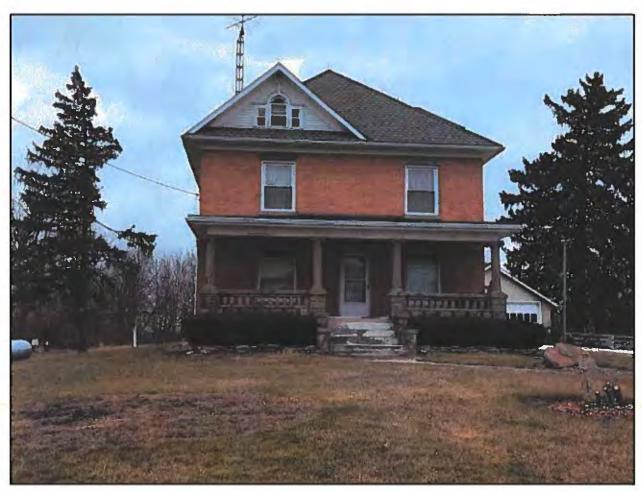
Inset 11. 3341 State Route 4

This is a two-story, hip roofed, brick, Foursquare-type house with Classical Revival-style influences (Inset 11). It is two bays wide with a gable-roofed dormer containing a Palladian window over the left-hand bay. An open, full-width porch with a center stair is supported by cast stone lonic columns and it has a cast stone block railing. The door is on center, flanked by fixed picture windows topped by leaded glass transoms. Remaining windows are one-over-one with stone sills and lintels; the foundation is cast stone block, and the roof is slate. A one-story, modern addition extends from the rear. The property record provides a date of construction of 1913, which is consistent with architectural influences and construction materials (Huron County, 2020). Adjacent to the house is a two-car, concrete block garage and northwest of the house is a wood-frame barn with vertical plank siding and a sliding door on the gable end. The property is notable as an example of an early twentieth century vernacular Classical Revival-style residence that retains a high degree of integrity of location, design, workmanship, and materials. The use of cast stone for structural and decorative porch elements was widespread in north central Ohio during the first quarter of the twentieth century as the material gained

popularity. Porches of this design were often added to existing home but in this instance, it was likely part of the original design based on the date of construction.

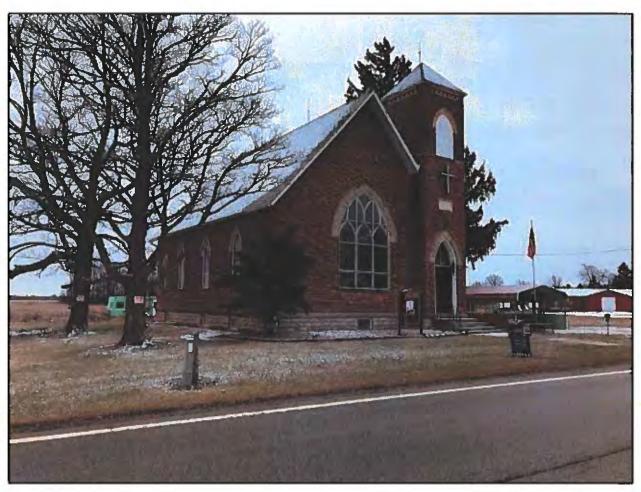
Inset 12. 2874 State Route 4

This is a front-gable, brick, Gothic Revival church building that is now used as a single-family residence (Inset 12). It is set on a rectangular footprint with a two-story, square tower topped by a pyramidal roof on the southwest corner. All visible penetrations have pointed arch tops with stone drip molding. A single large window occupies the center of the façade under the gable, four windows run along each elevation, and there is a window on the southwest side of the tower. The entrance, consisting of paired wooden doors topped by a pointed arch transom, is set in the tower facing the road. On each wall of the tower on the second level is a pointed arch opening that has been blocked over with vinyl siding. The property record provides a date of construction of 1906 but based on architectural influences and historical records the date is circa 1870. It appears on an 1873 Atlas of Huron County Ohio labeled as a Lutheran Church (Lake,

1873). The building as a very good example of a Gothic Revival-style rural church that retains a high degree of integrity of location, setting, design and workmanship. The majority of materials appear to be original as well.

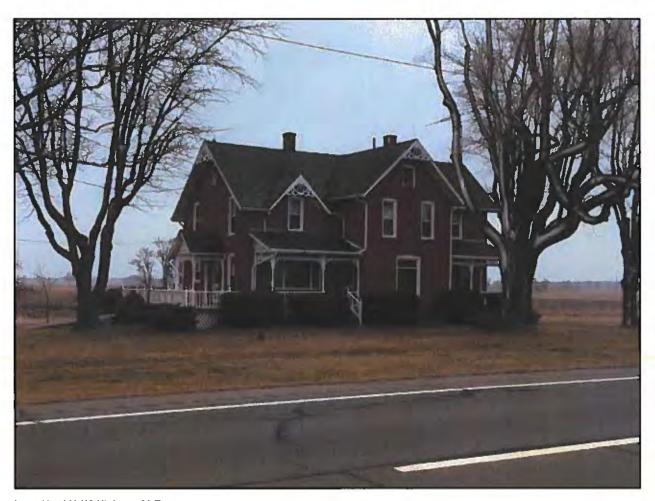
Inset 13. 5360 US Highway 20 East

This is a two-story, cross-gable, Queen Anne-style house (Inset 13). The nearly symmetrical façade consists of a projecting center bay flanked by open, shed-roofed porches. A gable-roofed dormer projects over the left-hand porch. The center bay has a picture window topped by a leaded-glass transom and the remaining windows are rectangular one-over-one, and all have splayed brick arch lintels. The porch eaves are underscored by spindle work frieze and quarter-round brackets supported by turned posts. Gables also have spindle work brackets. Architectural influences indicate a date of construction circa 1875. A house is present on the site on the 1873 *Atlas of Huron County, Ohio* (Lake, 1873). Also on the property are six outbuildings. Directly behind the house is a one-story, wood-frame garage. West of the house, facing the road is a wood-frame bank barn with vertical plank siding and a high drive accessing a sliding door on the broad side and a shed-roofed addition on the rear. Other structures are a steel carport, a wood-

frame shed, a steel Quonset hut, a steel and plastic greenhouse, and a one-story garage. The barn is an intact example of a late-nineteenth English-style barn that indicates the property was historically a farmstead. The property is notable as an example of a vernacular Queen Anne-style residence that retains a high degree of integrity of location, design, workmanship, and materials.

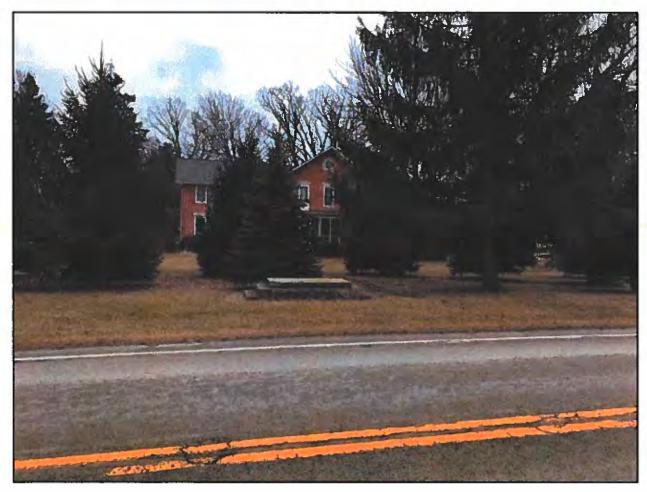
Inset 14. 4191 State Route 547

This is a two-story, front-gable, brick house with a two-story, side-gable wing extending to the east (Inset 14). A one-story, screened porch spans the principal block and wraps the corner to the wing where it meets a recessed screened porch. Above the porch on the principal block there is a door in the left-hand bay indicating a second story porch that is no longer extant. Windows appear to be six-over-six, undetermined material, with stone lintels and sills; a rose window is located in the gable. Deep eaves are underscored by single brackets. The property record provides a construction date of 1853, which is plausible based on settlement patterns, historical mapping, and architectural influences. The massing and fenestration indicate Greek Revival style influences, while the brackets and screened

porches were likely part of a circa 1900 renovation. The house appears on the 1853 Atlas of Huron County, Ohio, consisting of 100 acres that straddled all corners of the intersection of modern-day County Route 547 and Town Line Road 32, under the ownership of "I. Banta". Acreage and ownership remained the same as of 1873 (Nunan, 1853; Lake, 1873). Today the parcel totals approximately 12 acres and no longer serves an agricultural purpose. Also on the property is a wood frame, gambrel roofed barn with vertical plank siding and sliding doors on the broad side and a wood-frame, gable-roofed barn, both on concrete block foundations. A third outbuilding is a concrete block garage; all outbuildings appear to date to the early to mid-nineteenth century. The property is notable as an example of a vernacular residence on a former farmstead that retains a high degree of integrity of location, design, workmanship, and materials. The house is a record of architectural influences spanning half a century.

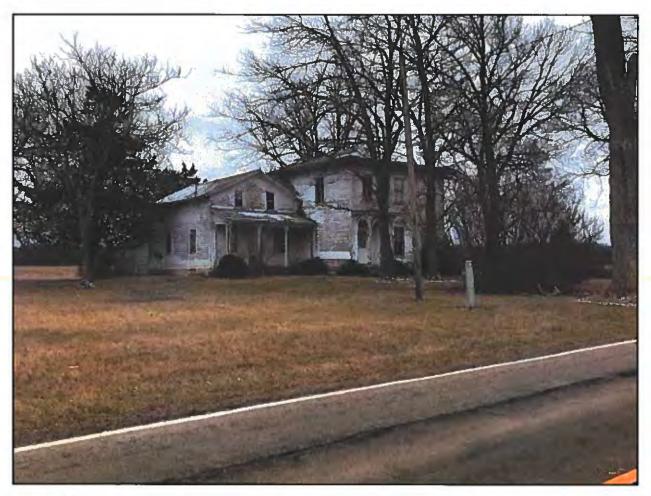
Inset 15. 1018 Section Line Road

This is a two-story, wood-frame, Italianate-style house with a hipped roof (Inset 15). It is three bays with the entry in the left-hand bay fronted by a one-bay wide porch with arched brackets. Shallow, single brackets underscore the eaves

of the main roof. Attached on the north side is a one-and-one-half-story, front-gable section with a full-width, shed roofed porch. Windows are a mix of wood two-over-two, wood one-over-one, and vinyl one-over-one. There are no outbuildings. The house appears first appears on the 1859 *Map of Huron County Ohio.*, on the property of Peter Ruffing, indicating a likely mid-nineteenth century date of construction for the gable-roofed section (Nunan, 1859). The section that is now the main house was possibly added between 1860 and 1870. The property is notable as an example of a vernacular interpretation of the Italianate style that retains a high degree of integrity of location, design, workmanship, and materials.

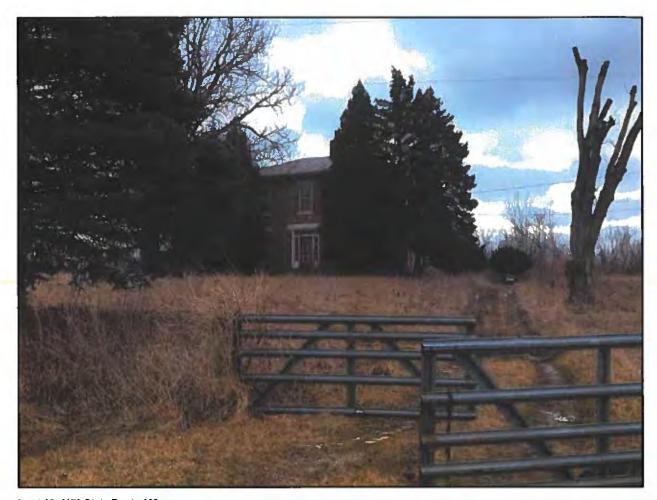
Inset 16. 4179 State Route 162

This is a two-story, three-bay, square, brick house with a hipped roof (Inset 16). The entry is in the center bay, framed by sidelights and a transom light. Windows appear to be wood six-over-six with stone sills and lintels. The roof is sheathed in metal standing seam and is underscored by brackets. The entire property is partially obscured by overgrown vegetation, making clear identification of materials difficult. The property record provides a date of

construction of 1820 (Huron, 2020). Based on architectural influences the date may have been slightly later, circa 1840. Historical mapping shows the property as being owned by Dennison (Denason) Niver from at least 1859 to 1891. As of the earliest date the parcel included 250 acres plus a lot across the road to the north that later contained a blacksmith shop (Nunan, 1859; Lake, 1873; Mesnard, 1891). West of the house is a side-gable, metal sided barn with a similarly framed barn attached perpendicular at the west end. The property is notable as an example of a vernacular interpretation of the Greek Revival style that retains a high degree of integrity of location, design, workmanship, and materials.

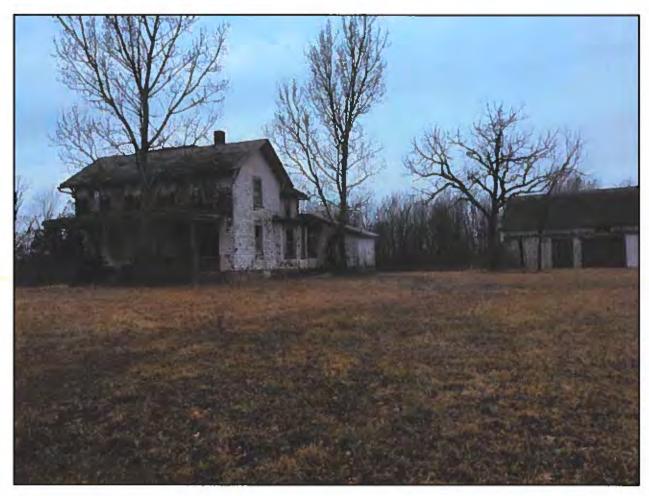
Inset 17. 4458 North Greenfield Road

This is a two-story, side-gable, wood frame house with a full-width porch (Inset 17). The house is five bays wide with a center entry; a one-and-one-half-story addition extends from the rear. The porch has a hipped-roof and is supported by cast stone columns and cast stone block piers and foundation. Railings are composed of brick. Windows appear to be wood, six-over-one, double-hung units, siding is wood shingles, and the roof is asphalt. The eaves are underscored

by knee brackets and exposed rafter tails. Based on the *Map of Huron County Ohio* a house was on this site as early as the late 1850s, but window configuration, siding material, and Craftsman details indicate a significant renovation circa 1915 (Nunan, 1859). North of the house are three agricultural outbuildings, a side-gable barn, a hipped-roof shed, and a one-story saltbox shed. The property is notable as an example of a nineteenth-century rural farmstead grouping consisting of a house and outbuildings and for its association with the agricultural development of northern Ohio. The property appears abandoned and the buildings neglected. However, as a collection they retain a moderately high degree of integrity of location, design, and feeling.

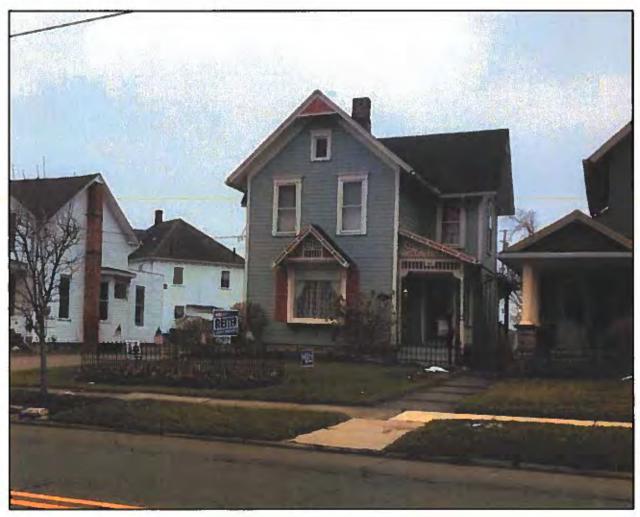
Inset 18, 211 Kilbourne Street

This is a two-story, wood-frame house with a cross-gable roof (Inset 18). The house is a vernacular interpretation of the Queen Anne-style and includes turned porch posts joined by a spindle work frieze, scroll-cut vergeboards and gable brackets, and a polychromatic paint scheme. The center projecting mass contains a picture window on the first story capped by a shallow, decorative gable roof centered between two one-over-one, double-hung windows on the second floor. The entry is off an open porch in the interior corner of the left-hand side of the house. Windows appear to be wood one-over-one, siding is clapboard, and the roof is asphalt shingles. The house first appears on an 1893 Sanborn Fire Insurance Map with a footprint and porch configuration matching the current conditions (Sanborn, 1893). A construction date of circa 1890 is consisted with late-Victorian-era architectural influences. The property is very good example of a vernacular Queen Anne-style house that retains a very high degree of integrity of location, design, materials, and workmanship.

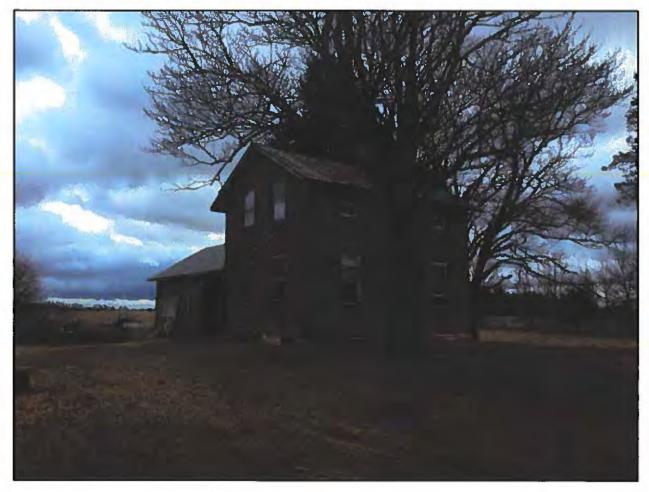
Inset 19. 5821 State Route 101

This is a one-and-one-half-story, side-gable, Flemish-bond brick house with a perpendicular one-story wing projecting from the rear (Inset 19). The wing has a recessed entry porch and a non-functional barn door on the northeast elevation. The principal block is three-bays wide with a center entry and sits on a field-stone foundation. The majority of windows are wood six-over-six, double-hung units with the exception of three three-light, knee-wall windows under the eave along the façade. All are topped by vertical brick lintels. The house lacks any ornamentation. The property record card states that the house sits on a 100-acre parcel (Sandusky, 2020). Based on architectural influences and historical mapping the house likely dates to circa 1860. It is present on an 1874 *Combination Atlas Map of Sandusky County.* though no acreage is listed. By 1898 the property bounds are similar to the current lines and the parcel is identified as consisting of 125 acres owned by "R. Sparks" (Everts, Stewart and Co, 1874; Hopple, 1898). The property is notable as an example of a vernacular farmhouse with a very high degree of integrity of location, materials, and design. In addition, it retains an expansive acreage that is still in agricultural use, lending to its integrity of setting.

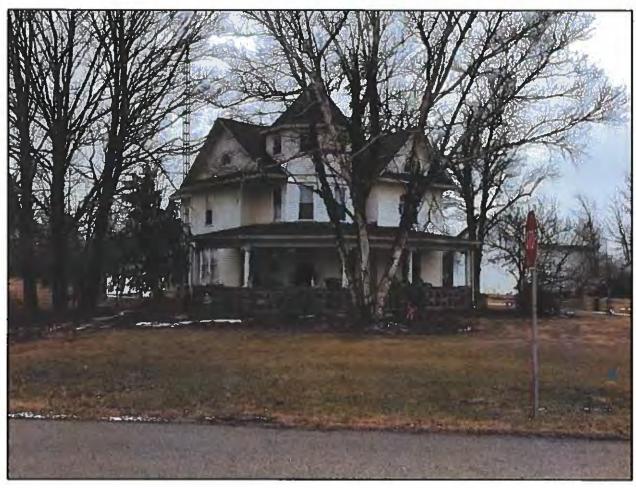
Inset 20. 6971 North State Route 18

This is a two-and-one-half-story, Queen Anne-style residence with asymmetrical massing; a steep, cross-gabled roof; and an octagonal turret (Inset 20). A wraparound porch has a low, hipped roof supported on lonic columns atop a stone or concrete masonry unit balustrade. The siding appears to be vinyl and the roof is finished in asphalt shingle. A ball finial atop the turret roof appears to be sheet metal. The windows are generally one-over-one single- or double-hung sash, except for fanlights in the gable ends. The building has a single-story rear addition. A three-bay, gable-roofed barn with wood siding and a metal roof is located to the southwest of the house, and a single-story shed with a gable roof is sited west of the barn. The current property, just over two acres, was partitioned from a 189-acre agricultural lot after 1896, and possibly prior to or soon after the house's construction by 1915 (Rerick Brothers, 1896; USGS, 1915). The property retains its historic agricultural setting. It is notable as an example of a nineteenth-century rural farmstead grouping consisting of a house and outbuildings and for its association with the agricultural development of northern Ohio.

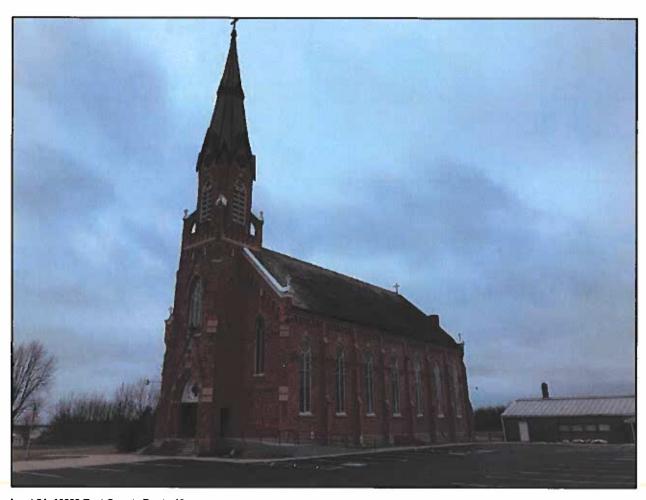
Inset 21. 16209 East County Route 46

Saint Gaspar del Bufalo is a Roman Catholic church built in 1884 in the Victorian Gothic style (Inset 21). It is rectangular in plan, with a projecting tower at the south and a projecting bay forming the apse at the north. The exterior is characterized by flat planes of brick in a running bond, punctuated with decorative brick corbeling and patterned brick stringcourses, atop a rusticated stone foundation. Sills, copings, arch voussoirs, and other details are of stone. The building has a steeply pitched gable roof clad in asphalt shingle. The structure is three bays wide and seven bays deep, with each bay on the east and west facades defined by buttresses and containing a gothic-arched, stained-glass window with wood tracery. A square tower projects from the center of the principal (south) façade and contains the principal entrance within an arched portico beneath a large stained-glass window. Angled buttresses define the corners of the tower, rising into flying buttresses where the square tower transitions to an octagonal belfry level. The cardinal facets of the octagonal section feature louvered gothic-arched openings below oculus windows. The tower is topped with a slate-clad steeple roof surmounted by a copper finial in the shape of a cross.

To the west of the church and set back from the road is a two-story, brick parsonage with a cross-gabled and hipped asphalt roof and a full-width porch with Queen Anne details. The house has one-over-one windows with stone sills and rests on a stone foundation. It is estimated to have been built between 1880 and 1900. A modern, single-story structure (presumably a parish hall) is located at the rear of the property, northeast of the church. A former convent is located immediately to the east. A cemetery associated with the church is located further east and set back from the road.

The church was established by the Precious Blood Society, a Catholic order formed in 1815 by St. Gaspar del Bufalo (Woods, 1891; Missionaries of the Precious Blood, 2020). Missionaries of the Precious Blood, led by Fr. Francis de Sales Brunner, arrived in central and western Ohio from Europe in 1844 to serve the region's German-speaking Catholic community. A church was established on the site by 1848. In 1850, Brunner built a chapel on a nearby site which would become the Sorrowful Mother Shrine (Sorrowful Mother Shrine, 2020). By the 1890s, the society owned parcels totaling over 230 acres to the north and south of present-day County Route 46 in the Township of Thompson, Seneca County (Woods, 1891). St. Gaspar del Bufalo church, then known as St. Michael's, was built in 1884, replacing an earlier church structure built in 1848 (Warner, Beers & Co., 1886). The Missionaries established several churches in Ohio and Indiana, as well as Saint Joseph's College and Calumet College, both in Indiana (Missionaries of the Precious Blood, 2020). The church and parsonage are notable as an intact example of ecclesiastical architecture in rural Ohio, as well as for their association with the Precious Blood Society and with Ohio's German-American community.

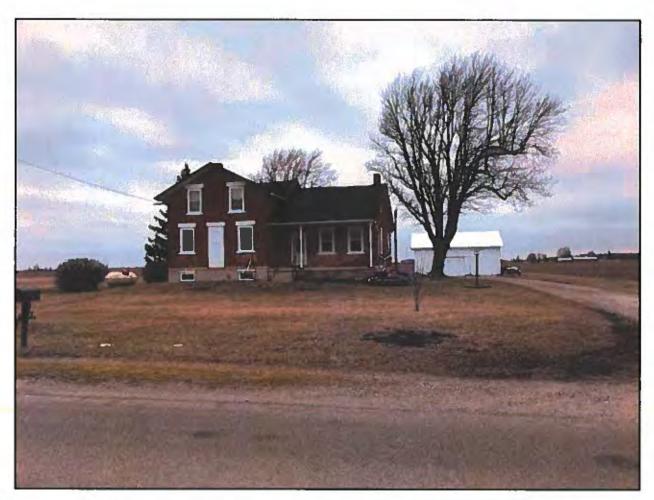
Inset 22, 16977 State Route 46

This is a one-and-one-half-story vernacular brick residence with a gable-and-ell form (Inset 22). The roof is clad in metal and the foundation is of parged masonry, with a stone water table on the principal façade only. The gable-front portion, to the west, contains a centered entry door on the first floor flanked by one-over-one windows, with a pair of one-over-one windows on the upper half-story. The door is not in use and stairs leading to it have been removed. A small, single-light window is tucked under the eave of the half-story on the west façade. The single-story, side-gabled portion to the east contains two one-over-one windows and an entry door within a porch supported by slender Doric columns resting on a stone or concrete masonry unit base. The windowsills and lintels are likely of stone but appear to be painted. Brick chimneys rise from the roof ridge near the south and east gable ends. A three-bay barn with a metal roof is located northeast of the house. The house was likely built prior to 1864, when it appears on 1864 *Map of Seneca Co., Ohio* as the residence of J. Westrick (Lake, 1864). The two-acre lot was partitioned from a 55-acre parcel sometime after 1890 (Woods, 1891). Although the lot is reduced in size, the property retains its historic agricultural setting. The

property is notable as an example of a mid-nineteenth-century rural farmstead grouping consisting of a house and barn, and for its association with the settlement and agricultural development of northern Ohio.

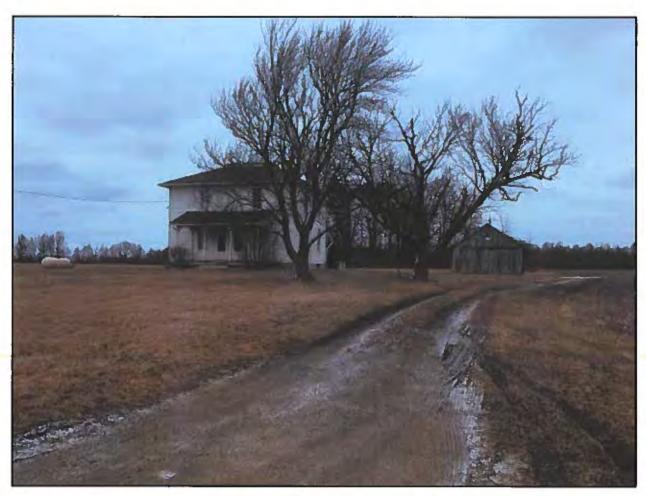
Inset 23. 12675 East Town Road 8

This is a two-story wood frame double house in a vernacular interpretation of the Italianate style (Inset 23). It is square in plan with symmetrically arranged facades atop a stone foundation and with a low, hipped roof. The exterior walls are clad in clapboard and the roof is asphalt. A wide front porch supported on turned posts with brackets contains paired entry doors. With the exception of those at the basement level, windows are one-over-one, and may be original. As a vernacular interpretation of the Italianate style, floor heights are relatively low and, though it is not known whether the eaves were originally bracketed, the narrow fascia suggests they may have been unadorned. A flat portion at the peak of the hipped roof suggests a cupola may have been present. A small barn with a metal roof, vertical board siding, and a sliding door is located to the northeast of the house. The house appears to have been built after 1864, when it appears on the *Map of Seneca Co., Ohio* as the property of W. (William) Anway, and prior to 1874, when it appears on the

Combination Atlas Map of Seneca County as the property of Phoebe J. Anway (Lake, 1864; Stewart, 1874). The property is still in agricultural use and retains its historic 80-acre size. The property is notable as an example of a vernacular Italianate farmhouse, a type and style of residence common to nineteenth-century rural Ohio and retaining a high degree of integrity of setting, materials, workmanship, and feeling.

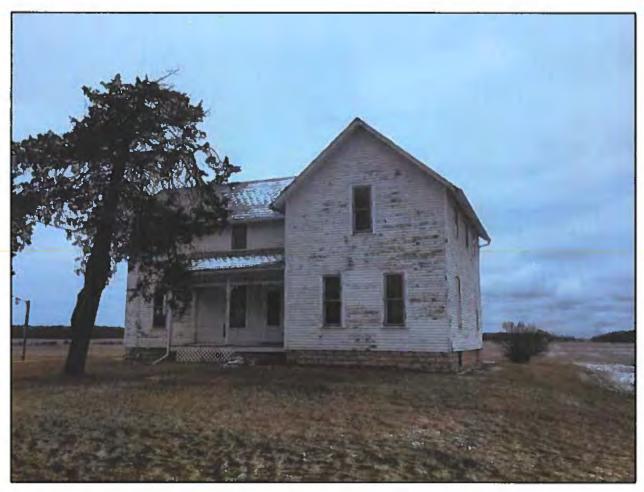
Inset 24. 14921 East Town Road 122

This is a one-and-one-half-story vernacular wood-frame residence with a gable-and-ell form (Inset 24). The exterior is clad in wood clapboard and the foundation is of cut stone. The slate roof features bands of decoratively shaped slates. The front-gable portion to the east is two bays wide, with symmetrically arranged windows on the south and east facades. The side-gable portion to the west features a two-bay-wide entry porch with Queen Anne details. Two doors lead inside from the porch. Windows are generally one-over-one. There are basement windows at the east and west, and a triple, casement window at the first floor of the west façade. There is a single-story extension at the rear of the house, which shares the same siding and roofing materials as the main volume. The house was likely constructed prior

to 1864, when it appeared on the *Map of Seneca Co., Ohio* as the farm and residence of Joseph Bogner (1836-1907), an Alsatian immigrant (Lake, 1864; Find A Grave, 2020). The barn appears to date from about the same time. The property retains its historic 80-acre size and is still in agricultural use. A small shed with a metal roof and vertical wood siding is located to the rear of the house. To the west is a four-bay barn with a metal-clad gable roof and vertical wood board siding. Three pairs of sliding doors are located on the south façade, and another pair is located on the east. The property is notable as an intact example of a mid-nineteenth-century farmstead. The house is a very good example of a vernacular farmhouse, a type and style of residence common to nineteenth-century rural Ohio and retaining an unusually high degree of integrity of setting, materials, workmanship, and feeling.

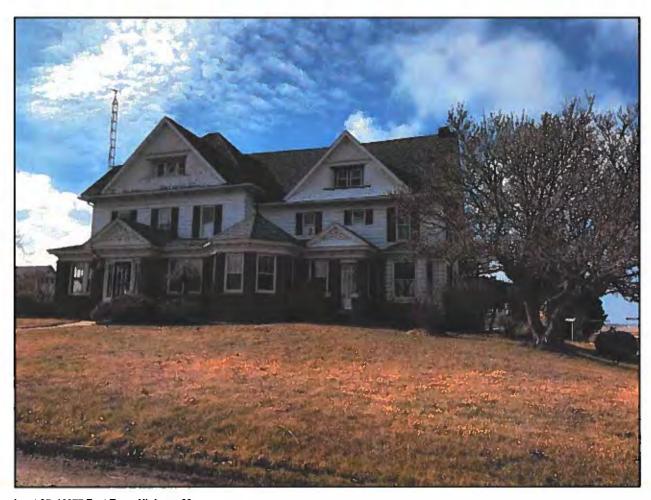
Inset 25. 16977 East Town Highway 88

This is a large, two-story wood-frame house in the Queen Anne style (Inset 25). It is roughly L-shaped in plan, consisting of two main rectangular volumes with multiple crossed roof gables and an enclosed, full-width front porch. The exterior is clad in a replacement material at the first and second floors, and in wood shingle with octagon butts at the gable

ends. Windows in the gable ends of the principal façade are recessed, with the shingle-clad wall surface curving inward to meet the jambs. The roof is clad in asphalt shingle, and projects atop modillions at the main eave. A brick chimney rises from the main roof ridge at the north; a second, exterior brick chimney pierces the roof eave at the rear (west) façade. The full-width porch on the principal façade appears to have been enclosed with brick piers and spandrels and three-over-one windows in the early twentieth century. The main entry to the porch features a door with divided lights and sidelights, while a second porch entrance has a similar door without sidelights. The complex roof of the porch features gables with sawn ornament in a scroll motif over each entrance, with an octagonal roof topped with a finial between them. The porch roof eaves contain modillions and dentil molding. Excepting those on the porch, windows are generally one-over-one. A fixed-sash window in one of the main roof gables features a diamond-shaped pane surrounded by smaller square panes. Based on historic imagery, wood clapboard siding was covered or replaced and nonoriginal shutters were added between 2008 and 2020 (Google, 2008). A rear addition consists of a single-story gable-roofed projection and a single-bay, gable-roofed garage. The property includes a carriage barn across the road, which has clapboard siding and dentil molding below an overhanging, flared gable end featuring shingles with octagon butts. The gable roof clad in slate. The overhead door is not original. This description of the carriage house is based on 2008 imagery and may not reflect current conditions (Google, 2008).

The house appears to have been built prior to 1874, when it appears on the 1874 Combination Atlas Map of Seneca County as the residence and farm of Samuel Weaver (Stewart, 1874). The simple, rectangular massing of the two main volumes suggests an earlier structure with subsequent Queen Anne modifications through additions and roof alterations. The house is unusually large for its rural setting in northern Ohio. The property includes land on both sides of the road; however, it has been reduced to less than 1.5 acres from its historic size of more than 300 acres (one of the larger landholdings in the Township of Venice). A grouping of historic barns, including a substantial barn featuring a cross-gable roof, was originally part of the property, but is no longer part of the same parcel as the house and carriage barn. The property is notable for its association with the agricultural development of northern Ohio, as an intact example of a nineteenth-century farmhouse expanded and altered over several generations of ownership by a prosperous farming family. Although no longer part of the same parcel or under the same ownership, several historically significant agricultural buildings are still extant, and as a whole, the grouping retains a high degree of integrity of materials, setting, and feeling.

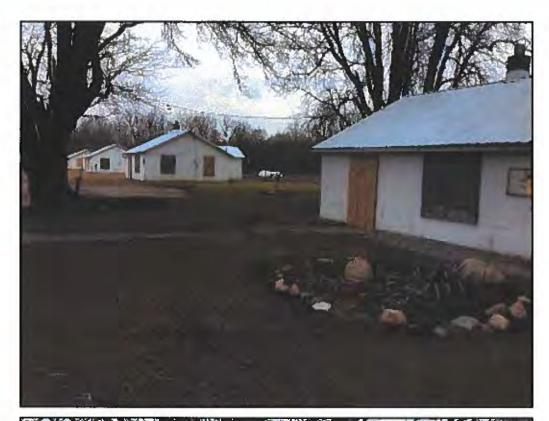
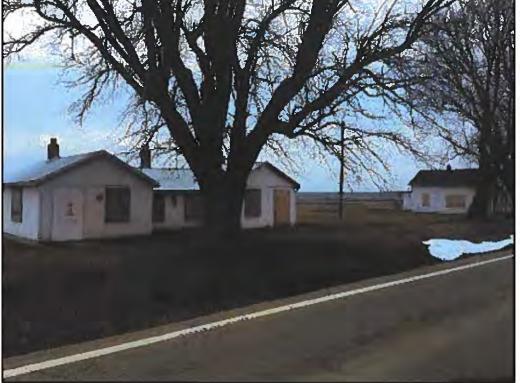
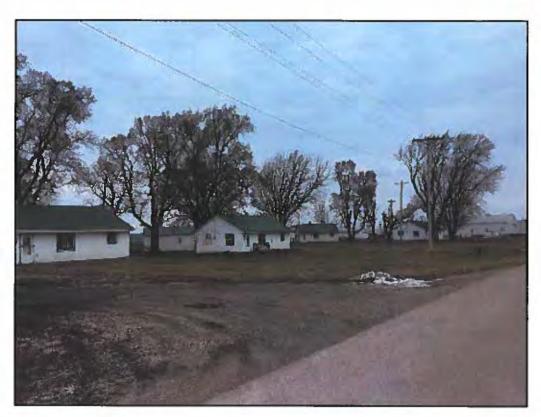
Inset 26. Farm Worker Housing
Top to Bottom: 0 Baseline Road; 0 State Route 103; and 0 Bevier Road.

Two properties were identified as being associated with the Wiers family on Baseline Road and State Route 103. A third example of farm work housing located near muck fields is located on Bevier Road. This collection is comprised of at least 19 buildings clustered at a dead-end road. The property is identified in county records as being owned by John F. Stambaugh & Co (Huron, 2020).

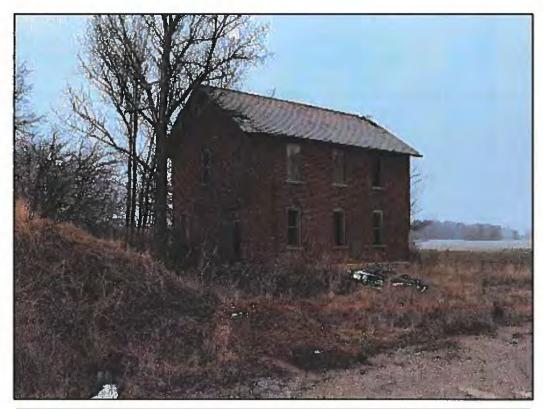
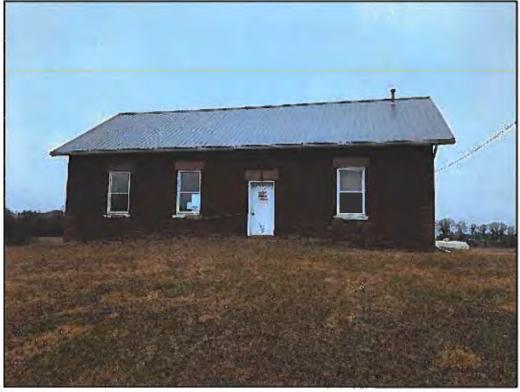
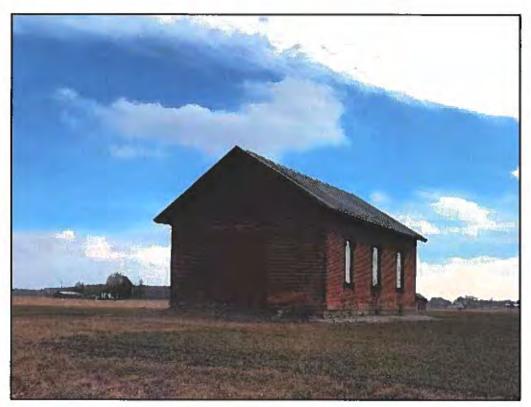
Inset 27. District Schoolhouses

- District School No. 5 0 County Route 32, Thompson Township, Seneca County
 - Also identified as the "Thompson Center School" this unusual two-story example retains its original form and fenestration, though all windows and doors are either missing or boarded over (Valentine, 1987). It first appears on the 1896 map of *The County of Seneca, Ohio,* labeled as "School No. 5" (Rerick, 1896).

- District School No. 1 2670 Peru West Section Line Road, Peru Township, Huron County
 - This is a one-story example with an unusual configuration; the only entrance is situated off-center on the eaves side elevation. The building has replacement windows and appears to have been converted to a residence. This school first appears on the 1873 Atlas of Huron County, and is labeled as District School No. 1 in 1891 on the Atlas of Huron County, Ohio (Lake 1873; Mesnard, 1891).

Top to Bottom: District School No. 5 – 0 County Route 32; District School No. 2 – 7472 Boundary Road; District School No. 1 – 0 Peru West Section Line Road.

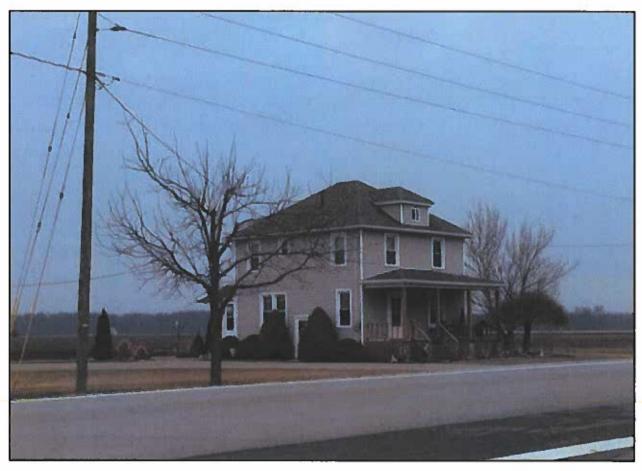
Inset 28. 3809 State Route 113 West

The property at 3809 State Route 113 West Monroeville (ERI0223306) is a two-story, wood-frame, Foursquare-style residence (Inset 28). It has a one-story, full-width, open porch on the front façade. The porch is constructed of unpainted, pressure-treated lumber. Other replacement materials include vinyl siding and windows. Although this property does not appear to satisfy NRHP eligibility criteria, it is representative of a vernacular building type common to north central Ohio. The house at 3809 State Route 113 West likely dates to the early-twentieth century and may have originally exhibited Craftsman detailing. During the 1920s large nineteenth century farms were divided into smaller parcels and there was an increase in the construction of single-family homes on smaller parcels that did not include agricultural land. Most of the residences of this type within the Historic Resources Study Area are vernacular examples

that have been modified through the use of modern materials resulting in loss of character defining architectural elements.

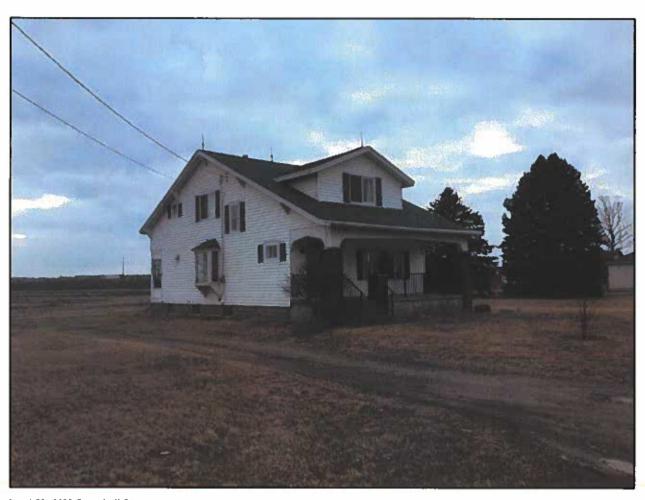
Inset 29. 4420 Campbell Street

The property at 4420 Campbell Street, Sandusky (ERI0275603) is a one-and-one-half story bungalow -style residence with a front gable that covers a full-width porch (Inset 29). A broad gable roofed dormer is centered on the front roof plane. The porch is supported by brick columns and it has an iron railing. Knee brackets underscore the eave. Although the property at 4420 Campbell Street does not appear to satisfy NRHP eligibility criteria, it is representative of a building type common to north central Ohio. Bungalows and one-story Craftsman inspired homes are common to the current building stock, one of the results of the previously described pattern of subdivision of larger agricultural properties that occurred in the early twentieth.

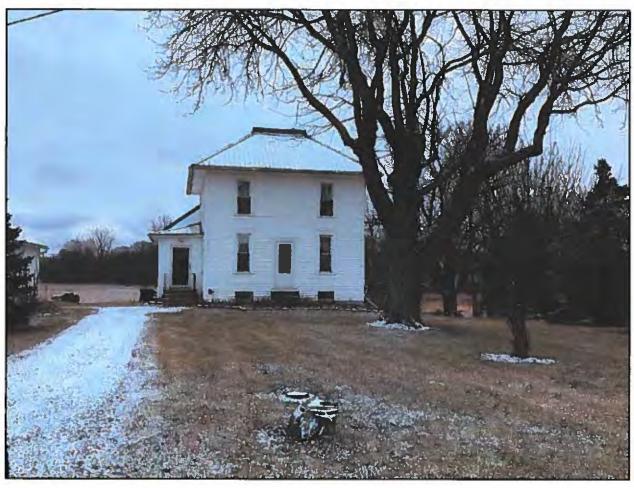
Inset 30. 4827 Pontiac Section Line Road

The property at 4827 Pontiac Section Line Road, Monroeville (HUR0086705) is a two-story, three-bay, wood-frame Italianate-style residence with a hipped roof (Inset 30). The entry is in the center bay, flanked by slender one-over-one, double-hung windows with two of the same aligned on the second story. The roof is flat in the center, indicating the former presence of a cupola. Massing and roof form are reminiscent of the Italianate style, but brackets, window hoods, and other decorative elements that may have existed have been removed. Although, the property does not appear to satisfy NRHP eligibility criteria, it is representative of a building type common in north central Ohio. Examples would have been constructed circa 1865-1885 and are located in rural settings that were historically associated with agriculture. Houses in this category tend to retain only their form and roof line. Modifications generally include replacement materials and removal of architectural detail, thereby compromising the structure's integrity.

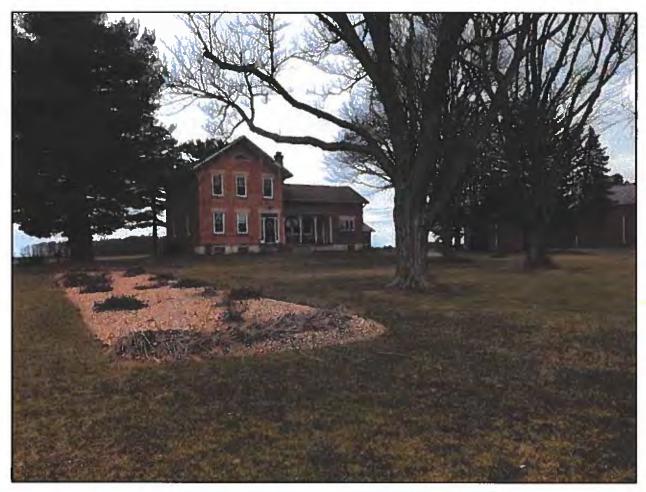
Inset 31. 2177 Sand Hill Road

Although the property does not appear to satisfy NRHP eligibility criteria, it is representative of a building type common to north central Ohio. Massing consisting of a front-gable principal block with a perpendicular wing is extremely common. The majority of examples are wood frame; however, brick examples such as this, often with brackets or other detail work, reflect a more upscale variation. As is the case here, many have been compromised through the introduction of replacement materials.

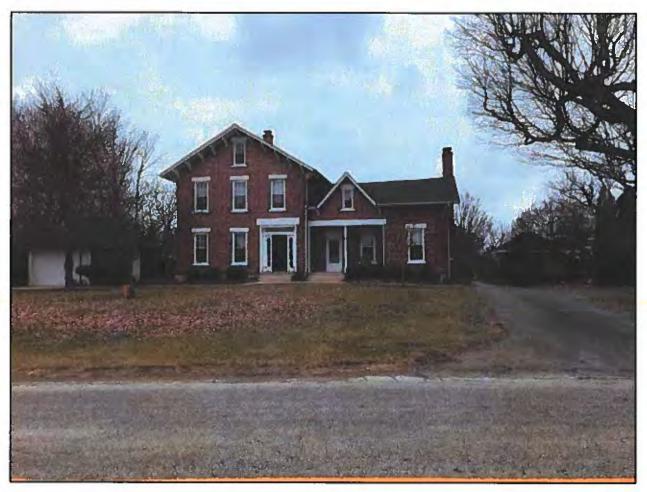
Inset 32, 3337 Sand Hill Road

The property at 3337 Sand Hill Road, Bellevue (HUR0007401) is a two-story, front-gable, brick house with a one-and one-half-story, side-gable wing extending to the west (Inset 32). The design incorporates Greek Revival and Gothic Revival influences. The principal block is three bays wide with the entry in the right-hand bay; the door is framed by side lights and a transom light. The wing is three bays wide and the two bays nearest the principal block contain a recessed, open porch. Differentiating this example from other front-gable block and wing houses is a gable wall-dormer

centered above the porch, accounting for the Gothic Revival-style influence. The roof is asphalt and is underscored by single brackets lining the eaves. The property record provides a date of construction of 1860, which is consistent with architectural influences and historical mapping. A house is present in this location on the 1873 *Atlas of Huron County, Ohio* (Lake, 1873; Huron County, 2020). Although the property does not appear to meet NRHP eligibility criteria is representative of a building type common to north central Ohio. This massing is less common than the simple block and wing examples, but still prevalent. Windows appear to be vinyl, six-over-six, with stone lintels and sills.
