Historic Resources Survey
October 2020
Environmental Design & Research
(Submitted to State Historic Preservation Office
January 5, 2021)

RE: Emerson Creek Wind Farm

Our office has reviewed the revised Historic Resources Survey Report, Emerson Creek Wind Farm, Groton and Oxford Townships, Erie County, Ohio, Lyme, Ridgefield, Sherman, Norwich, and Richmond Townships, Huron County, Ohio, prepared by Environmental Design and Research (EDR) in October 2020. The project is a 297.66-megawatt wind energy facility consisting of up to 87 wind turbine generators and associated infrastructure.

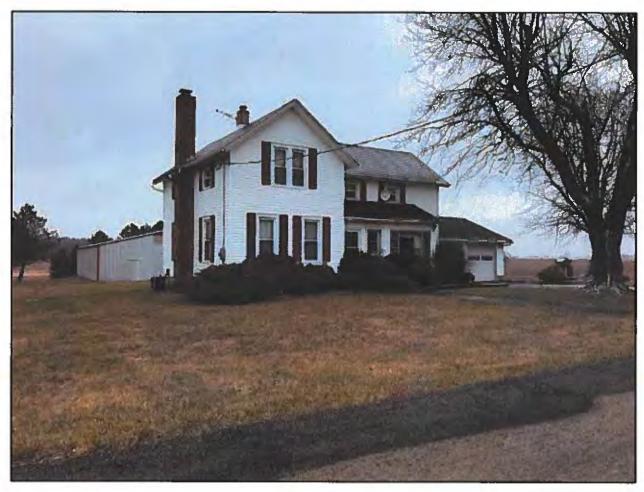
Inset 33. 16323 County Route 24

The property at 16323 County Route 24, Attica (SEN0133312) is a one-and-one-half-story, wood frame, gable-and-ell residence with an asphalt roof and vinyl siding (Inset 33). An exterior brick chimney interrupts the roof eave on the west façade. Windows are generally one-over-one and do not appear to be original. Other alterations include an enclosed entry porch and a substantial rear addition with an attached, two-bay garage. Two pole barns built in the 1970s and 1980s are located to the north of the house. The house may have been constructed as early as 1864, and most likely

by 1874 (Lake, 1864; Stewart, 1874). Although still in agricultural use and retaining its historic 80-acre size, this property does not appear to satisfy NRHP eligibility criteria because the house has been modified through the use of modern materials. Any historic agricultural buildings are no longer extant.

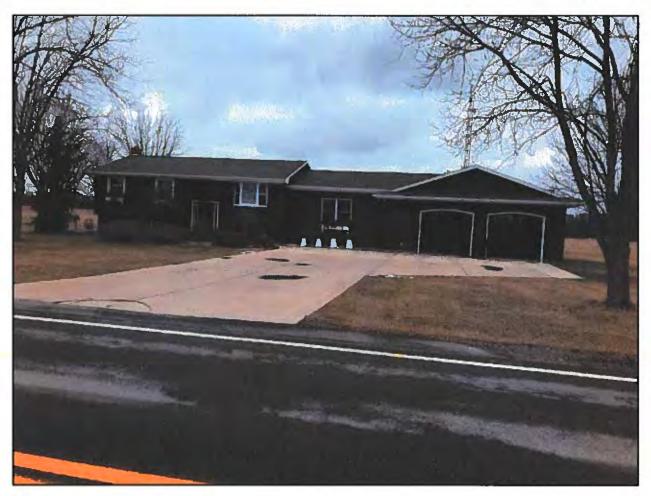
Inset 34, 3880 North State Route 269

to north central Ohio. During the twentieth century, large nineteenth century farms were divided into smaller parcels and there was an increase in the construction of single-family homes on smaller parcels that did not include agricultural land. Ranch style homes are common to the current building stock. Most are vernacular examples that have been modified through the use of modern materials and loss of character defining architectural elements.

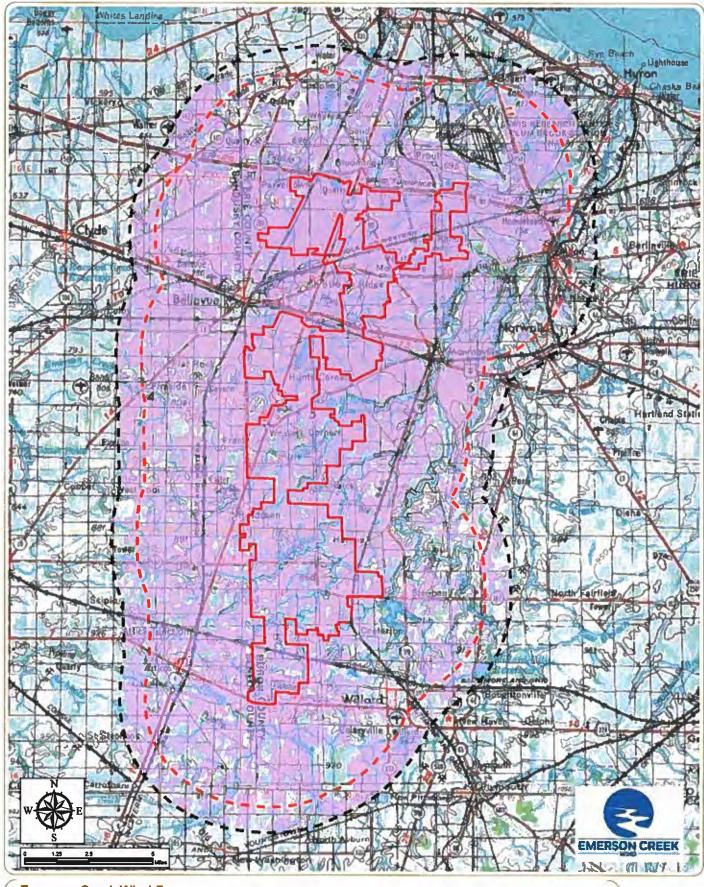
Figure 2: Project Layout and APE for Indirect Effects

The Project Area consists of an approximately 41,000-acre polygon within which all ECWF components will be contained, including parcels currently under lease (or other real property interests) by Firelands Wind (see Figure 2).

Therefore, the APE for Indirect Effects on historic resources includes all areas within the Historic Resources Study Area (per 4906-04-08(D) of the OAC) where Project components may be visible and where there is a potential for a significant visual effect (see Figure 2).

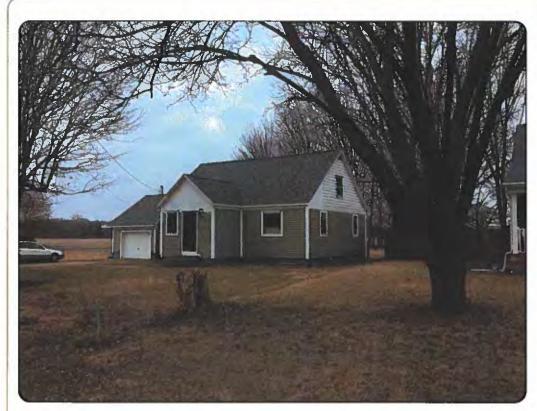
Survey ID: P-1

Photograph Direction: North-northwest

Meets NRHP Eligibility
Criteria: No

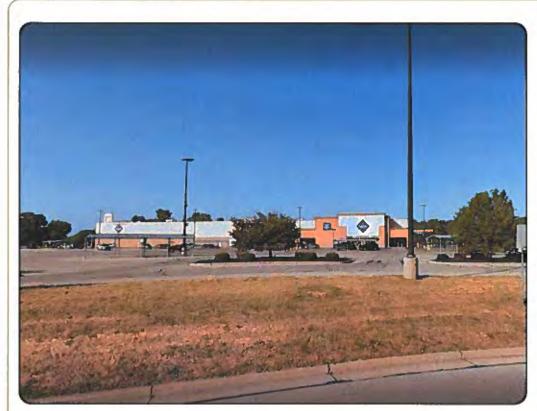
Resource ID: 00000011

Resource Name: No name given (appears demolished)

Meets NRHP Eligibility
Criteria: Resource No Longer

Extant

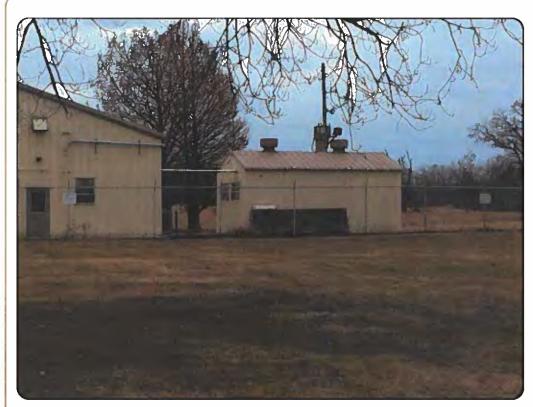
Resource ID: ERI0262403

Resource Name: Plant Protection Boiler House

Meets NRHP Eligibility

Criteria: No

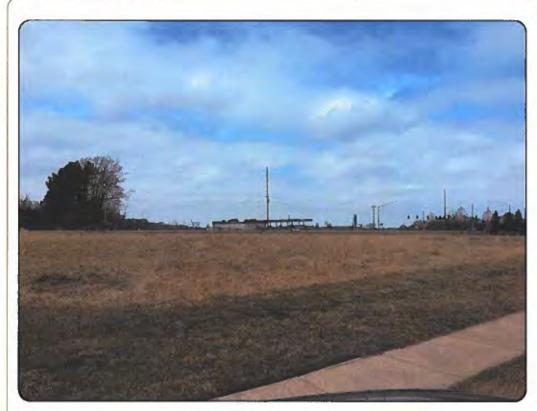
Resource ID: ERI0227604

Resource Name: Didion Property (appears demolished)

Meets NRHP Eligibility
Criteria: Resource No Longer

Extant

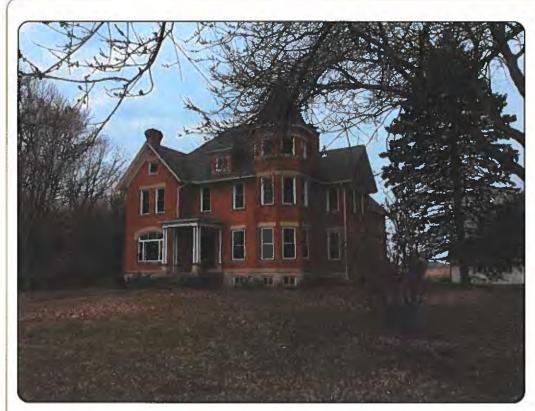
Resource ID: ERI0228503

Resource Name: No name given, a two-story vernacular residence.

Meets NRHP Eligibility

Criteria: Yes

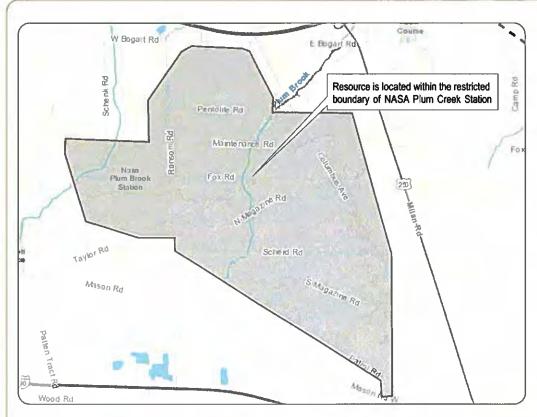
Resource Name: Spacecraft Propulsion Research Facility (resource located within restricted NASA Plum Creek Station boundary)

Meets NRHP Eligibility Criteria: NRHP-Listed

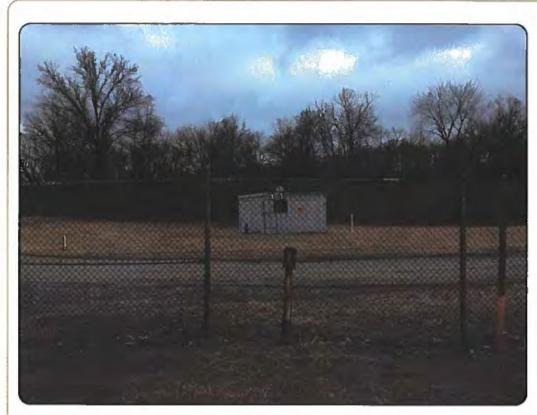
Resource ID: ERI0262803

Resource Name: Gas Meter House, a small, one-story steel shed.

Meets NRHP Eligibility Criteria: No

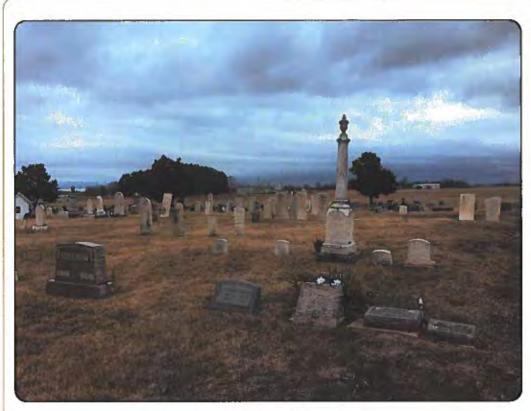
Resource ID: 10735

Resource Name: Parkhurst

Meets NRHP Eligibility
Criteria: Yes

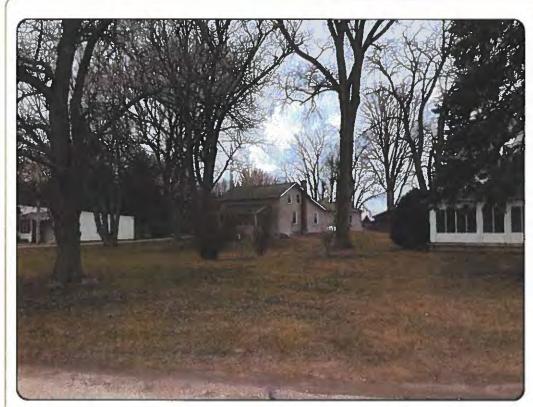
Resource ID: ERI0217006

Resource Name: Ebert House, a one-and-one-halfstory saltbox residence.

Meets NRHP Eligibility Criteria: No

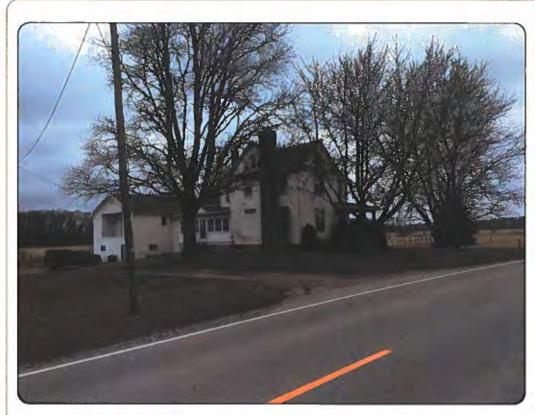
Resource ID: ERI0216506

Resource Name: Charles & Lisa Ohlemacher House, a two-story Queen Anne-style residence.

Meets NRHP Eligibility
Criteria: No

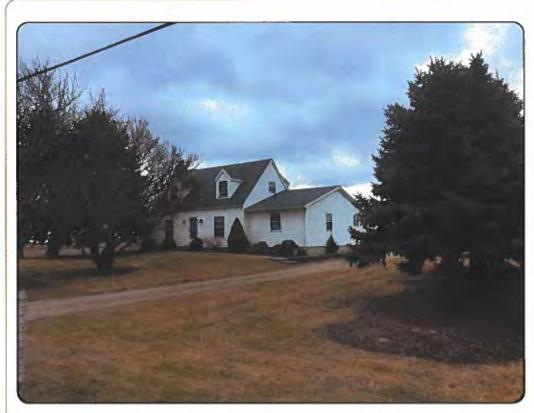
Resource ID: ERI0216606

Resource Name: Robert Schwanger Jr. House, a one-and-one-half-story Cape Cod-style residence.

Meets NRHP Eligibility Criteria: No

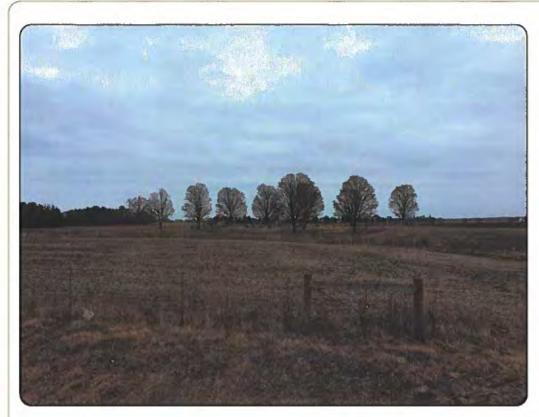
Resource ID: 3019

Resource Name: Saint Johns Union Corners (Saint John's)

Meets NRHP Eligibility

Criteria: Yes

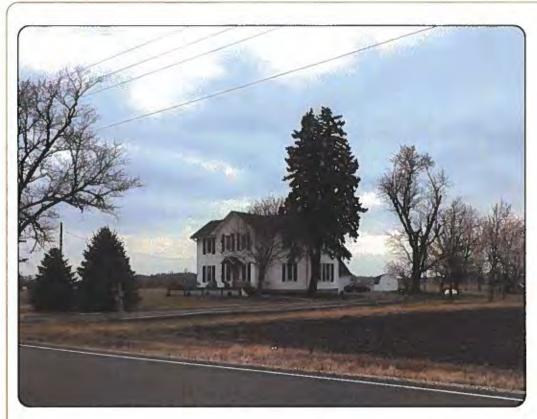
Resource ID: ERI0218606

Resource Name: No name given, a two-story vernacular

Meets NRHP Eligibility

Criteria: No

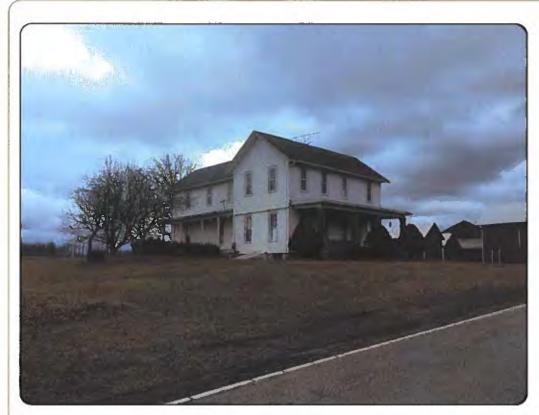
Resource ID: SAN0061312

Resource Name: Gallagher Farm, a two-story Greek Revival-style residence.

Meets NRHP Eligibility Criteria: No

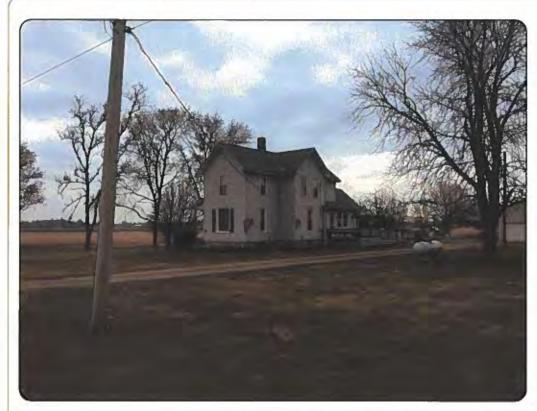
Resource ID: ERI0218706

Resource Name: Kenneth & Elizabeth Tunnel House, a two-story vernacular residence.

Meets NRHP Eligibility Criteria: No

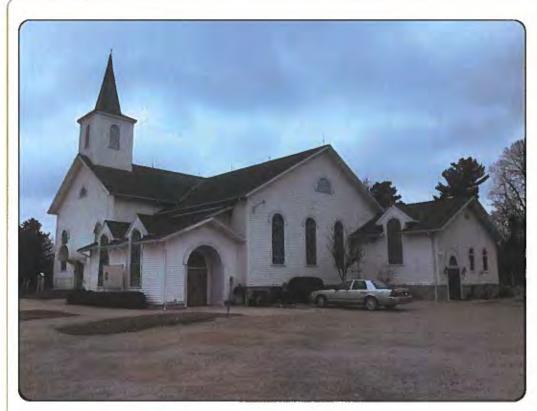
Resource ID: ERI0240906

Resource Name: St Johns United Church of Christ, a one-story church with Gothic Revival-style elements.

Meets NRHP Eligibility Criteria: No

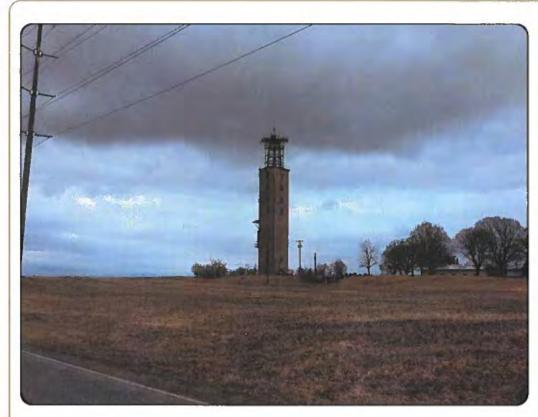
Resource ID: ERI0263810

Resource Name: Castalia Microwave Repeater Station, a nine-story microwave tower.

Meets NRHP Eligibility

Criteria: Yes

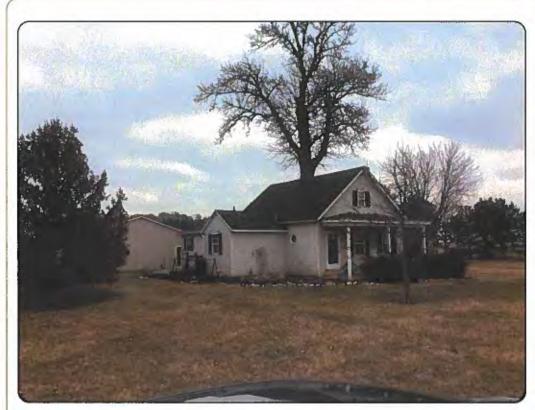
Resource ID: ERI0221506

Resource Name: Kenneth Chill House, a one-andone-half-story vernacular residence.

Meets NRHP Eligibility

Criteria: No

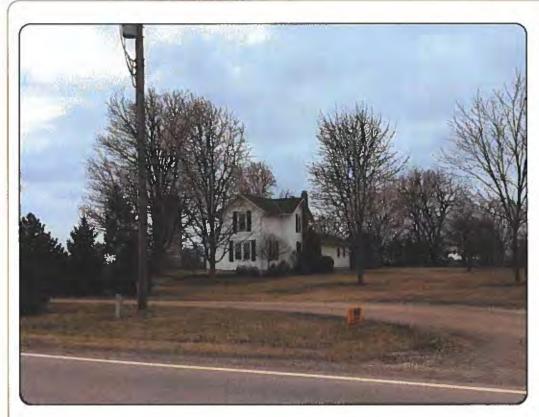
Resource ID: ERI0219006

Resource Name: Sharon Fear, a two-story vernacular

Meets NRHP Eligibility

Criteria: No

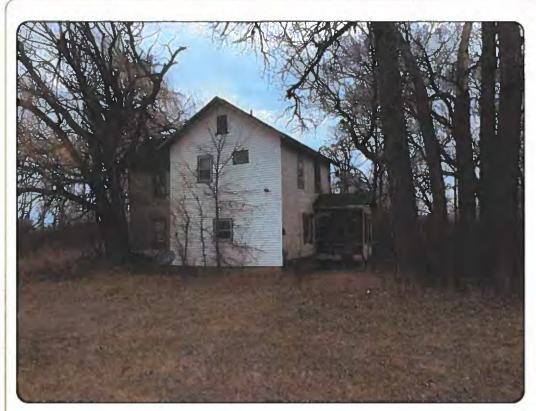
Resource ID: ERI0226607

Resource Name: No name given, a two-story vernacular residence.

Meets NRHP Eligibility

Criteria: No

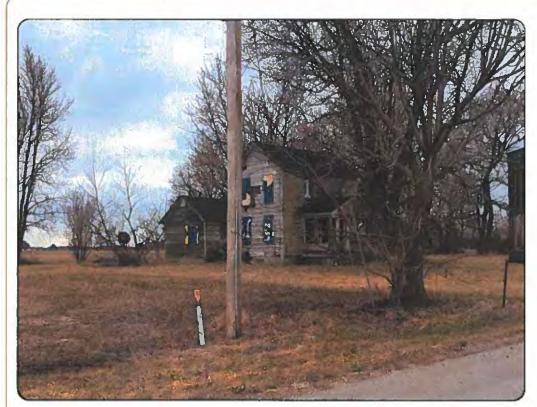
Resource ID: ERI0227806

Resource Name: No name given, a two-story vernacular residence.

Meets NRHP Eligibility Criteria: No

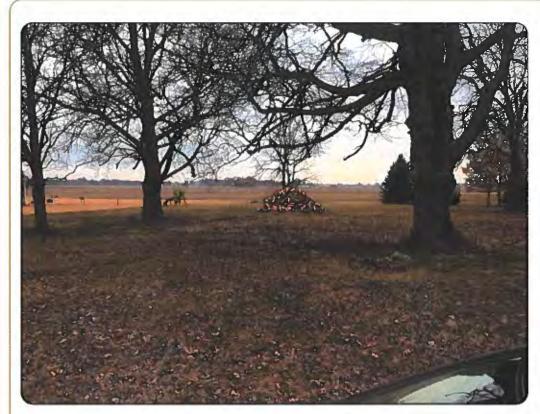
Resource ID: ERI0242806

Resource Name: Deering Farms Inc. (appears demolished)

Meets NRHP Eligibility
Criteria: Resource No Longer

Extant

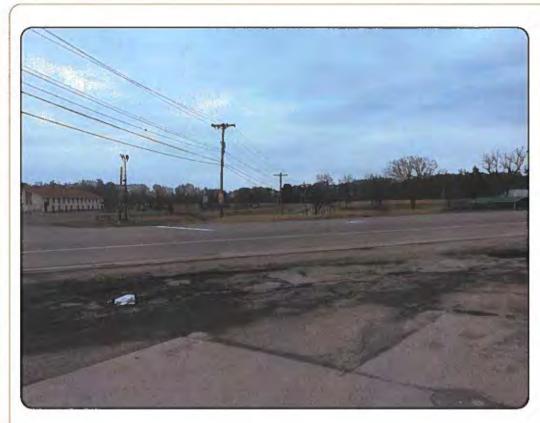
Resource ID: ERI0226407

Resource Name: No name given (appears demolished)

Meets NRHP Eligibility
Criteria: Resource No Longer

Extant

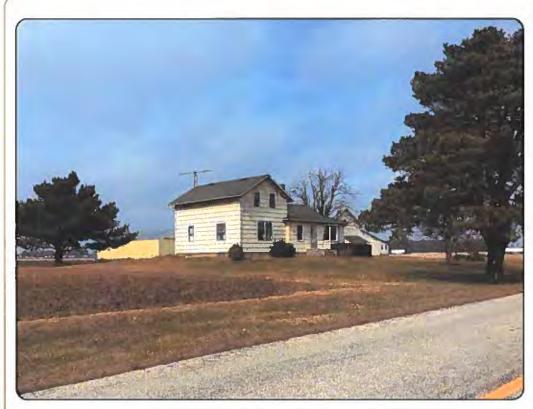
Resource ID: ERI0241406

Resource Name: Arlene H Kaiser, a one-and-one-halfstory vernacular residence.

Meets NRHP Eligibility Criteria: No

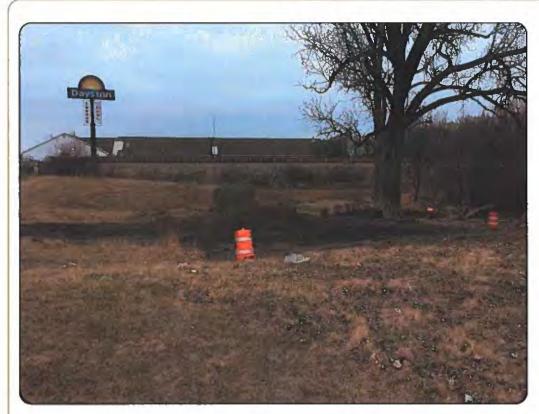
Resource ID: ERI0226007

Resource Name: Frank W Eden House (appears

Meets NRHP Eligibility
Criteria: Resource No Longer

Extant

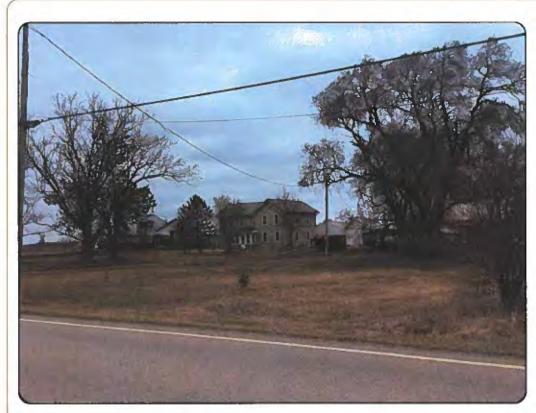
Resource ID: ERI0224106

Resource Name: Clair Sargeant, a two-story vernacular residence.

Meets NRHP Eligibility
Criteria: Yes

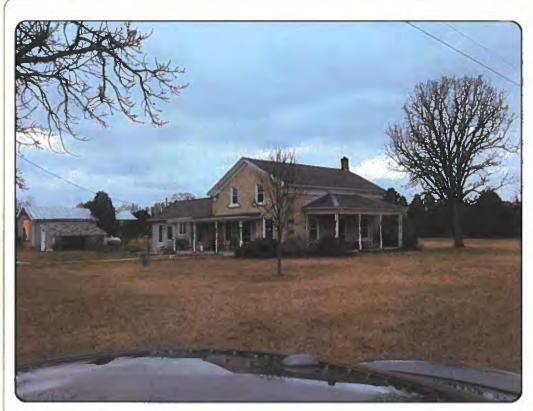
Resource ID: ERI0224006

Resource Name: Susan Py, a one-and-one-half-story stone Greek Revival-style residence.

Meets NRHP Eligibility
Criteria: Yes

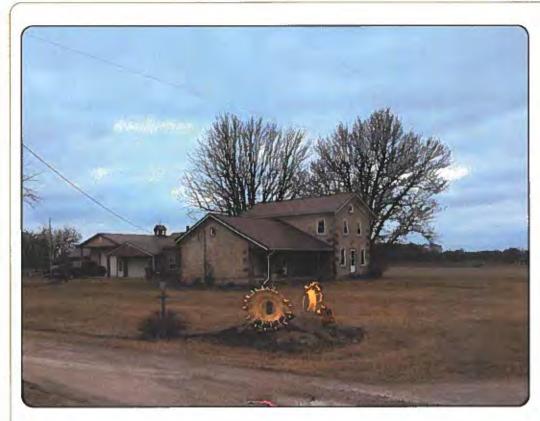
Resource ID: ERI0224206

Resource Name: Carl & Sharon Meinart, a two-story stone Greek Revival-style

Meets NRHP Eligibility

Criteria: Yes

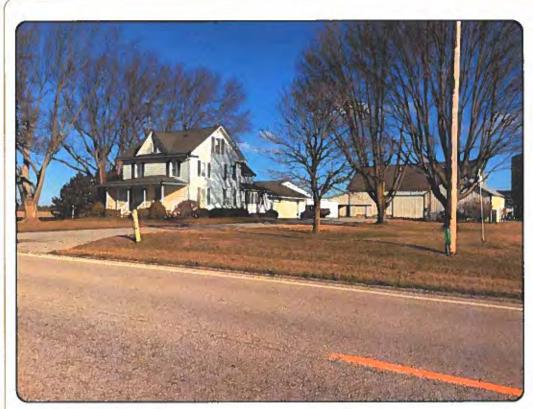
Resource ID: ERI0225106

Resource Name: J. S. Tillilson, a two-story vernacular residence.

Meets NRHP Eligibility
Criteria: No

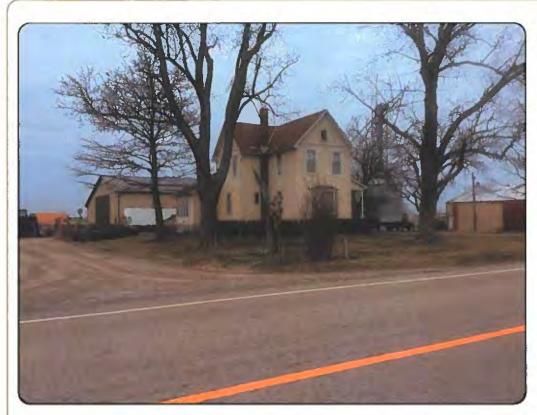
Resource ID: ERI0225806

Resource Name: Leroy & Anita Stotz, a two-story vernacular residence.

Meets NRHP Eligibility Criteria: No

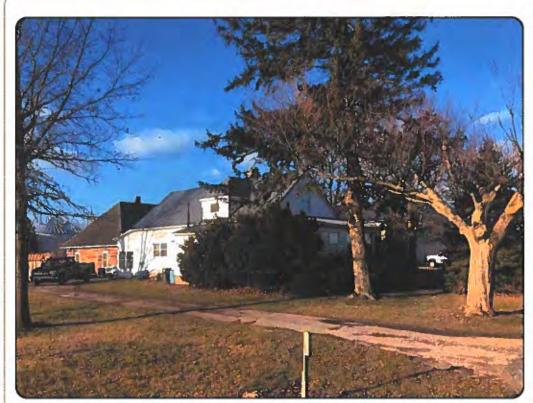
Resource ID: ERI0224506

Resource Name: Dahs, a one-and-one-half-story vernacular residence.

Meets NRHP Eligibility Criteria: No

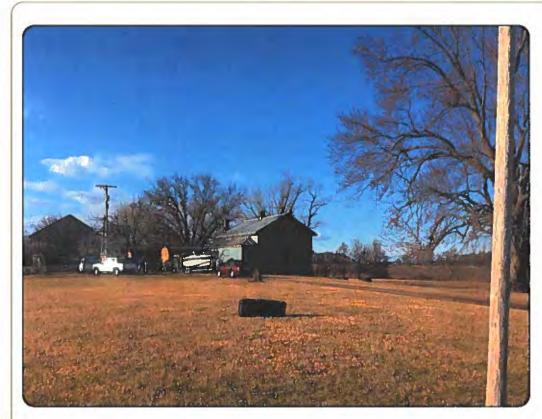
Resource ID: ERI0225006

Resource Name: Drum, a one-and-one-half-story vernacular residence.

Meets NRHP Eligibility

Criteria: No

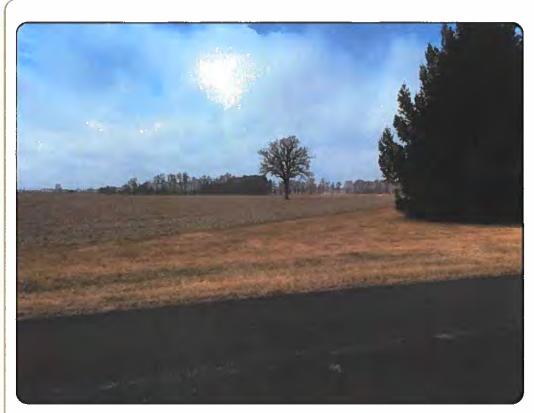
Resource ID: ERI0241606

Resource Name: Merry School House (appears demolished)

Meets NRHP Eligibility
Criteria: Resource No Longer

Extant

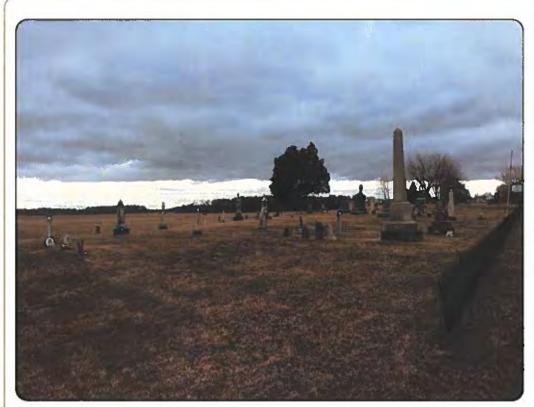
Resource ID: 10750

Resource Name: Wales Corners Cemetery

Meets NRHP Eligibility

Criteria: Yes

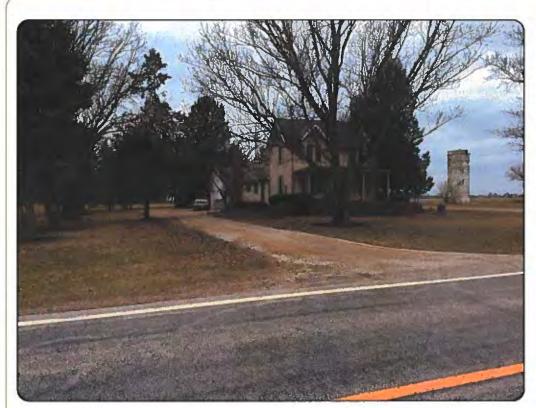
Resource ID: ERI0219606

Resource Name: Lois Schlessman, a two-story Gothic Revival-style cottage.

Meets NRHP Eligibility Criteria: No

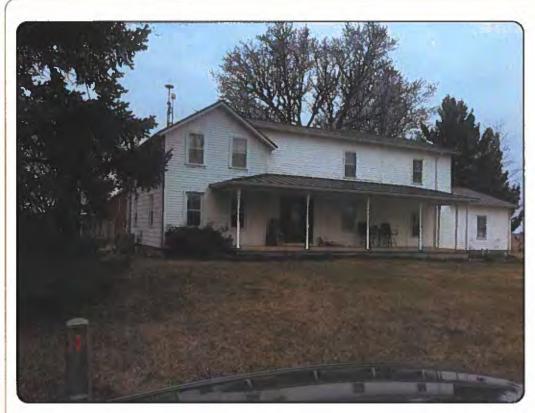
Resource ID: ERI0213206

Resource Name: Robert Raymond, Jr & Pam J. Raymond, a two-story vernacular residence.

Meets NRHP Eligibility

Criteria: No

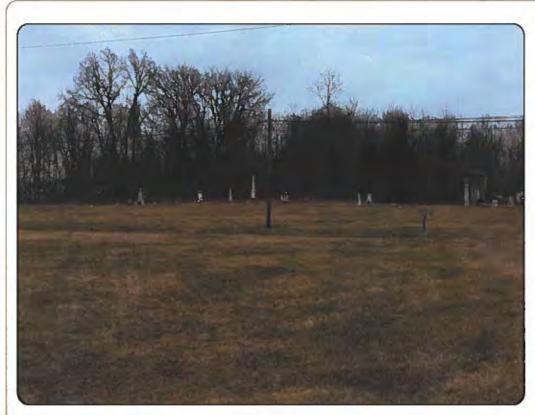
Resource ID: 3015

Resource Name: North Milan Hill-Milan North Cemetery

Meets NRHP Eligibility

Criteria: Yes

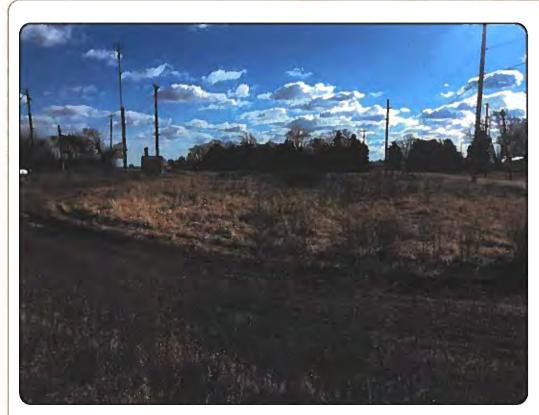
Resource ID: ERI0214506

Resource Name: No name given (appears demolished, duplicate of ERI0214706)

Meets NRHP Eligibility
Criteria: Resource No Longer
Extant

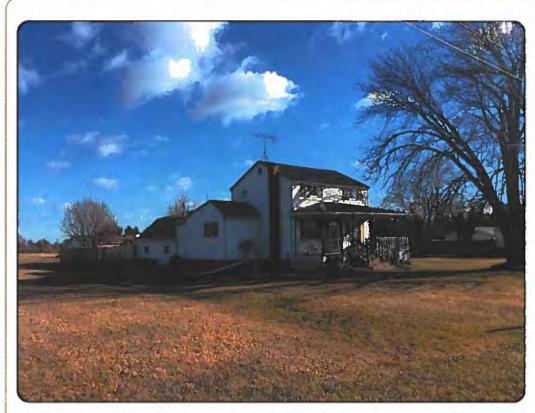
Resource ID: ERI0213606

Resource Name: No name given, a one-and-one-half-story vernacular residence.

Meets NRHP Eligibility Criteria: No

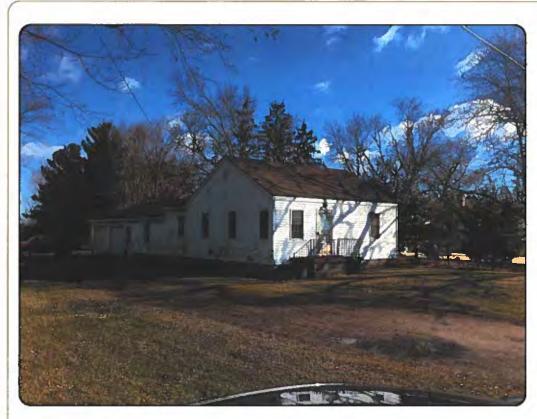
Resource ID: ERI0213806

Resource Name: Gerry Schneider, a one-story vernacular residence.

Meets NRHP Eligibility Criteria: No

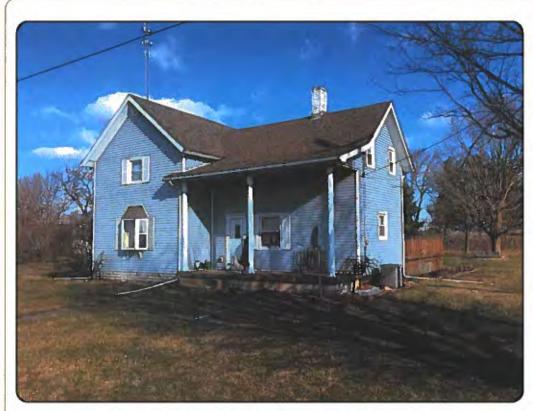
Resource ID: ERI0214006

Resource Name: Ray J. Schaefer, a one-and-one-halfstory vernacular residence.

Photograph Direction:South-southeast

Meets NRHP Eligibility Criteria: No

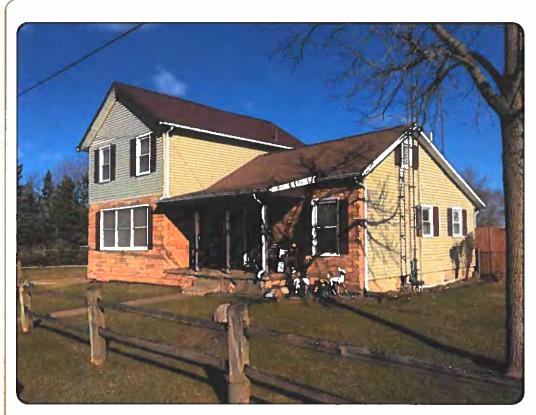
Resource ID: ERI0214406

Resource Name: Dean Skinner, a two-story vernacular residence.

Photograph Direction:
North-northwest

Meets NRHP Eligibility Criteria: No

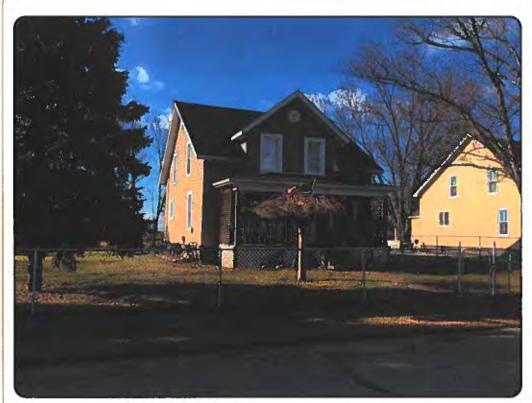
Resource ID: ERI0214206

Resource Name: Robert & Janice Wallen, a one-andone-half-story vernacular residence.

Meets NRHP Eligibility

Criteria: No

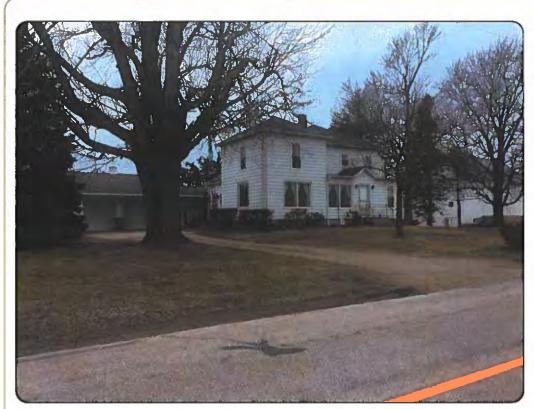
Resource ID: ERI0213006

Resource Name: Verna M. Crecelius, a two-story vernacular residence.

Photograph Direction: South-southwest

Meets NRHP Eligibility Criteria: No

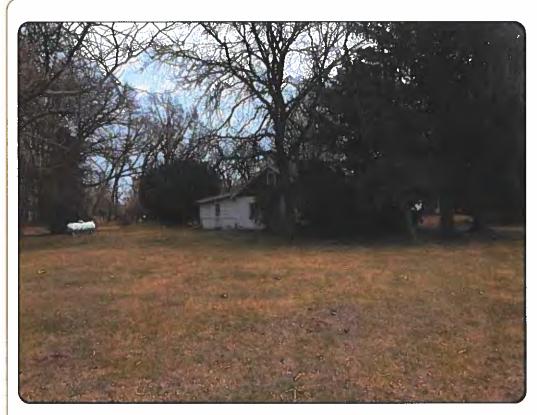
Resource ID: ERI0242006

Resource Name: Robert & Ruth Buffenbarger, a oneand-one-half-story vernacular residence.

Photograph Direction: Southeast

Meets NRHP Eligibility Criteria: No

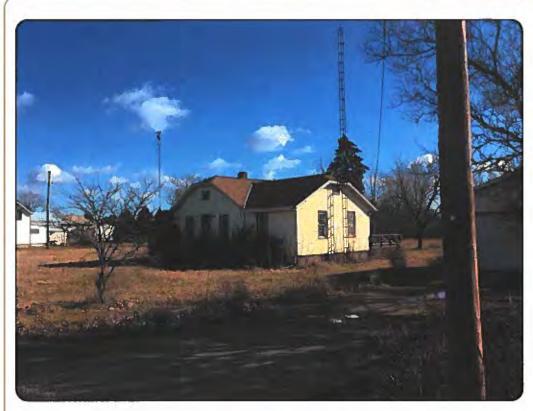
Resource ID: ERI0215006

Resource Name: John Barrett, a one-story vernacular residence.

Photograph Direction: North-northwest

Meets NRHP Eligibility Criteria: No

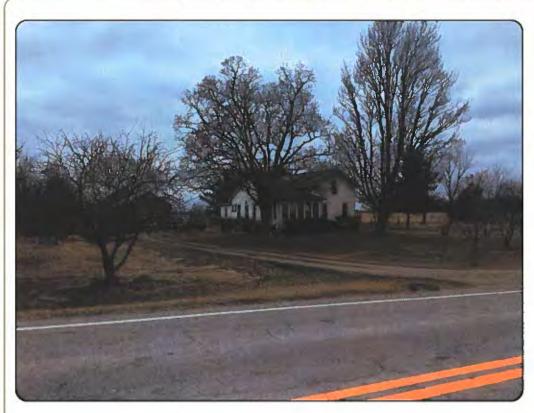
Resource ID: ERI0219806

Resource Name: No name given, a one-and-one-half-story vernacular residence.

Photograph Direction: South-southwest

Meets NRHP Eligibility Criteria: No

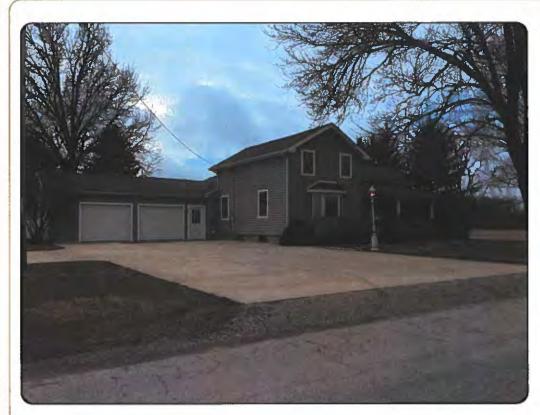
Resource ID: ERI0215306

Resource Name: Martha Hutchinson, a two-story vernacular residence.

Meets NRHP Eligibility

Criteria: No

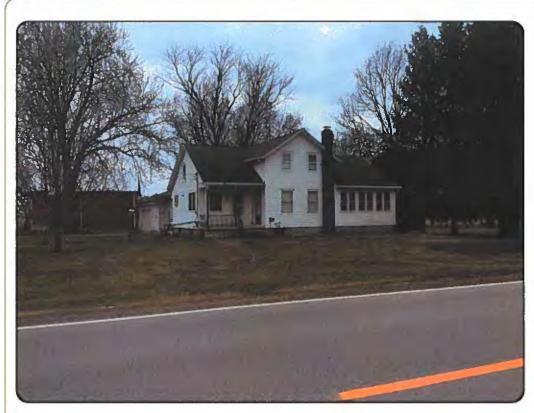
Resource ID: ERI0219906

Resource Name: Harriet Schlessman, a two-story vernacular residence.

Photograph Direction: Southwest

Meets NRHP Eligibility Criteria: No

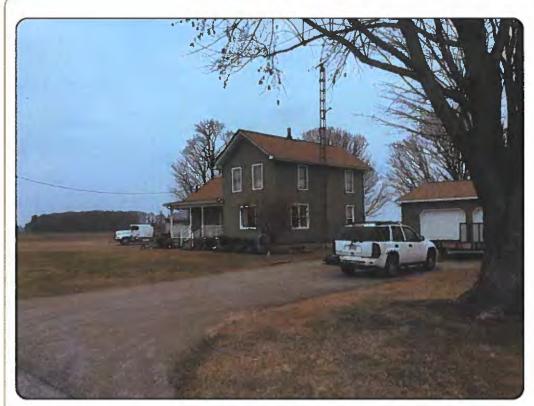
Resource ID: ERI0242306

Resource Name: Jerry & Cynthia Strong, a two-story vernacular residence.

Meets NRHP Eligibility

Criteria: No

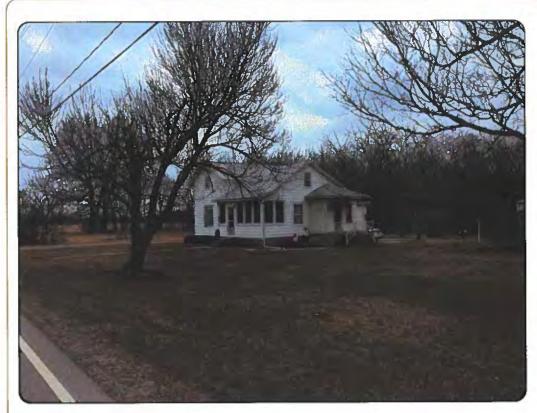
Resource ID: ERI0220106

Resource Name: Nancy Schnee, a one-and-one-halfstory vernacular residence.

Photograph Direction: North-northwest

Meets NRHP Eligibility Criteria: No

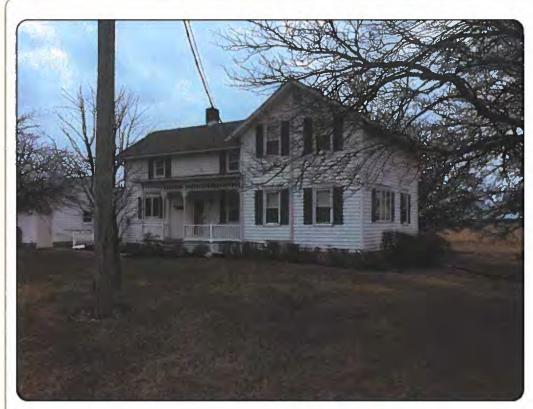
Resource ID: ERI0220306

Resource Name: Thomas & Sue Lund, a two-story vernacular residence.

Photograph Direction: North-northeast

Meets NRHP Eligibility Criteria: No

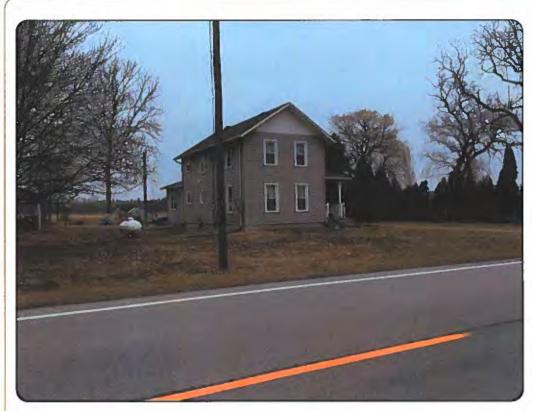
Resource ID: ERI0223706

Resource Name: Theodore & Mary Wyar, a two-story vernacular residence.

Meets NRHP Eligibility

Criteria: No

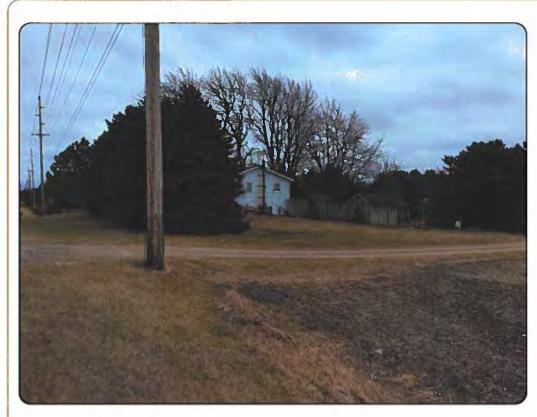
Resource ID: SAN0043412

Resource Name: Mook House (appears demolished)

Meets NRHP Eligibility
Criteria: Resource No Longer

Extant

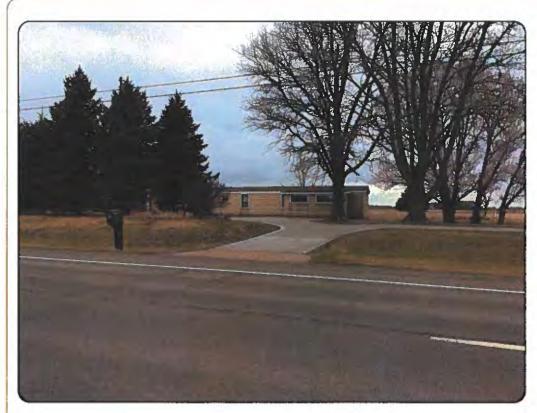
Resource ID: SAN0043612

Resource Name: Parker House (appears demolished)

Meets NRHP Eligibility
Criteria: Resource No Longer

Extant

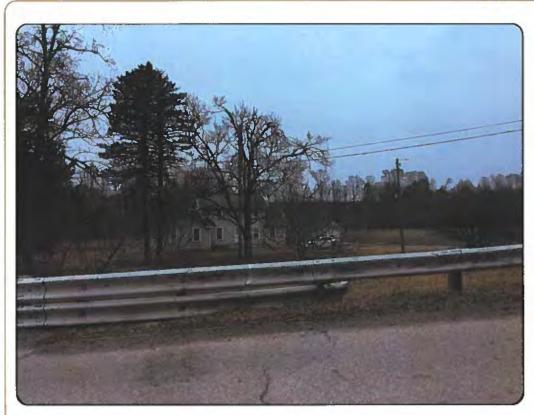
Resource ID: ERI0215506

Resource Name: Chase & Elizabeth Heyman, a two-story vernacular residence.

Photograph Direction: Northwest

Meets NRHP Eligibility Criteria: No

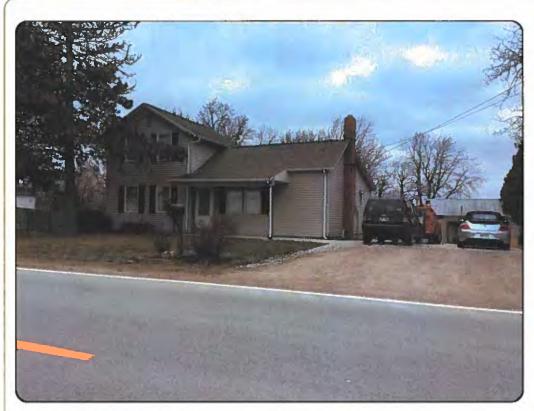
Resource ID: ERI0220806

Resource Name: Gordon & Patricia Adams, a two-story vernacular residence.

Photograph Direction: South-southwest

Meets NRHP Eligibility Criteria: No

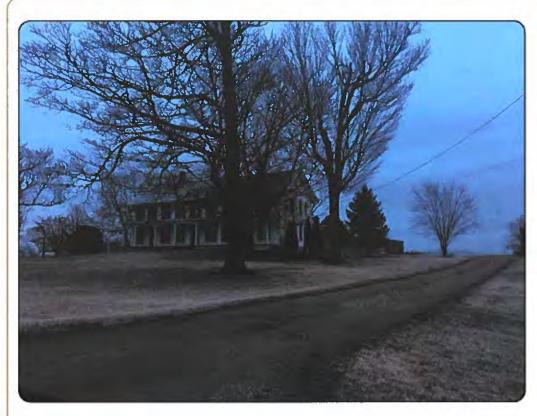
Resource ID: ERI0229710

Resource Name: William Nims House, a two-story Italianate residence.

Photograph Direction: North-northwest

Meets NRHP Eligibility Criteria: Yes

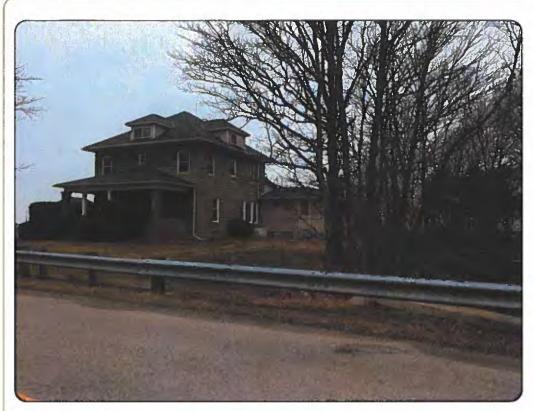
Resource ID: ERI0221206

Resource Name: No name given, a two-story preformed concrete Four Square-style residence.

Photograph Direction: South-southwest

Meets NRHP Eligibility
Criteria: No

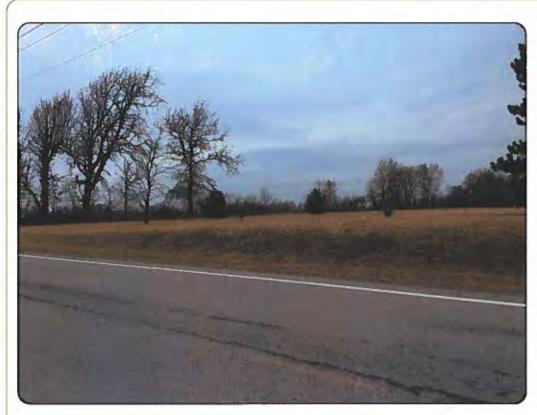
Resource ID: ERI0222806

Resource Name: No name given (appears demolished)

Meets NRHP Eligibility
Criteria: Resource No Longer
Extant

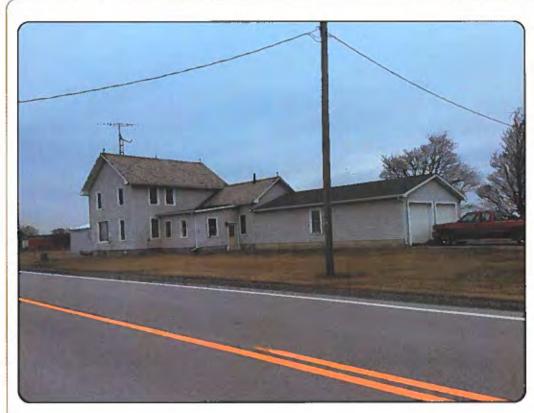
Resource ID: ERI0223006

Resource Name: Leber, a two-story vernacular residence.

Meets NRHP Eligibility Criteria: No

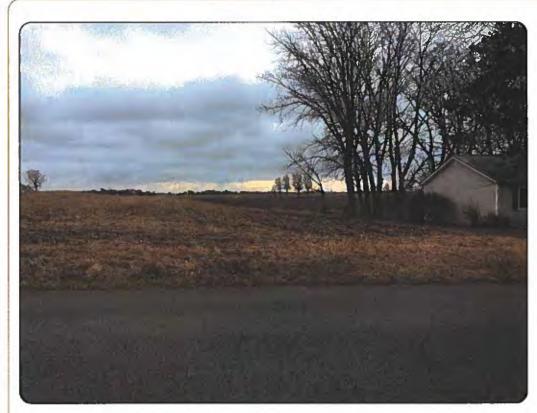
Resource ID: 5842

Resource Name: Page Farm

Meets NRHP Eligibility
Criteria: Resource No Longer

Extant

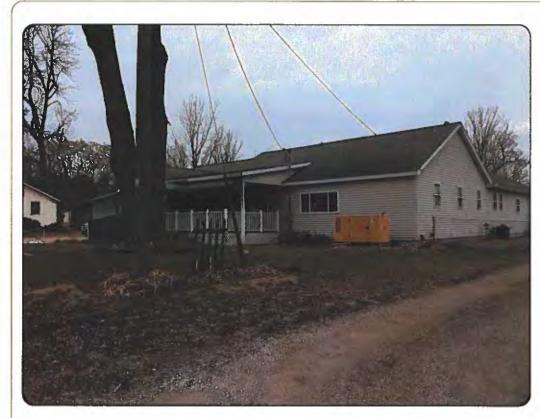
Resource ID: SAN0042012

Resource Name: Stockade-Style Log House (appears

Meets NRHP Eligibility
Criteria: Resource No Longer

Extant

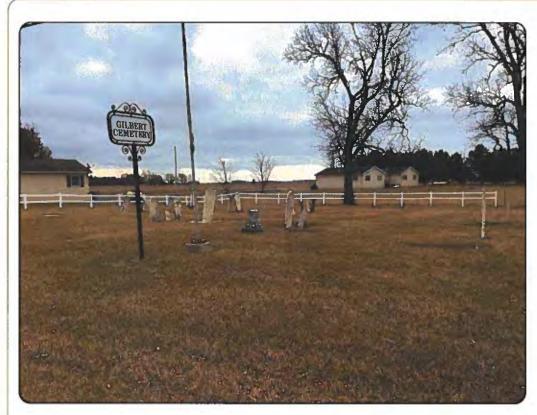
Resource ID: 10747

Resource Name: Gilbert-Cholera-Collins-Portland Road Cemetery

Meets NRHP Eligibility

Criteria: Yes

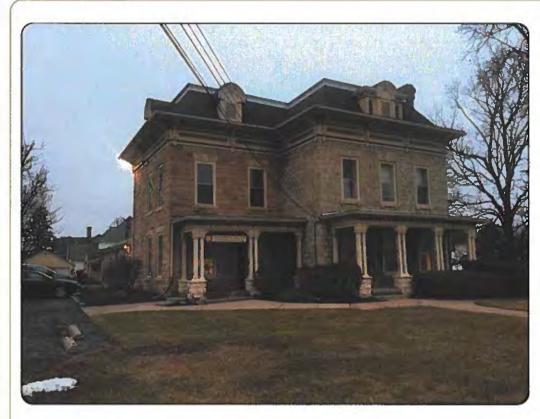
Resource ID: SAN0000712

Resource Name: No name given, a two-story stone Second Empire-style residence.

Meets NRHP Eligibility Criteria: Yes

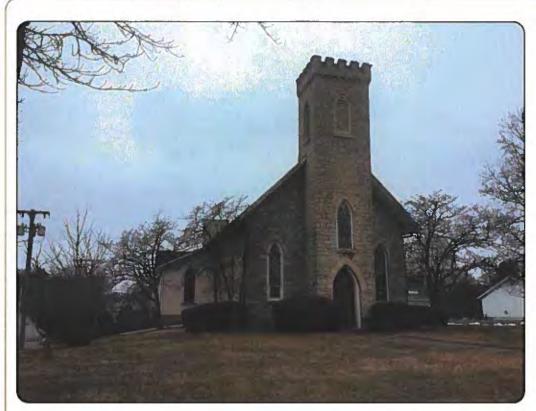
Resource ID: SAN0000912

Resource Name: St Paul's Episcopal Church, a two-story stone church.

Meets NRHP Eligibility

Criteria: Yes

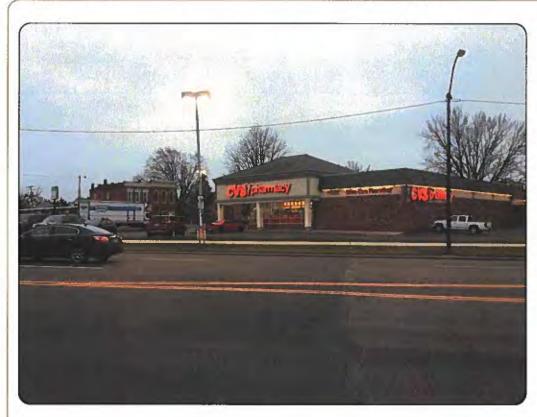
Resource ID: SAN0039612

Resource Name: Fulton & Son Insurance Agency (appears demolished)

Meets NRHP Eligibility
Criteria: Resource No Longer

Extant

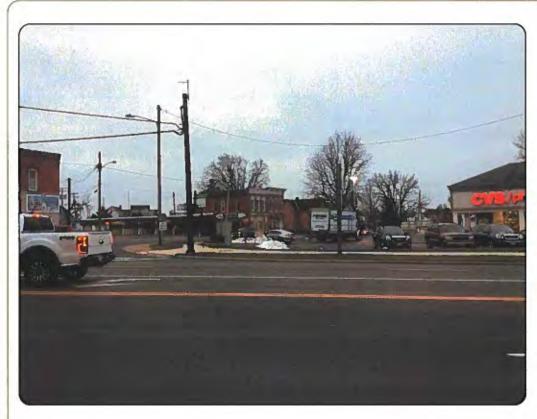
Resource ID: SAN0037512

Resource Name: Opera House (appears demolished)

Meets NRHP Eligibility
Criteria: Resource No Longer

Extant

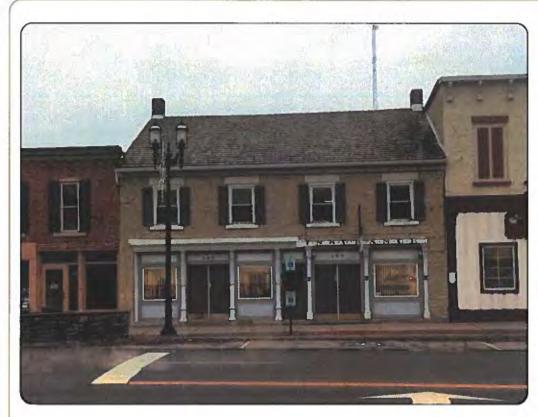
Resource ID: SAN0038612

Resource Name: Doctor Pifer Bldg. & Resco Bldg., a two-story Greek Revival-style storefront.

Meets NRHP Eligibility Criteria: No

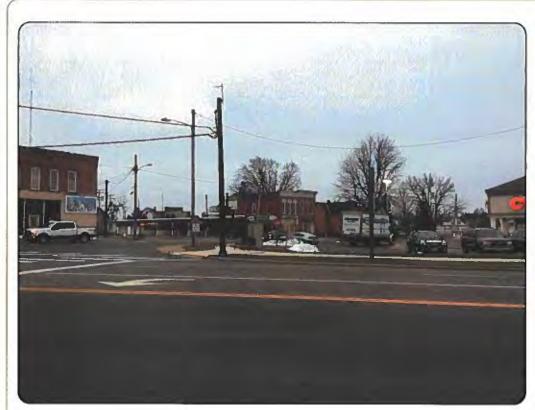
Resource ID: SAN0037312

Resource Name: Toni's Discount Center (appears demolished)

Meets NRHP Eligibility
Criteria: Resource No Longer

Extant

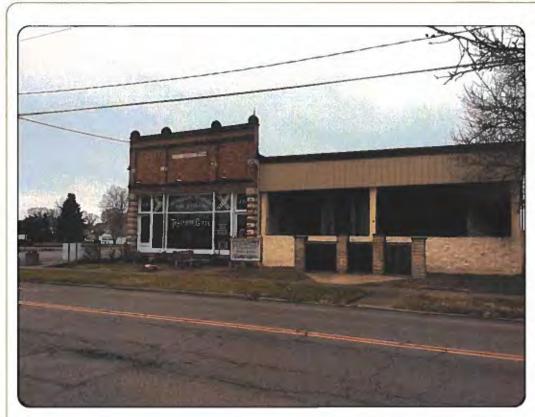
Resource ID: SAN0042512

Resource Name: Monument Works, a two-story storefront with orientalist elements.

Meets NRHP Eligibility

Criteria: No

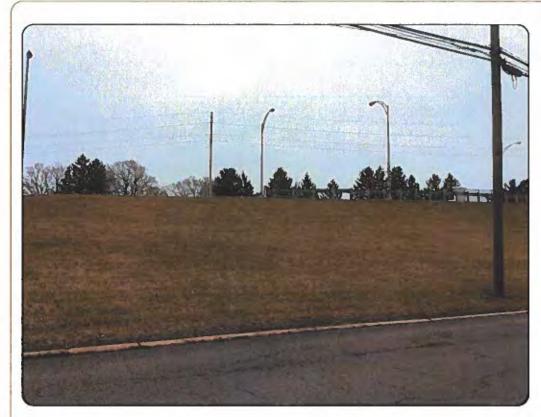
Resource ID: HUR0063501

Resource Name: Pat O'Brien House (appears demolished)

Meets NRHP Eligibility
Criteria: Resource No Longer

Extant

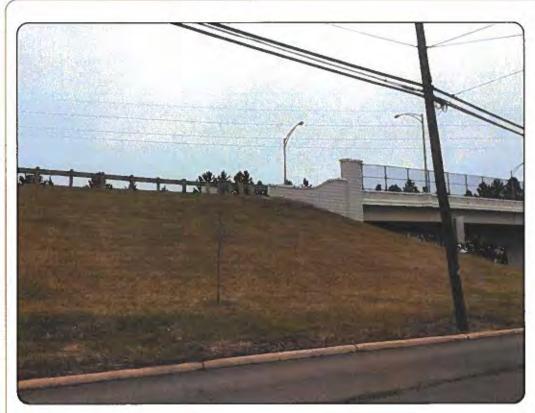
Resource ID: HUR0063601

Resource Name: Betty Schneer House (appears

Meets NRHP Eligibility
Criteria: Resource No Longer

Extant

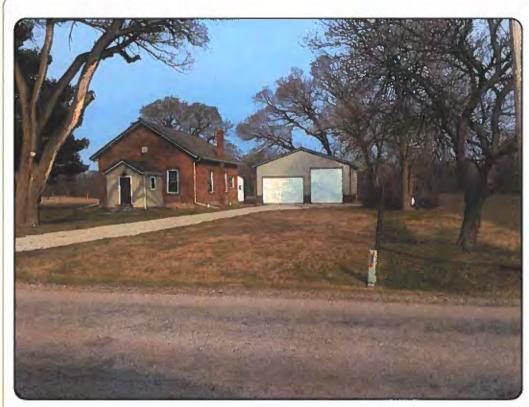
Resource ID: HUR0011202

Resource Name: Ridgefield Dist #2 School, a one-story brick former school house.

Meets NRHP Eligibility Criteria: No

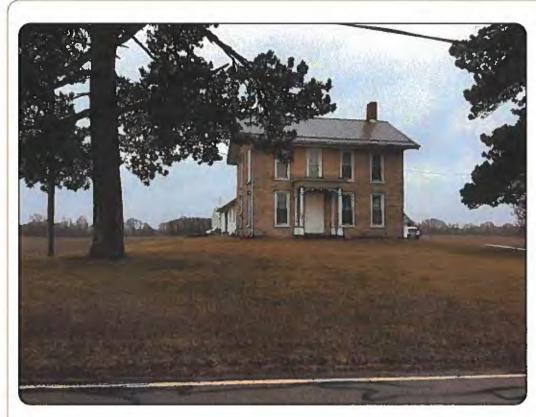
Resource ID: SAN0044812

Resource Name: Schoen Stone House, a two-story Greek Revival-style stone residence.

Meets NRHP Eligibility

Criteria: No

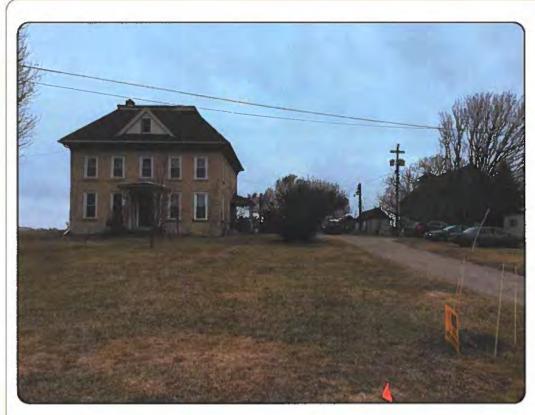
Resource ID: SAN0050312

Resource Name: Moyer Stone House, a two-story stone Italianate residence.

Meets NRHP Eligibility Criteria: No

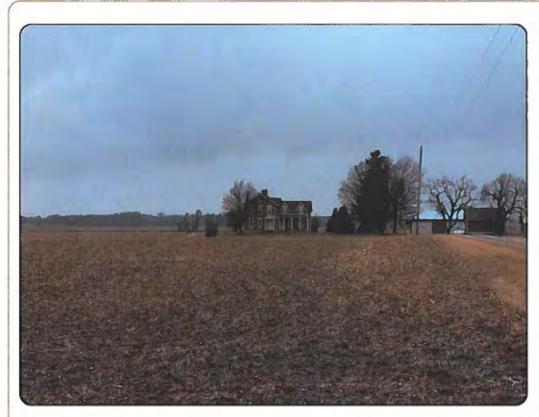
Resource ID: SAN0043712

Resource Name: Heter Farmhouse, a two-story Greek Revival-style residence with Gothic Revival-style elements.

Meets NRHP Eligibility Criteria: No

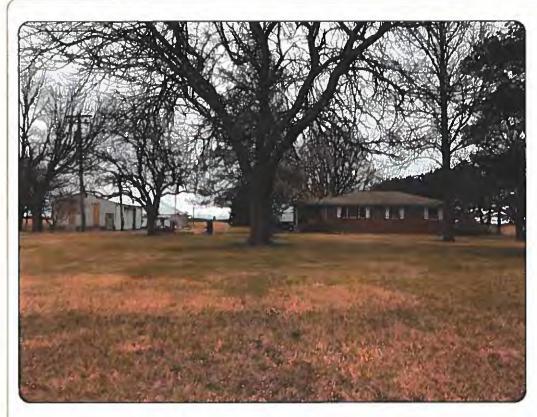
Resource ID: SEN0054305

Resource Name: Vacant (appears demolished)

Meets NRHP Eligibility
Criteria: Resource No Longer

Extant

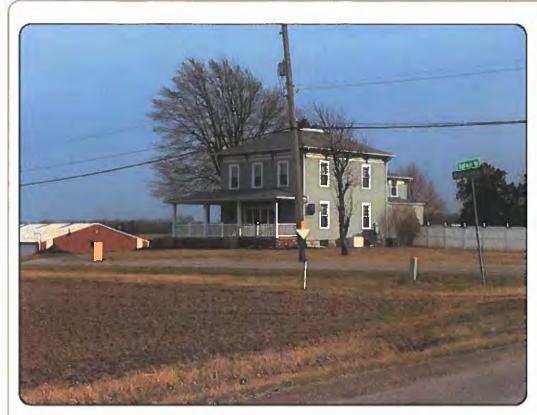
Resource ID: HUR0011302

Resource Name: AM Cole House, a two-story italianate residence.

Meets NRHP Eligibility Criteria: No

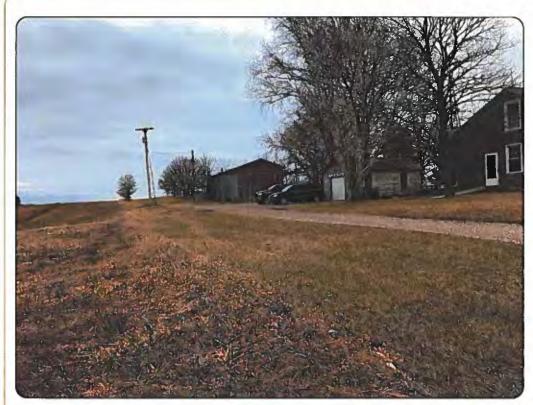
Resource ID: 79001941

Resource Name: Heter Farm

Meets NRHP Eligibility Criteria: NRHP-Listed

Resource
