Historic Resources Survey
October 2020
Environmental Design & Research
(Submitted to State Historic Preservation Office
January 5, 2021)

RE: Emerson Creek Wind Farm

Our office has reviewed the revised Historic Resources Survey Report, Emerson Creek Wind Farm, Groton and Oxford Townships, Erie County, Ohio, Lyme, Ridgefield, Sherman, Norwich, and Richmond Townships, Huron County, Ohio, prepared by Environmental Design and Research (EDR) in October 2020. The project is a 297.66-megawatt wind energy facility consisting of up to 87 wind turbine generators and associated infrastructure.

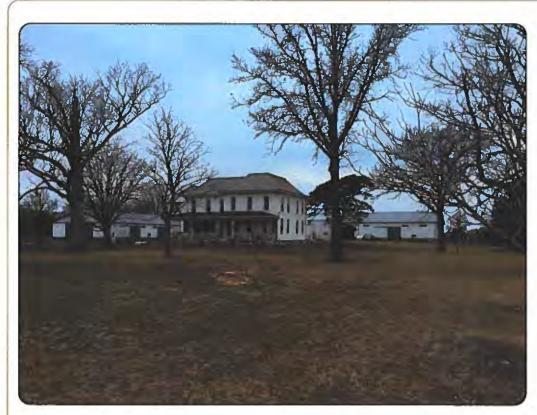
Resource ID: HUR0007201

Resource Name: William A. Fitch House, a two-story Italianate residence.

Meets NRHP Eligibility Criteria: No

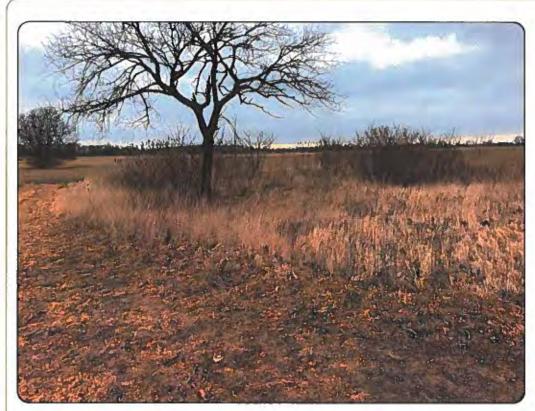
Resource ID: SEN0054405

Resource Name: Clarence Drown Farm (appears demolished; duplicate of NRHP-Listed Henny Barn [79003646])

Meets NRHP Eligibility

Criteria: Yes

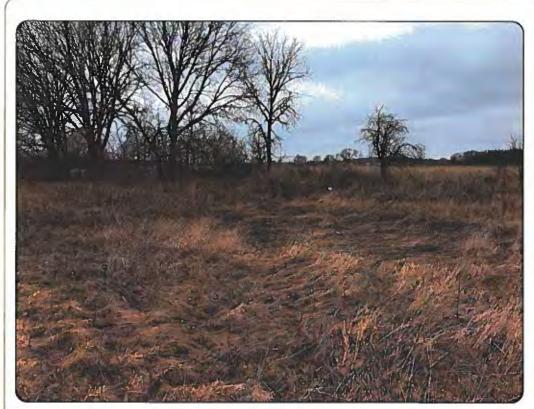
Resource ID: 79003646

Resource Name: Henny Barn (appears demolished; duplicate of Clarence Drown Barn [SEN0054505])

Meets NRHP Eligibility
Criteria: Resource No Longer

Extant

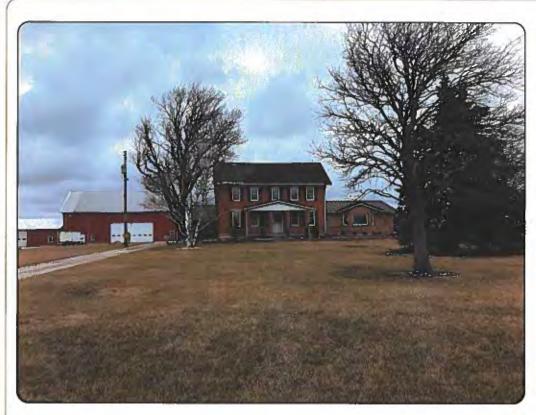
Resource ID: HUR0007301

Resource Name: Frederick Opperman House, a twostory Greek Revival-style residence.

Meets NRHP Eligibility

Criteria: No

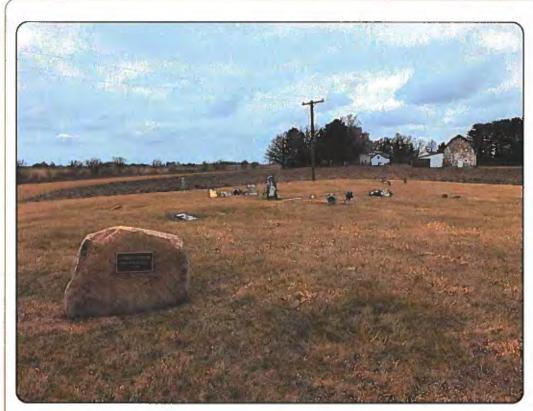
Resource ID: 5792

Resource Name: Raymond

Meets NRHP Eligibility

Criteria: Yes

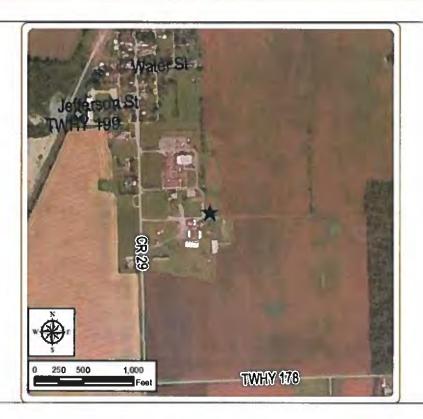
Resource ID: SEN0098605

Resource Name: Ralph Newly Admin Bldg (appears demolished on aerial map, star indicates the OHPOgeoreferenced point)

Meets NRHP Eligibility
Criteria: Resource No Longer

Extant

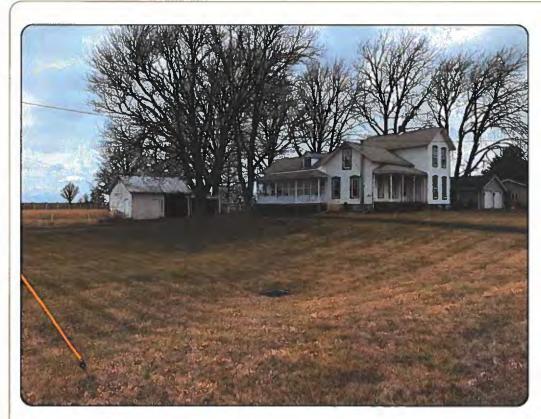
Resource ID: HUR0065102

Resource Name: Schug Family Farm, a two-story vernacular residence.

Meets NRHP Eligibility Criteria: No

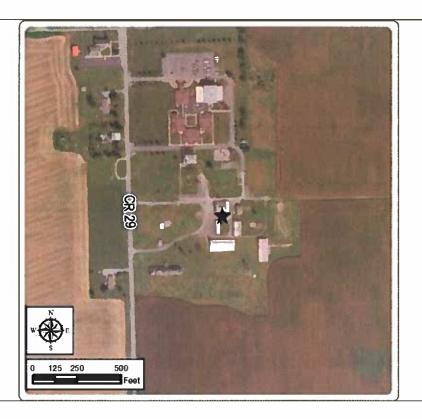
Resource ID: SEN0098705

Resource Name: Shop (not visible from road, star indicates the OHPOgeoreferenced point)

Meets NRHP Eligibility
Criteria: Not accessible/not

visible

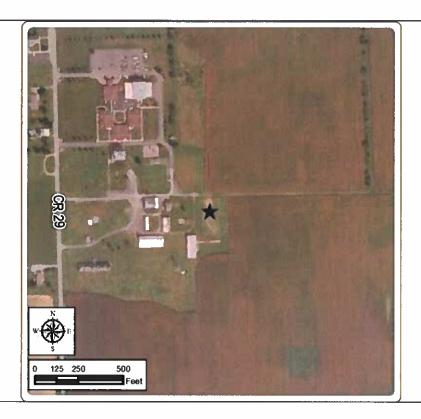
Resource ID: SEN0098505

Resource Name: Storage Shed (appears demolished on aerial map, star indicates the OHPO-georeferenced point)

Meets NRHP Eligibility
Criteria: Resource No Longer

Extant

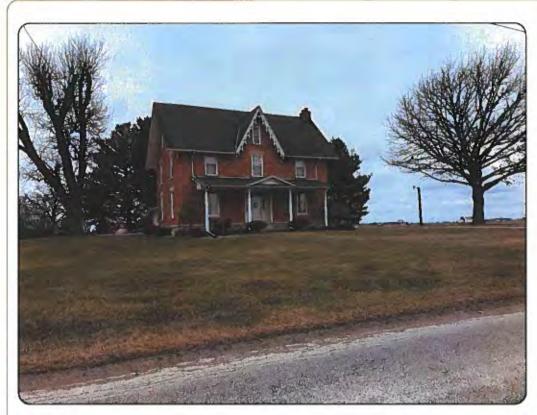
Resource ID: HUR0007501

Resource Name: J.P. Heymann House, a one-andone-half-story Gothic Revivalstyle cottage.

Meets NRHP Eligibility Criteria: NRHP-Listed Resource (contributing resource)

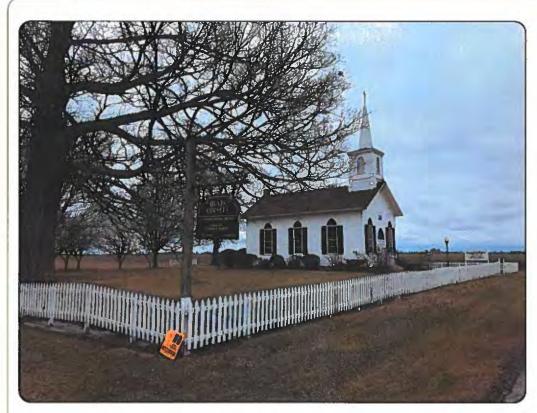
Resource ID: 93000896

Resource Name: Hunts Corners, an NHRP-Listed historic district.

Meets NRHP Eligibility Criteria: NRHP-Listed Resource

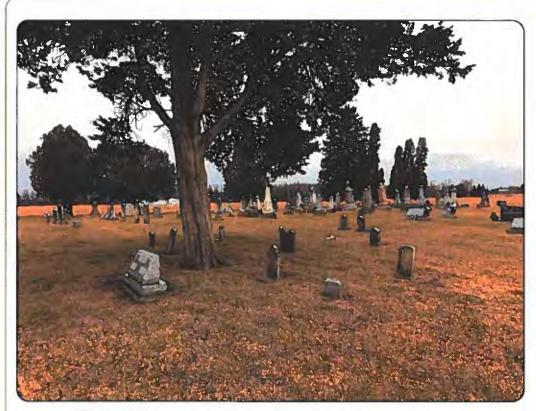
Resource ID: 5793

Resource Name: Saint Paul German Lutheran (Saint Pauls) Cemetery

Meets NRHP Eligibility

Criteria: No

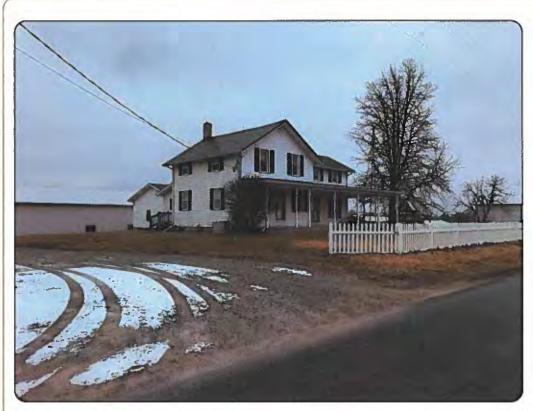
Resource ID: SEN0112505

Resource Name: Martin Oliver House, a two-story vernacular residence.

Meets NRHP Eligibility Criteria: No

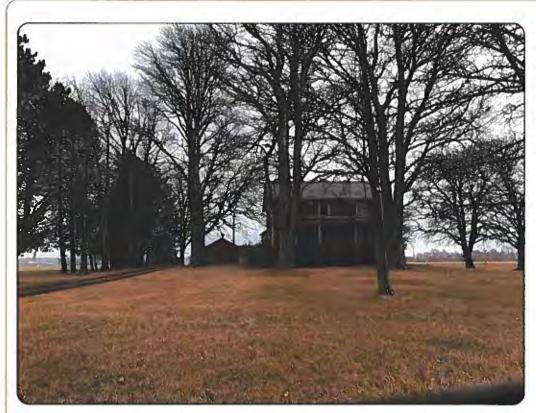
Resource ID: HUR0035801

Resource Name: Elias Smith House, a two-story Greek Revival-style residence.

Meets NRHP Eligibility

Criteria: Yes

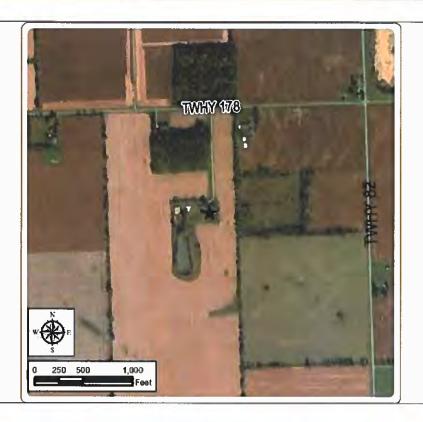
Resource ID: SEN0112905

Resource Name: John M Krauss House (not visible from road, star indicates the OHPO-georeferenced point)

Meets NRHP Eligibility
Criteria: Not accessible/not

visible

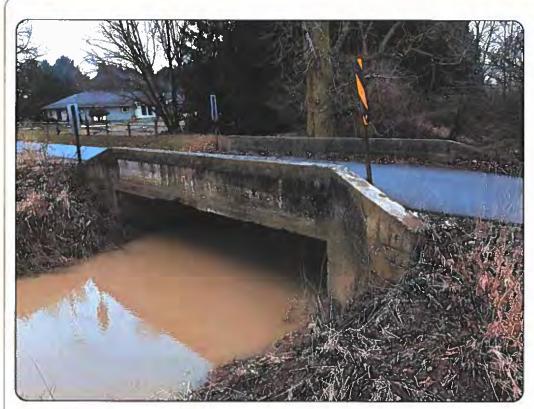
Resource ID:

Resource Name: TR 80 over Royer Ditch, a concrete culvert.

Meets NRHP Eligibility Criteria: Yes

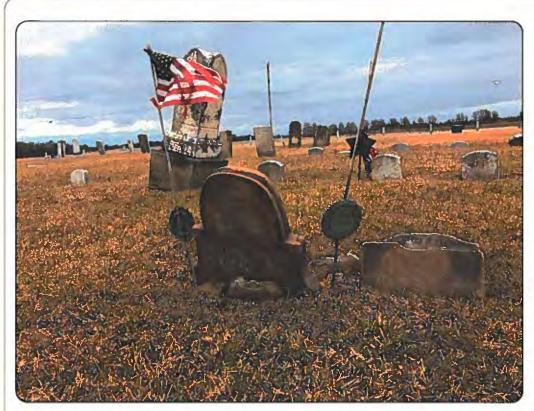
Resource ID: 5790

Resource Name: Heyman-Hunts Corners-Sutton Cemetery

Meets NRHP Eligibility Criteria: No

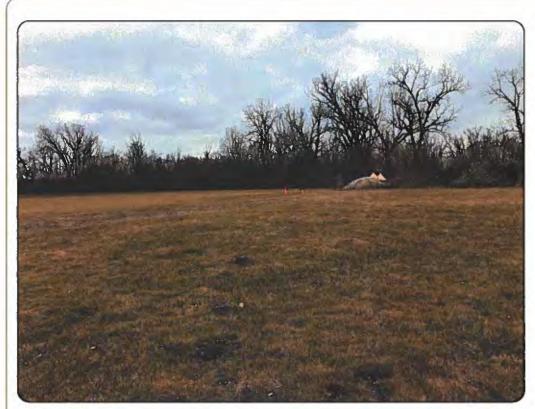
Resource ID: HUR0028302

Resource Name: Joseph Walters House (appears demolished)

Meets NRHP Eligibility
Criteria: Resource No Longer

Extant

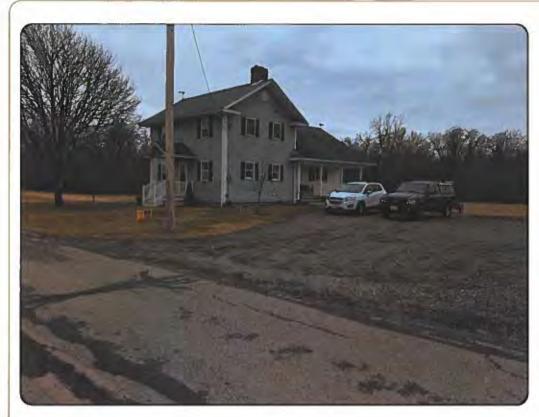
Resource ID: HUR0036805

Resource Name: JGW Heymann House, a two-story vernacular residence.

Meets NRHP Eligibility

Criteria: No

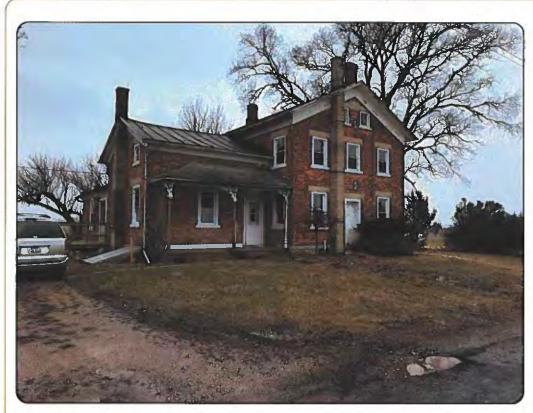
Resource ID: SEN0099905

Resource Name: Orwig House, a two-story Greek Revival-style residence.

Meets NRHP Eligibility Criteria: Yes

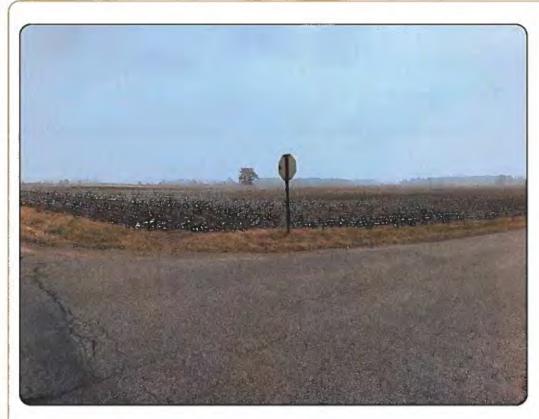
Resource ID: 11161

Resource Name: Underhill Cemetery (appears demolished)

Meets NRHP Eligibility
Criteria: Resource No Longer

Extant

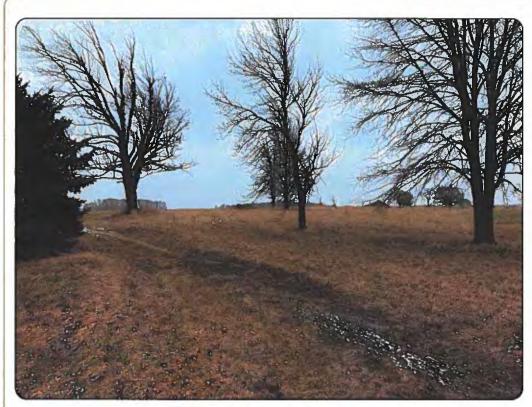
Resource ID: SEN0099705

Resource Name: John Weller House (appears demolished)

Meets NRHP Eligibility
Criteria: Resource No Longer

Extant

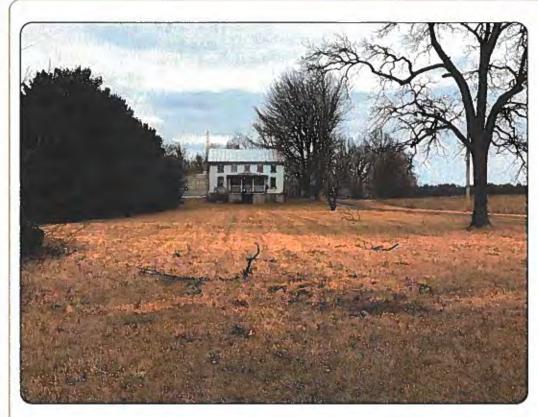
Resource ID: SEN0113305

Resource Name: Abram Sherck House, a twostory Greek Revival-style residence.

Meets NRHP Eligibility Criteria: No

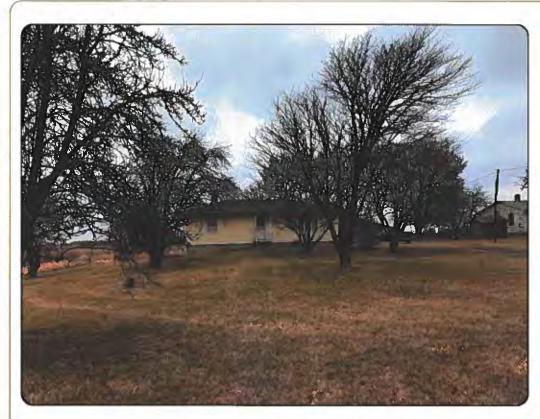
Resource ID: SEN0113905

Resource Name: Turner Warner Smokehouse, a onestory Ranch-style residence.

Meets NRHP Eligibility

Criteria: No

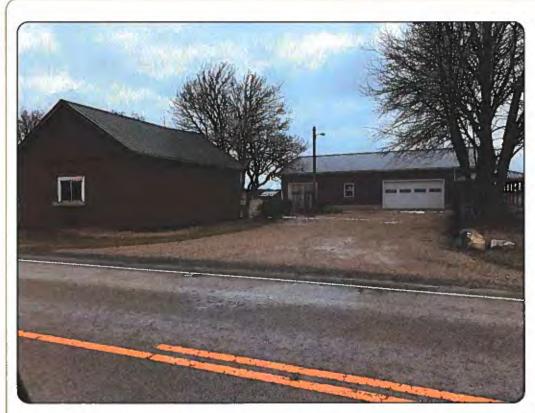
Resource ID: HUR0036505

Resource Name: Peter Weidinger House (appears demolished)

Meets NRHP Eligibility
Criteria: Resource No Longer
Extant

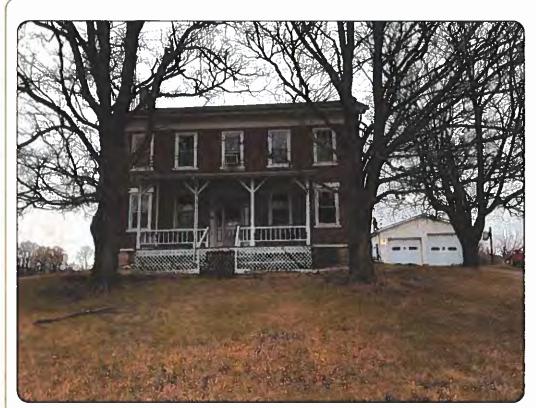
Resource ID: SEN0113205

Resource Name: Jacob Miller House, a two-story Greek Revival-style residence.

Meets NRHP Eligibility

Criteria: No

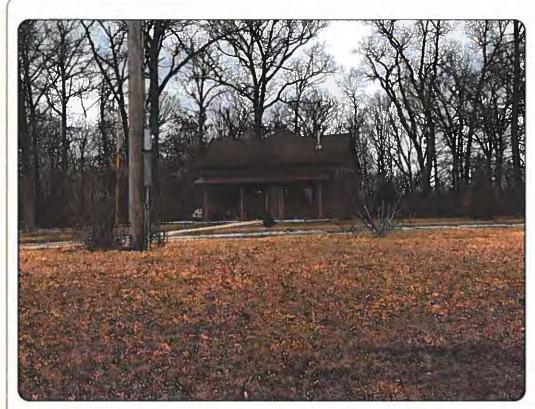
Resource ID: HUR0026205

Resource Name: Slate Run Log House, a one-story log

Meets NRHP Eligibility

Criteria: No

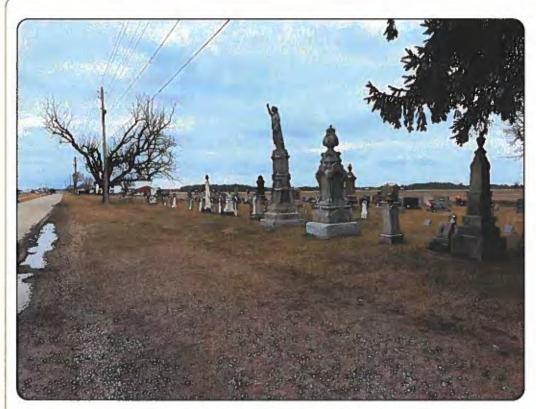
Resource ID: 5831

Resource Name: Pontiac-Saint Peter's Lutheran Cemetery

Meets NRHP Eligibility Criteria: No

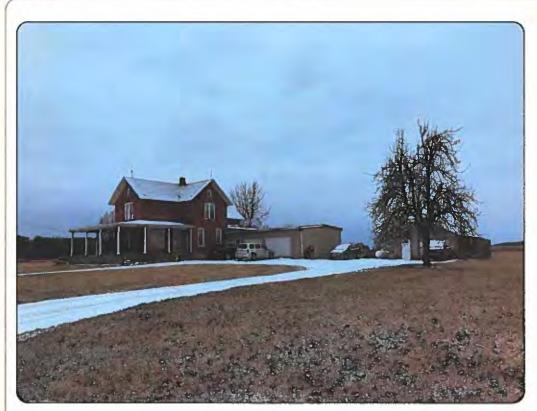
Resource ID: HUR0036105

Resource Name: J. Westrick House, a two-story brick vernacular residence.

Meets NRHP Eligibility

Criteria: No

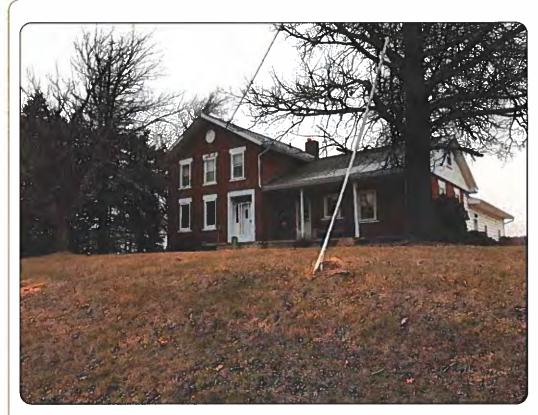
Resource ID: SEN0113605

Resource Name: John Werley House, a twostory Greek Revival-style residence.

Meets NRHP Eligibility Criteria: No

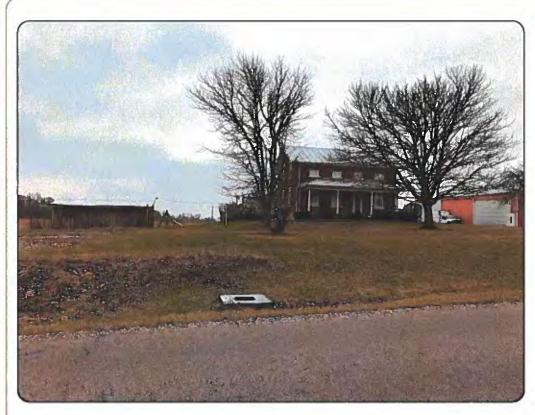
Resource ID: SEN0090805

Resource Name: Eli Whitney House, a one-and-one-halfstory brick Greek Revivalstyle residence.

Meets NRHP Eligibility

Criteria: No

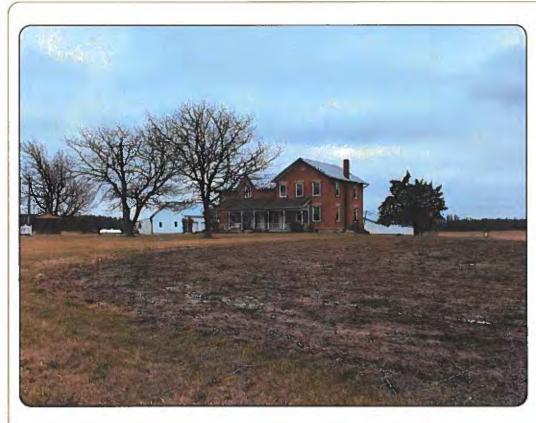
Resource ID: SEN0100005

Resource Name: Thomas Miller Farm, a two-story Greek Revival-style residence with Gothic Revival-style elements.

Meets NRHP Eligibility Criteria: Yes

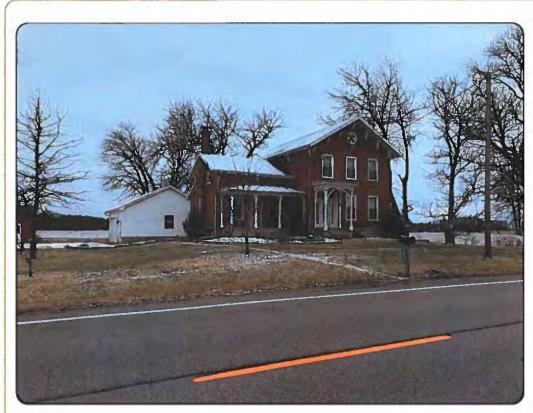
Resource ID: HUR0036005

Resource Name: AM Ruffing House, a two-story Greek Revival-style residence.

Meets NRHP Eligibility

Criteria: Yes

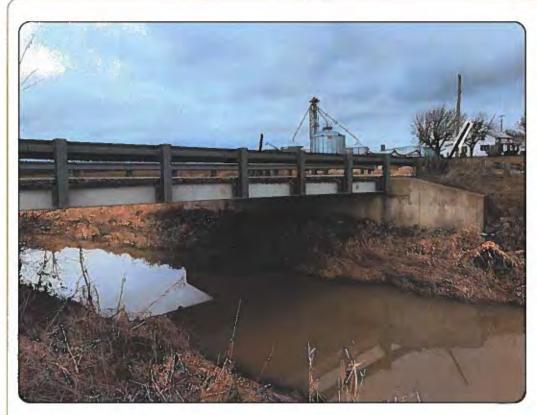
Resource ID: HUR0039405

Resource Name: Heyman Road at Frink Run Bridge (appears demolished)

Meets NRHP Eligibility
Criteria: Resource No Longer

Extant

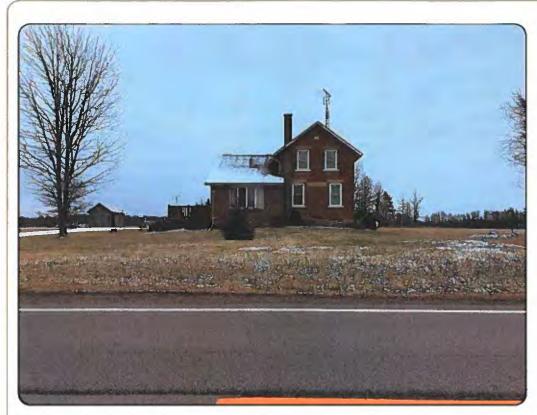
Resource ID: HUR0035905

Resource Name: G. Lepley House, a one-and-one-halfstory brick Greek Revivalstyle residence.

Meets NRHP Eligibility Criteria: No

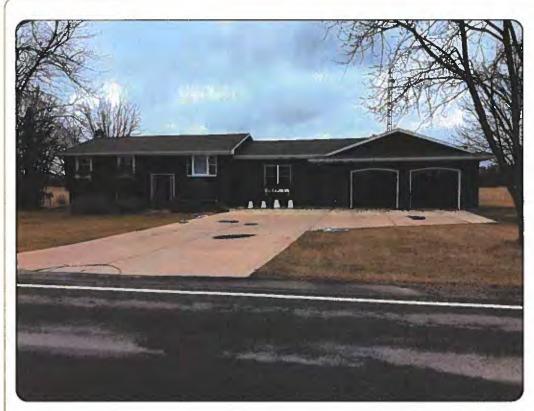
Resource ID: SEN0118905

Resource Name: Joseph Nice House (appears demolished)

Meets NRHP Eligibility
Criteria: Resource No Longer

Extant

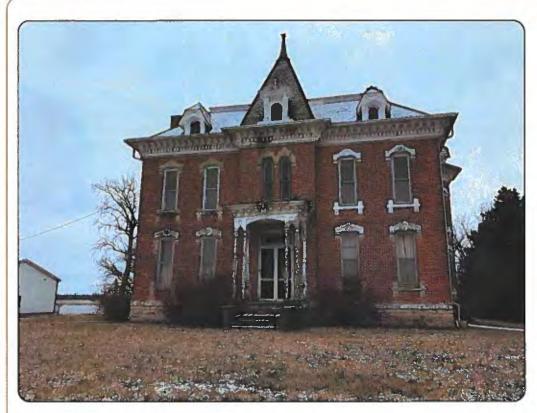
Resource ID: HUR0043605

Resource Name: Edward Geyer House, a two-story Italianate residence.

Meets NRHP Eligibility Criteria: Yes

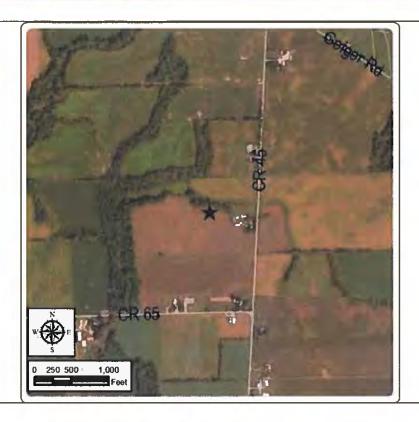
Resource ID: 14751

Resource Name: Vantine Cemetery (not visible from road, star indicates the OHPO-georeferenced point)

Meets NRHP Eligibility
Criteria: Not accessible/not

visible

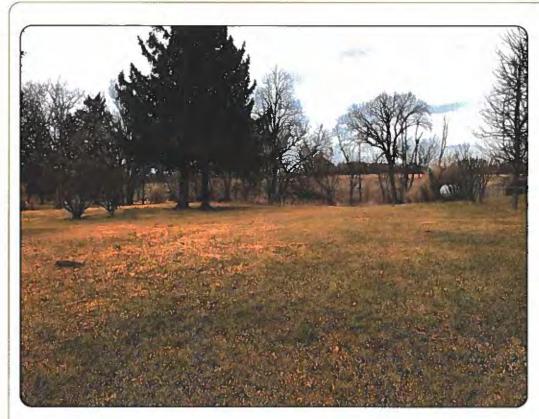
Resource ID: 5832

Resource Name: Wilson Cemetery (appears demolished)

Meets NRHP Eligibility
Criteria: Resource No Longer

Extant

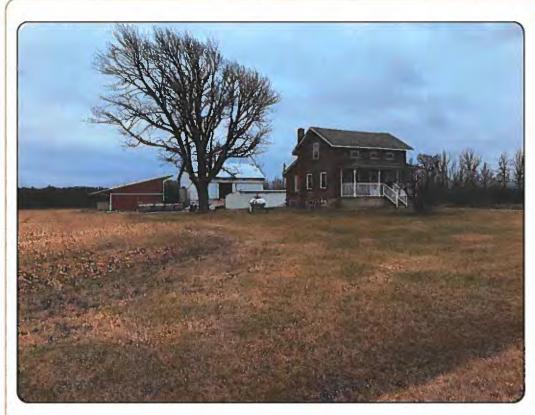
Resource ID: HUR0039205

Resource Name: J. Westwick House, a one-and-one-halfstory brick Greek Revivalstyle residence.

Meets NRHP Eligibility Criteria: No

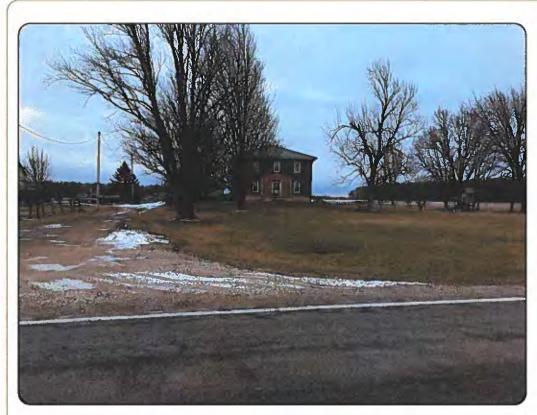
Resource ID: HUR0039005

Resource Name: Joseph Ruffing House, a two-story Italianate residence.

Meets NRHP Eligibility Criteria: No

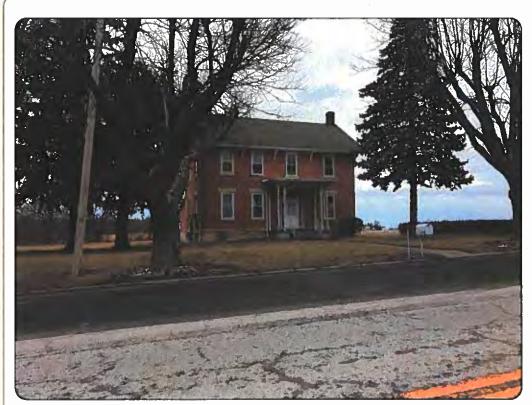
Resource ID: HUR0038805

Resource Name: St Sebastian Parsonage, a two-story Greek Revival-style residence.

Meets NRHP Eligibility Criteria: No

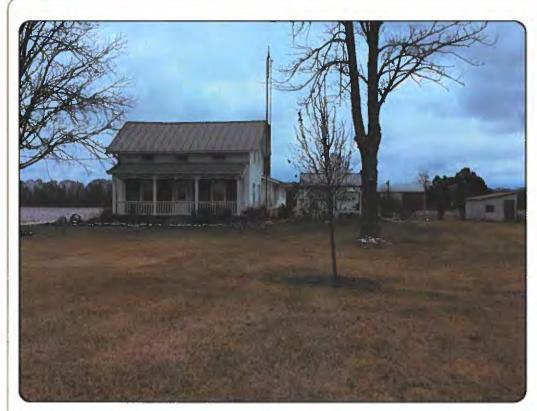
Resource ID: HUR0037205

Resource Name: John Ruffing House, a one-andone-half-story Greek Revivalstyle residence.

Meets NRHP Eligibility Criteria: No

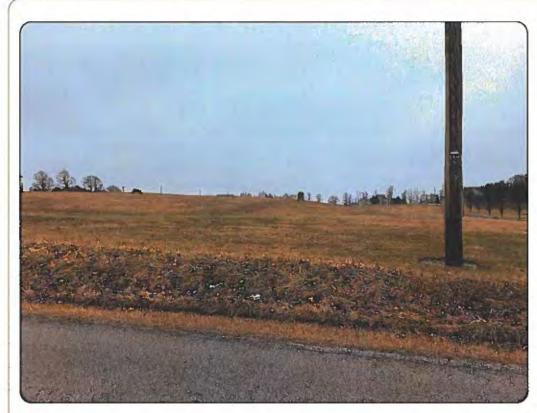
Resource ID: 5829

Resource Name: Adams Farm Cemetery (appears

Meets NRHP Eligibility
Criteria: Resource No Longer

Extant

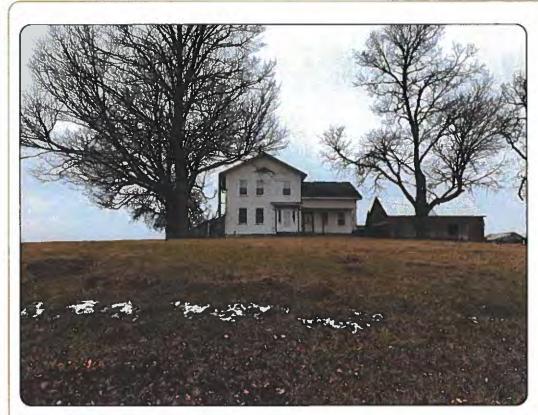
Resource ID: HUR0027105

Resource Name: W.H. Snyder House, a two-story vernacular residence.

Meets NRHP Eligibility

Criteria: No

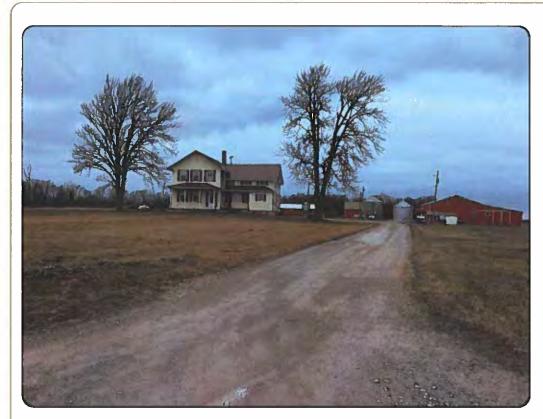
Resource ID: HUR0037405

Resource Name: F. Bishop House, a two-story vernacular residence.

Meets NRHP Eligibility

Criteria: No

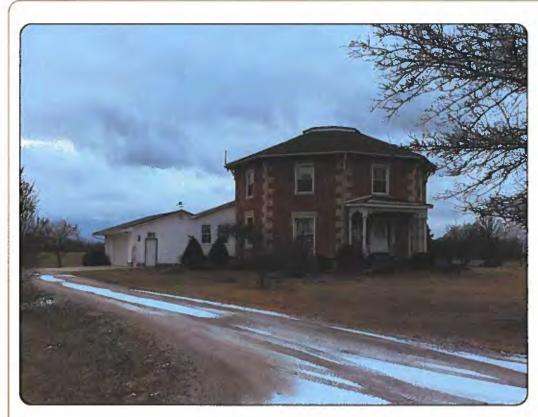
Resource ID: HUR0037305

Resource Name: Howard J. Smith House, a brick octagonal residence.

Meets NRHP Eligibility
Criteria: Yes

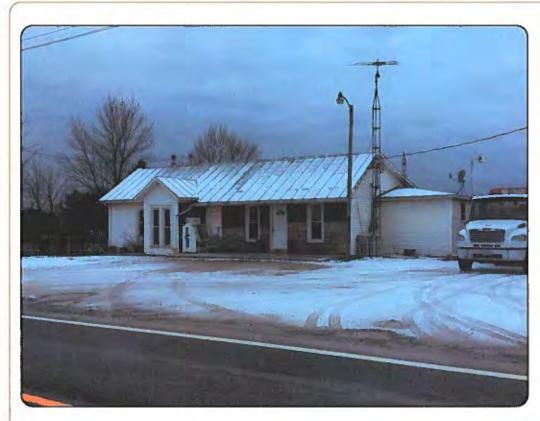
Resource ID: SEN0111412

Resource Name: Clinton Beamer House, a one-story modular residence.

Meets NRHP Eligibility Criteria: No

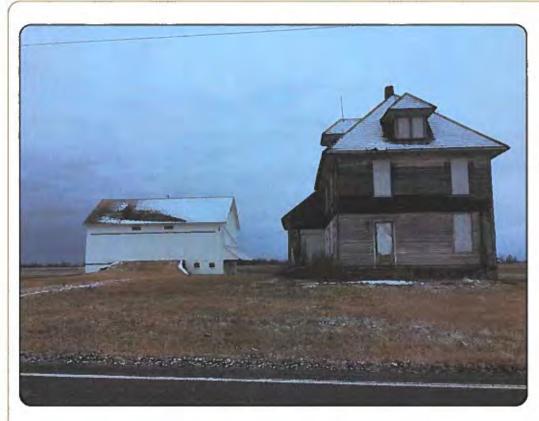
Resource ID: SEN0124412

Resource Name: Miller Property, a two-story vernacular residence.

Meets NRHP Eligibility Criteria: No

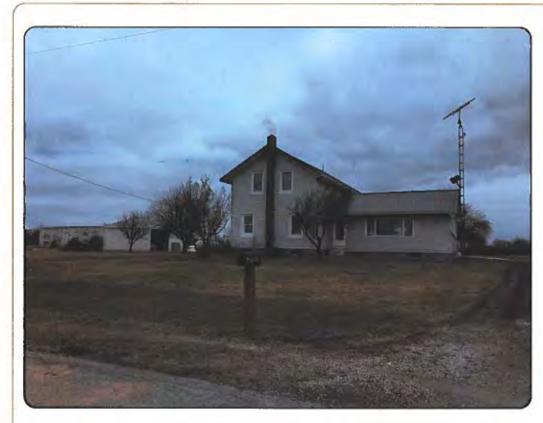
Resource ID: HUR0038405

Resource Name: Link House, a two-story vernacular

Meets NRHP Eligibility Criteria: No

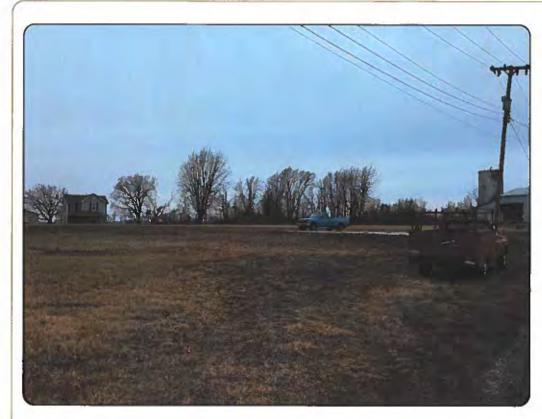
Resource ID: HUR0038305

Resource Name: Havana Mill (appears demolished)

Meets NRHP Eligibility
Criteria: Resource No Longer

Extant

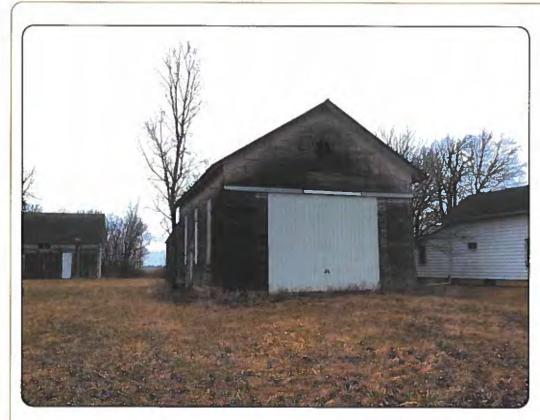
Resource ID: HUR0038205

Resource Name: Havana Meeting Hall, currently a onestory garage.

Meets NRHP Eligibility

Criteria: No

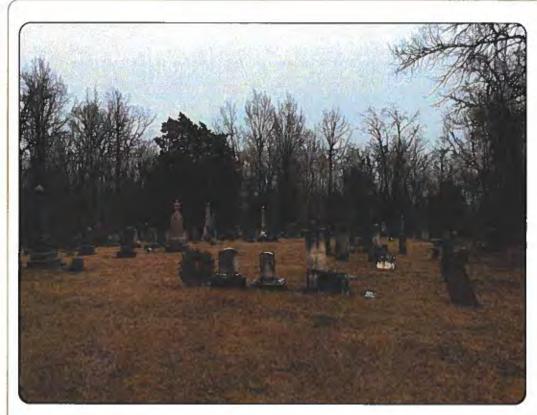
Resource ID: 5827

Resource Name: Boughton (North Norwich) Cemetery

Meets NRHP Eligibility Criteria: No

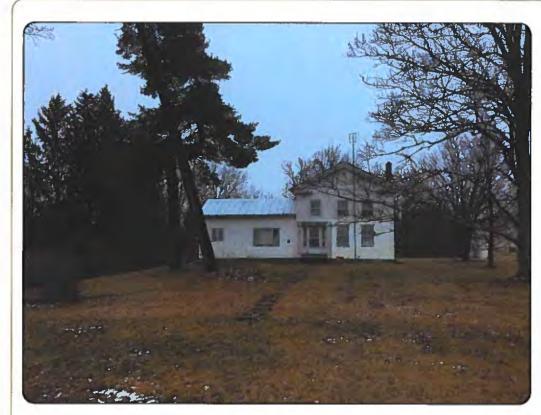
Resource ID: HUR0038105

Resource Name: A.B. Gilson House, a two-story Greek Revival-style residence.

Meets NRHP Eligibility Criteria: No

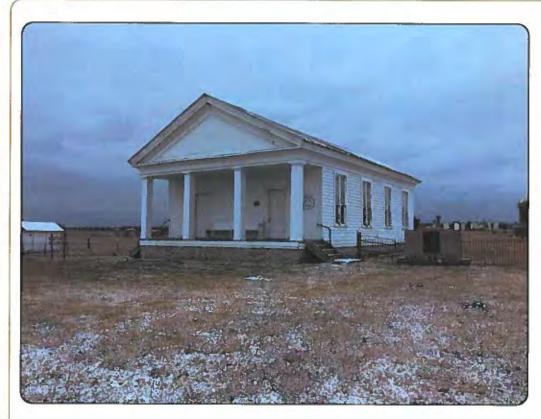
Resource ID: 87001982

Resource Name: Omar Chapel, a one-story Greek Revival-style church building.

Meets NRHP Eligibility Criteria: NRHP-Listed Resource

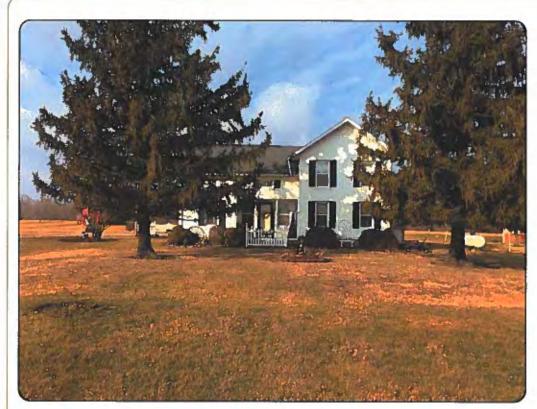
Resource ID: HUR0031005

Resource Name: Thomas McLane House, a two-story vernacular residence.

Meets NRHP Eligibility Criteria: No

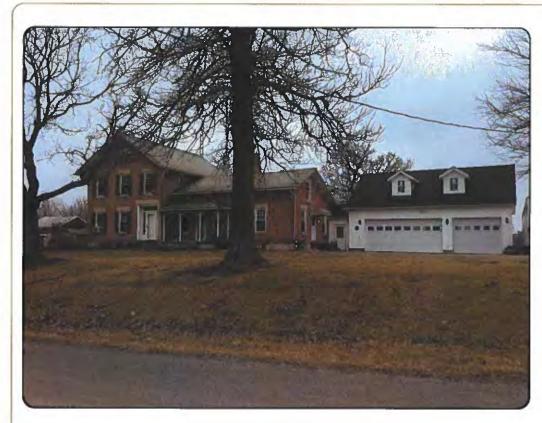
Resource ID: HUR0039605

Resource Name: Aaron Wheeler House, a twostory Greek Revival-style residence.

Meets NRHP Eligibility

Criteria: Yes

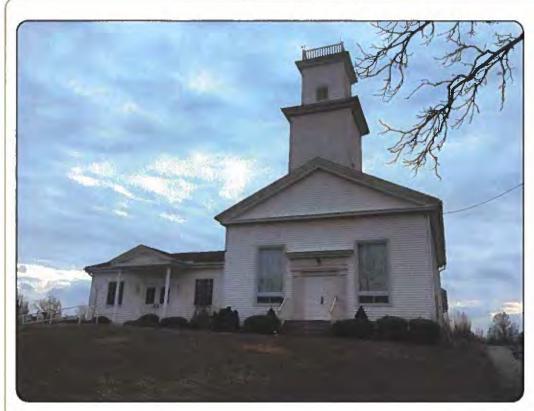
Resource ID: HUR0030005

Resource Name: Church of the Master, a one-story Greek Revival-style church building.

Meets NRHP Eligibility

Criteria: No

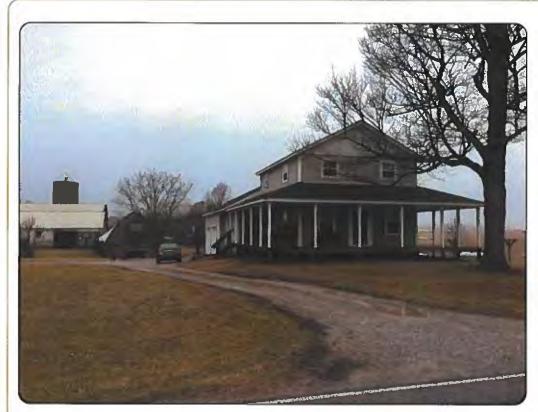
Resource ID: HUR0031805

Resource Name: Barber House, a two-story vernacular

Meets NRHP Eligibility Criteria: No

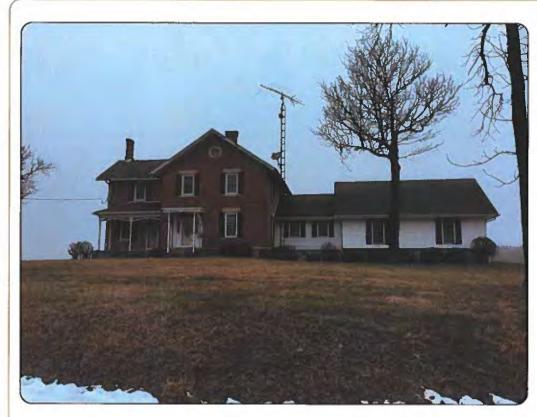
Resource ID: HUR0032005

Resource Name: L.Q. Campbell House, a twostory Greek Revival-style residence.

Meets NRHP Eligibility

Criteria: No

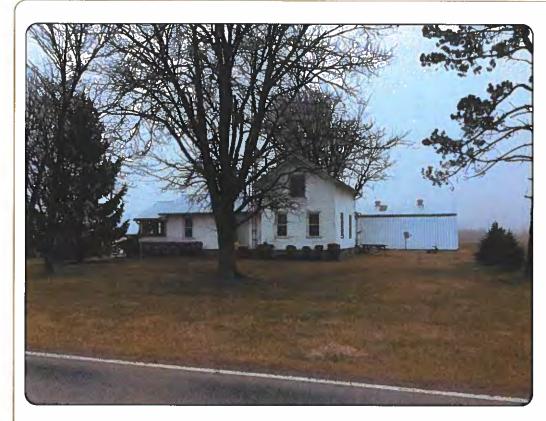
Resource ID: HUR0039905

Resource Name: George Joiner House, a one-andone-half-story vernacular residence.

Meets NRHP Eligibility

Criteria: No

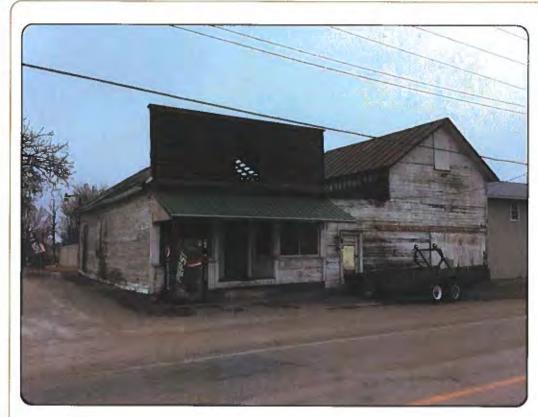
Resource ID: HUR0043805

Resource Name: Centerton Mill (appears demolished)

Meets NRHP Eligibility
Criteria: Resource No Longer

Extant

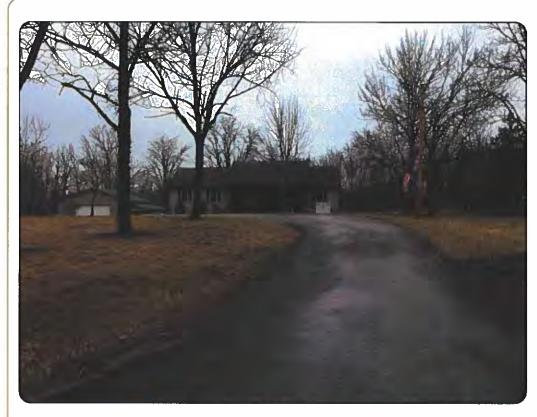
Resource ID: HUR0044005

Resource Name: Pierce Bowen House (appears demolished)

Meets NRHP Eligibility
Criteria: Resource No Longer
Extant

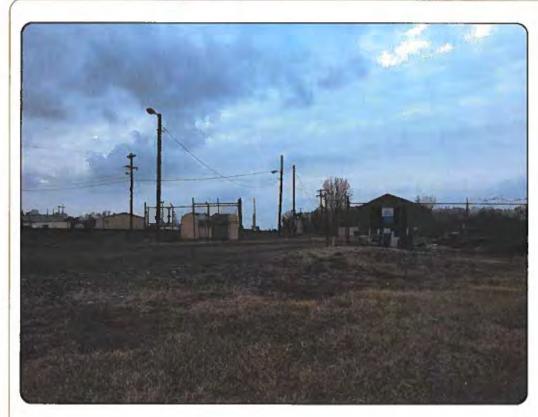
Resource ID: HUR0018608

Resource Name: B&O RR Machine Shop (photo taken from ROW)

Meets NRHP Eligibility
Criteria: Not accessible/not

visible

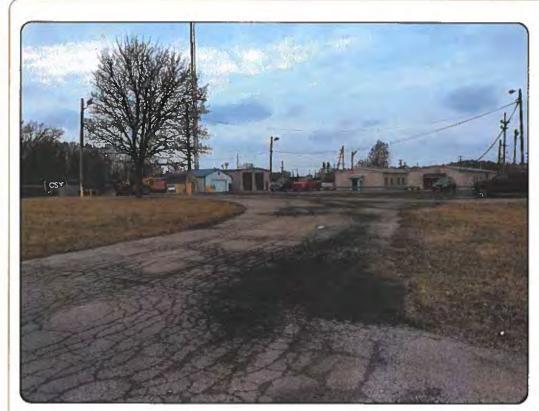
Resource ID: HUR0017708

Resource Name: B&O RR YMCA (appears demolished)

Meets NRHP Eligibility

Criteria: Resource No Longer Extant

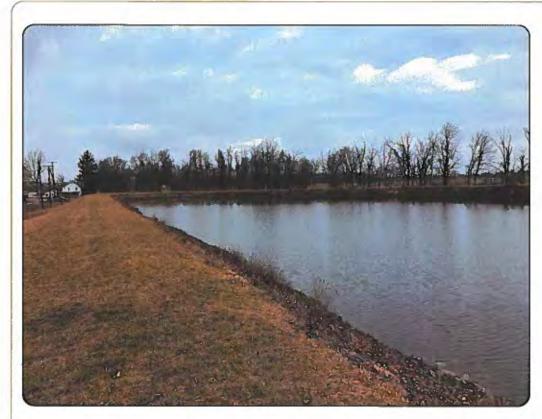
Resource ID: SEN0122517

Resource Name: Village of Attica Water Plant, a earthwork reservoir.

Meets NRHP Eligibility Criteria: No

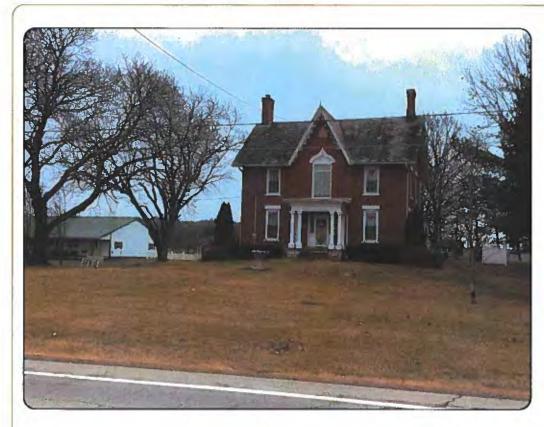
Resource ID: HUR0037608

Resource Name: Joseph H Beelman House, a onestory Gothic Revival-style residence.

Meets NRHP Eligibility

Criteria: Yes

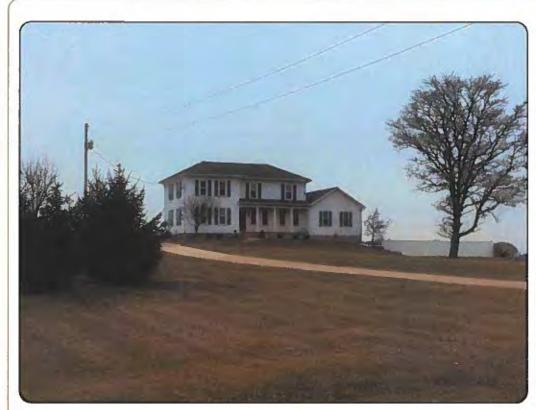
Resource ID: HUR0045008

Resource Name: Henery Frederick House, a two-story vernacular residence.

Meets NRHP Eligibility

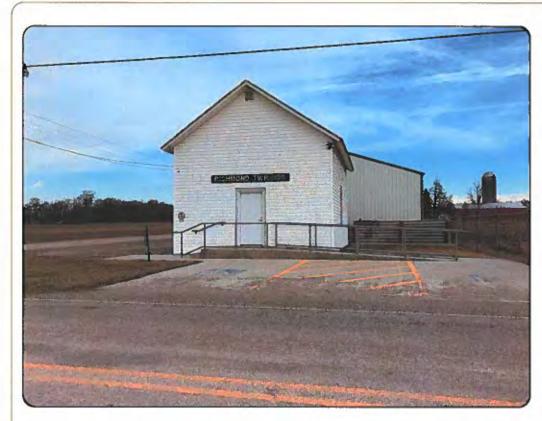
Resource ID: HUR0044208

Resource Name: Richmond Town Hal, a one-story vernacular building.

Meets NRHP Eligibility Criteria: No

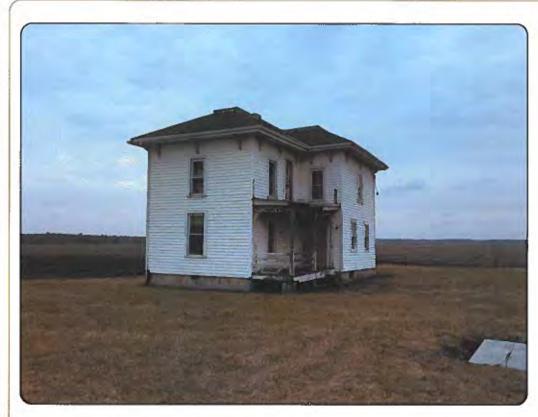
Resource ID: HUR0044808

Resource Name: Conrad Nagle House, a two-story Italianate residence.

Meets NRHP Eligibility Criteria: No

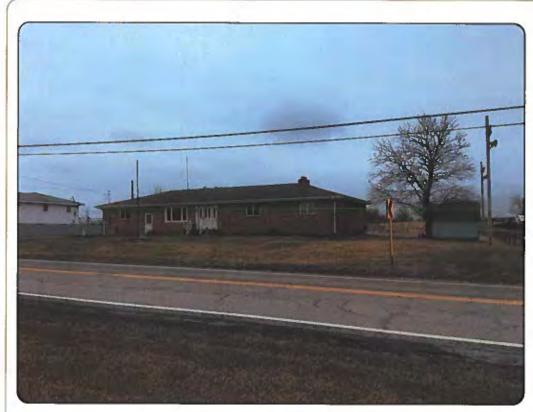
Resource ID: N/A

Resource Name: A one-story Ranch-style residence.

Criteria: No

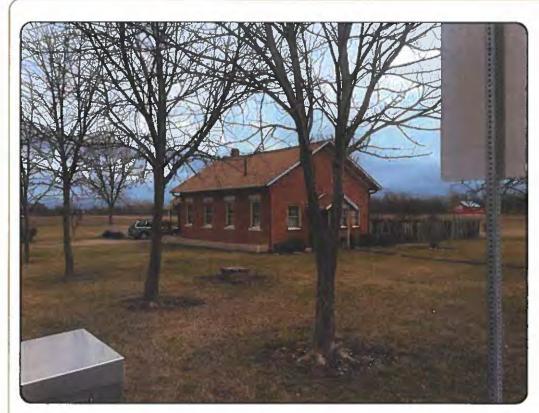
Resource ID: N/A

Resource Name: A oneand-one-half-story former schoolhouse.

Criteria: No

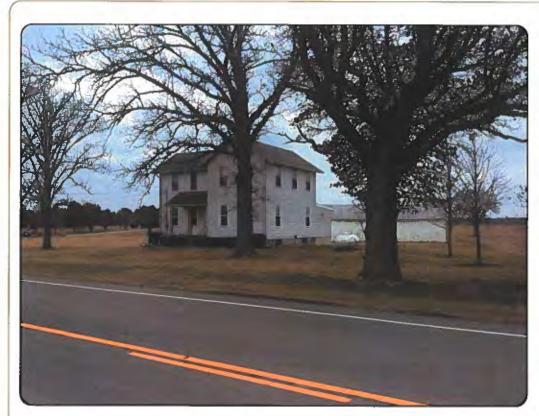
Resource ID: N/A

Resource Name: A two-story vernacular residence.

Criteria: No

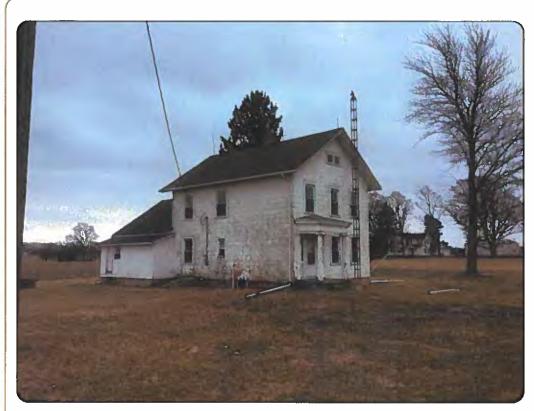
Resource ID: N/A

Resource Name: A two-story vernacular residence, with Neoclassical elements.

Criteria: No

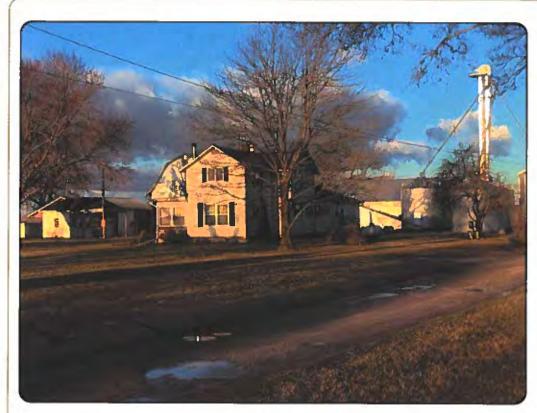
Resource ID: N/A

Resource Name: A twostory vernacular residence and associated agricultural buildings.

Criteria: No

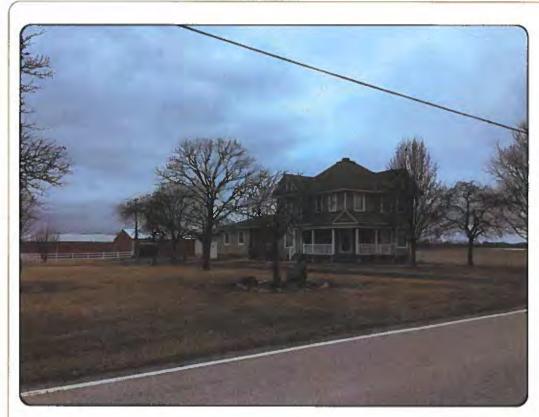
Resource ID: N/A

Resource Name: A two-story Queen Anne-style residence.

Meets NRHP Eligibility Criteria: No

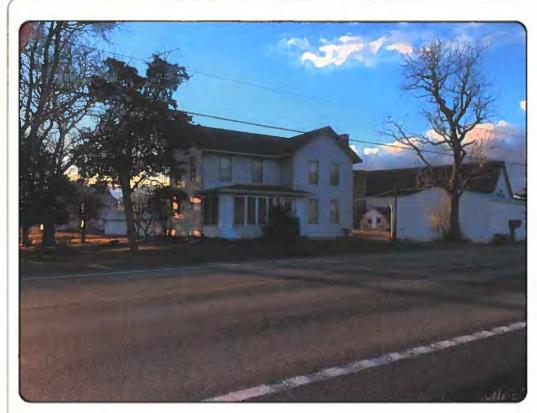
Resource ID: N/A

Resource Name: A two-story vernacular residence.

Criteria: No

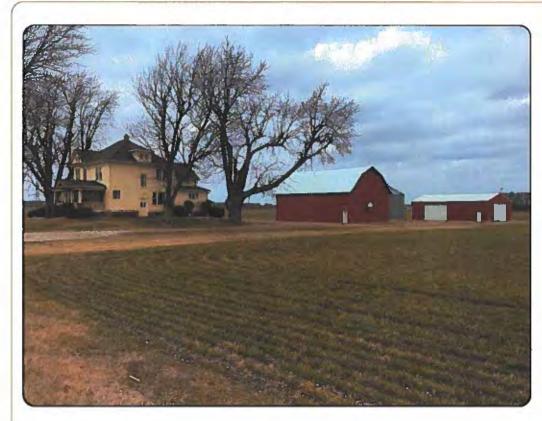
Resource ID: ERI0277704

Resource Name: A farmstead consisting of a two-story Queen Anne-style residence and two barns.

Criteria: Yes

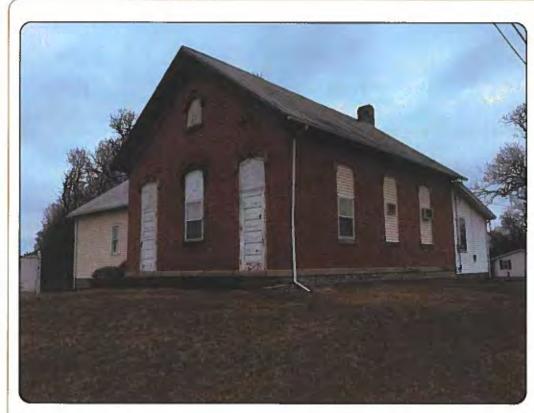
Resource ID: N/A

Resource Name: A one-story former schoolhouse.

Meets NRHP Eligibility Criteria: No

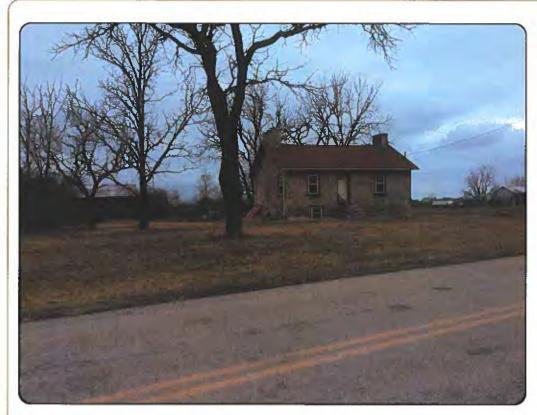
Resource ID: N/A

Resource Name: A one-story Greek Revival-style stone residence.

Criteria: No

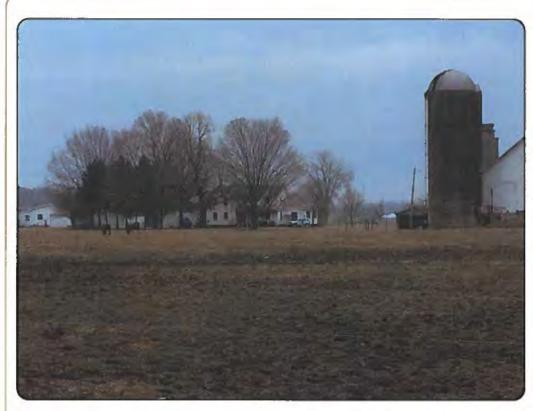
Resource ID: N/A

Resource Name: A farmstead consisting of a haybarn, a shed, and a two-story vernacular residence. Set back from the road approximately 1,000 feet.

Meets NRHP Eligibility
Criteria: Unable to determine

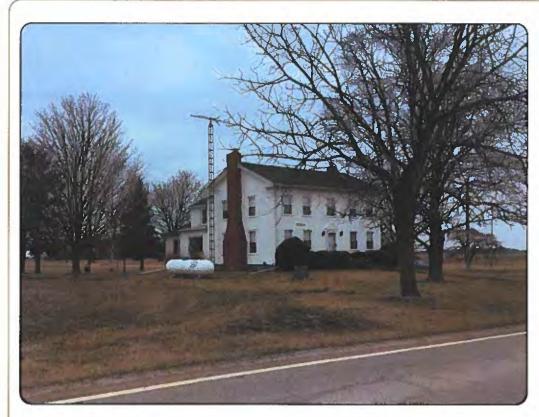
Resource ID: N/A

Resource Name: A onestory Greek Revival-style residence.

Meets NRHP Eligibility Criteria: No

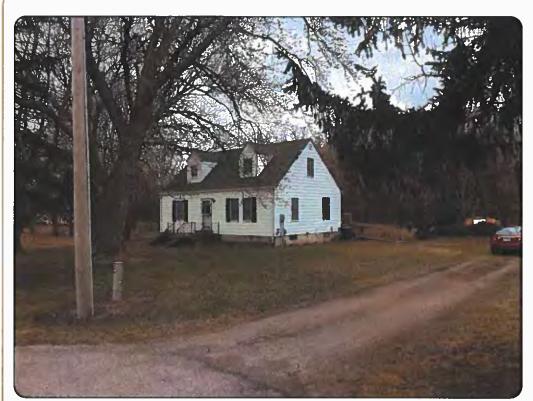
Resource ID: N/A

Resource Name: A one-andone-half-story Cape Cod-style residence.

Meets NRHP Eligibility Criteria: No

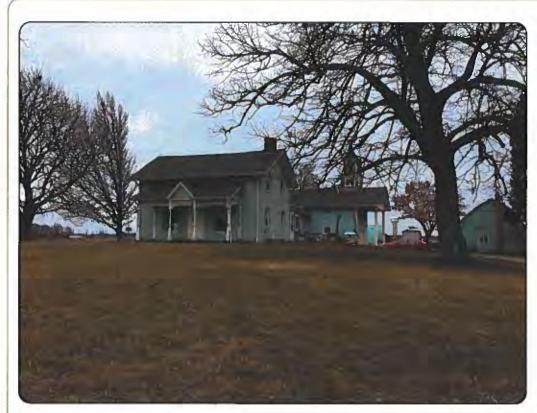
Resource ID: N/A

Resource Name: A twostory Greek Revival-style residence.

Criteria: No

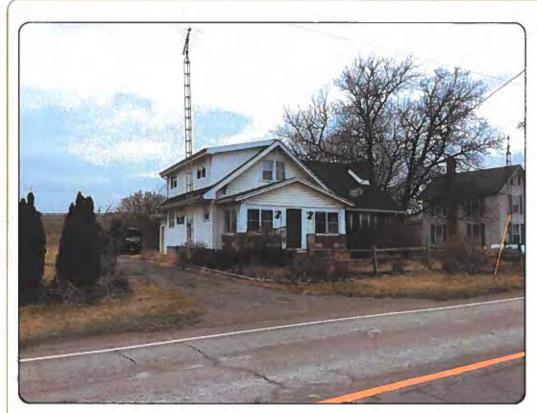
Resource ID: N/A

Resource Name: A two-story vernacular residence.

Meets NRHP Eligibility Criteria: No

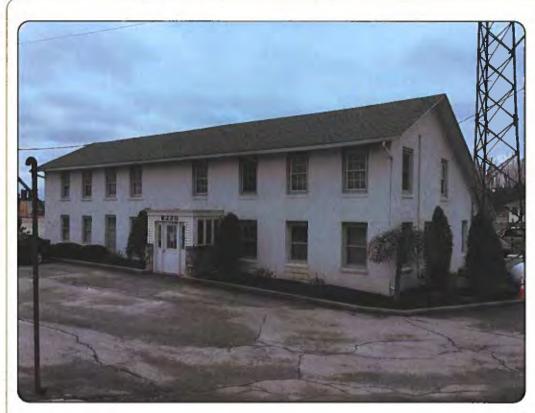
Resource ID: N/A

Resource Name: A two-story brick apartment block.

Criteria: No

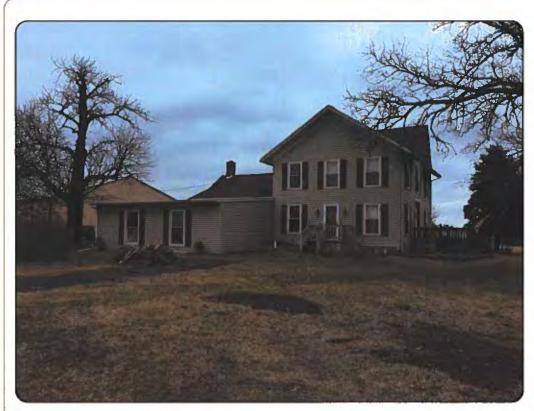
Resource ID: N/A

Resource Name: A two-story vernacular residence.

Meets NRHP Eligibility
Criteria: No

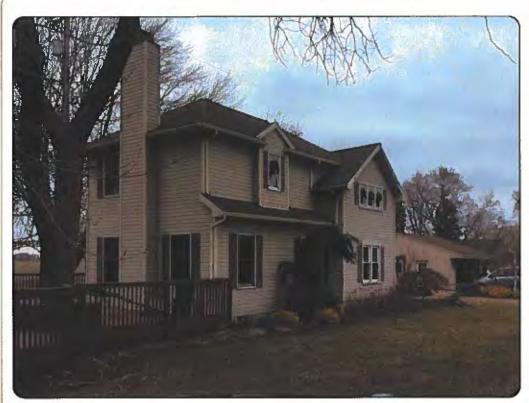
Resource ID: N/A

Resource Name: A two-story vernacular residence.

Criteria: No

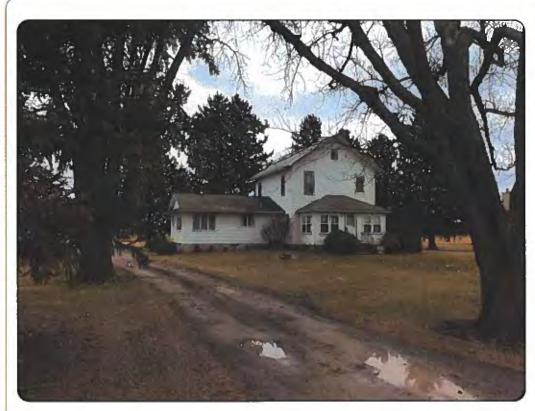
Resource Name: A two-story vernacular residence.

10208 Billings Road, Groton Township, Erie County

Meets NRHP Eligibility Criteria: No
