Historic Resources Survey
October 2020
Environmental Design & Research
(Submitted to State Historic Preservation Office
January 5, 2021)

RE: Emerson Creek Wind Farm

Our office has reviewed the revised Historic Resources Survey Report, Emerson Creek Wind Farm, Groton and Oxford Townships, Erie County, Ohio, Lyme, Ridgefield, Sherman, Norwich, and Richmond Townships, Huron County, Ohio, prepared by Environmental Design and Research (EDR) in October 2020. The project is a 297.66-megawatt wind energy facility consisting of up to 87 wind turbine generators and associated infrastructure.

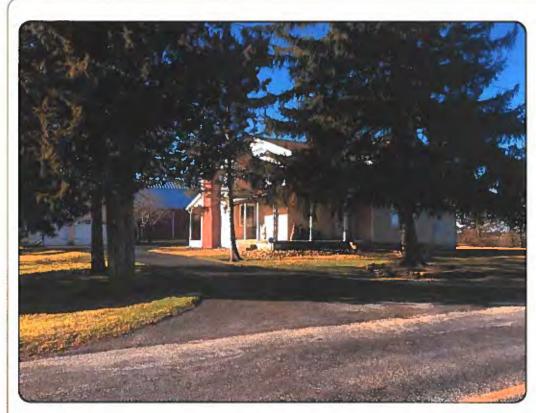
Resource Name: A two-story vernacular residence.

Criteria: No

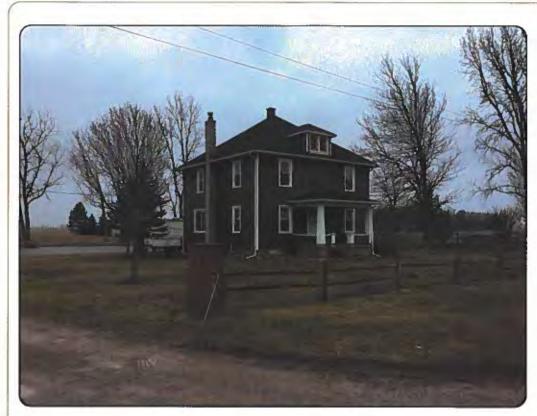
Resource Name: A two-story Foursquare-style residence.

Criteria: No

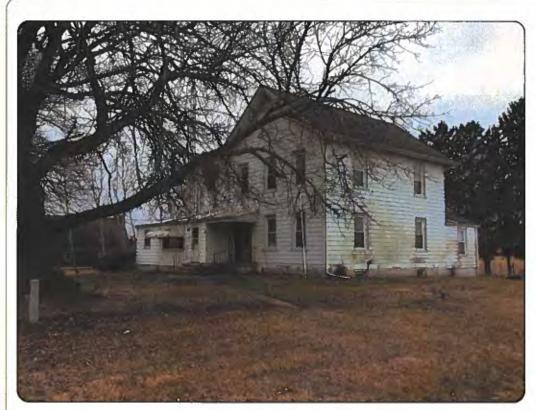
Resource Name: A two-story vernacular residence.

Meets NRHP Eligibility Criteria: No

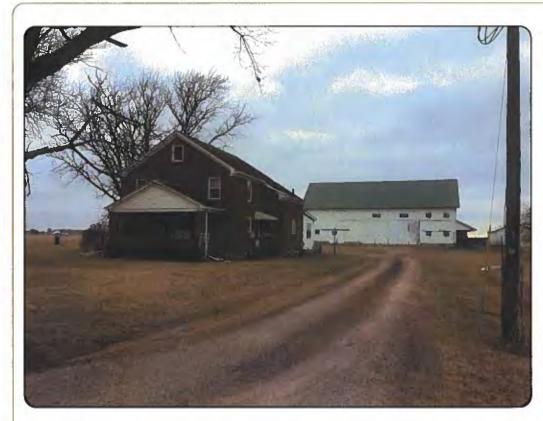
Resource Name: A two-story vernacular residence with an accompanying hay barn.

Meets NRHP Eligibility Criteria: No

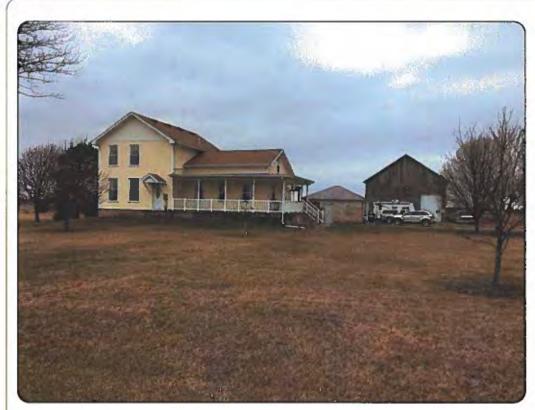
Resource Name: A twostory Greek Revival-style residence.

Meets NRHP Eligibility Criteria: No

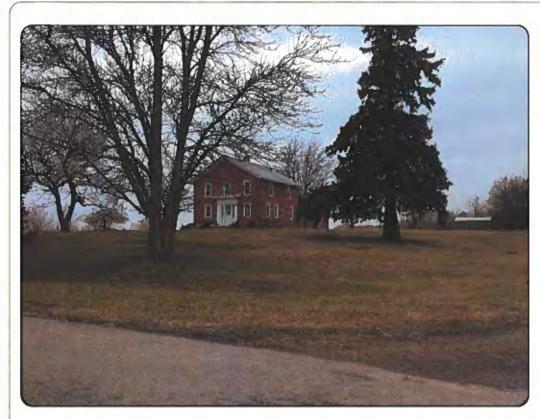
Resource Name: A one-andone-half-story Greek Revivalstyle residence.

Criteria: No

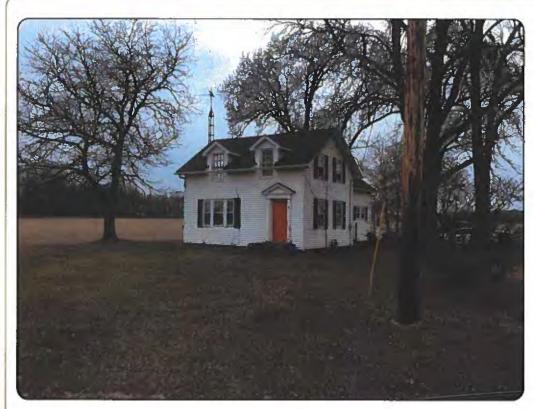
Resource Name: A oneand-one-half-story Colonial Revival-style residence.

Criteria: No

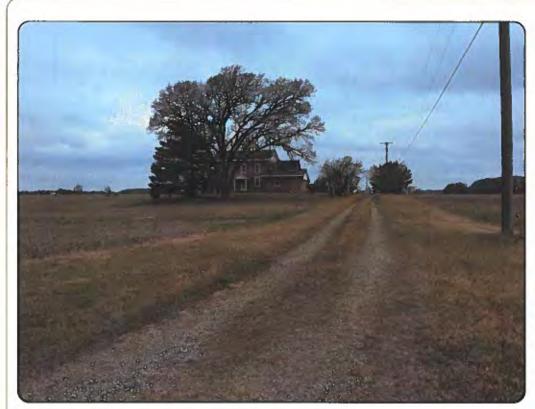
Resource Name: A twostory Colonial Revival-style residence.

Meets NRHP Eligibility
Criteria: Unable to determine

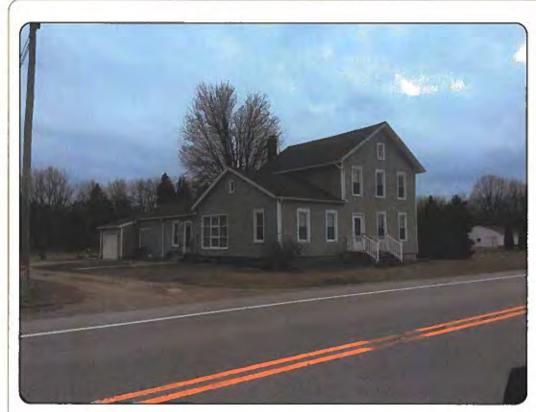
Resource Name: A two-story vernacular residence.

Meets NRHP Eligibility Criteria: No

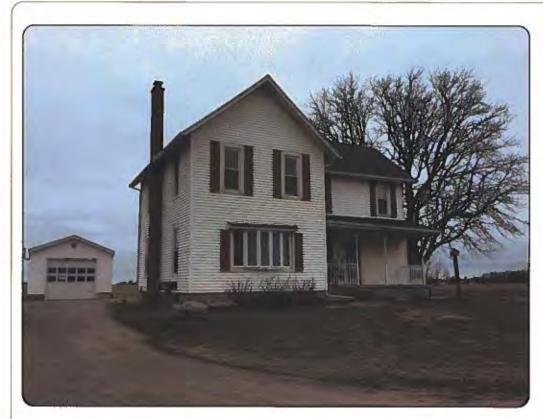
Resource Name: A two-story vernacular residence.

Meets NRHP Eligibility Criteria: No

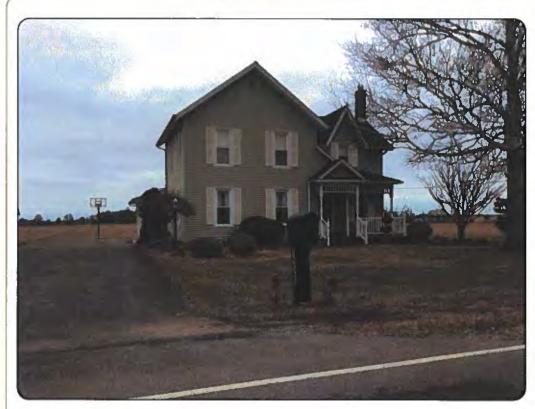
Resource Name: A two-story Greek Revival-style residence with Gothic Revival-style lateral projection.

Criteria: No

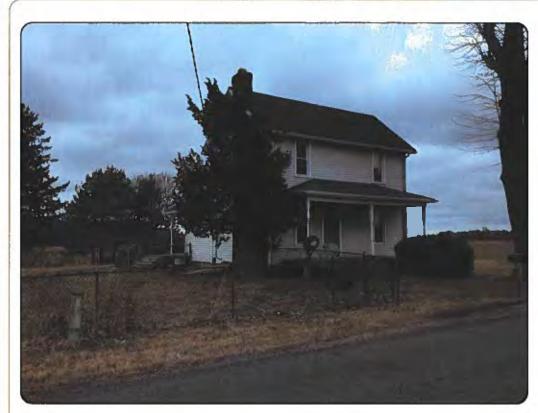
Resource Name: A two-story vernacular residence.

Meets NRHP Eligibility Criteria: No

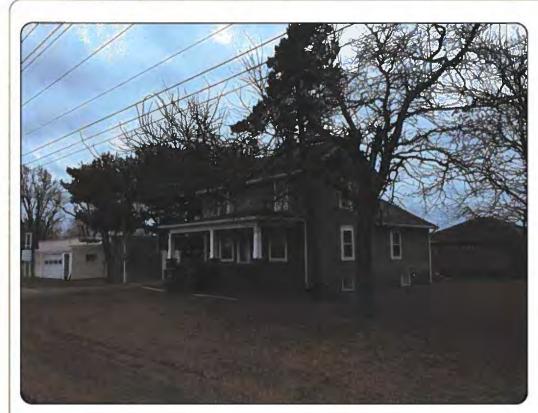
Resource Name: A two-story vernacular residence.

Criteria: No

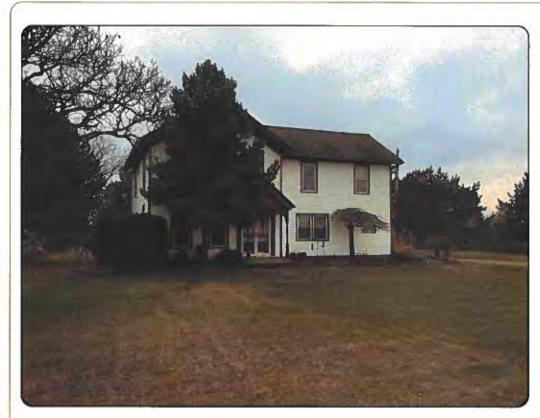
Resource Name: A twostory Greek Revival-style residence.

Meets NRHP Eligibility Criteria: No

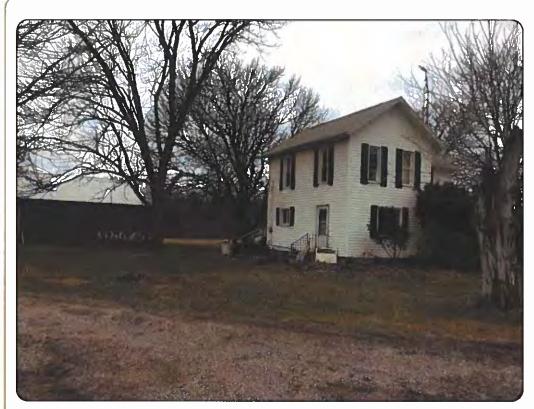
Resource Name: A two-story vernacular residence.

Meets NRHP Eligibility Criteria: No

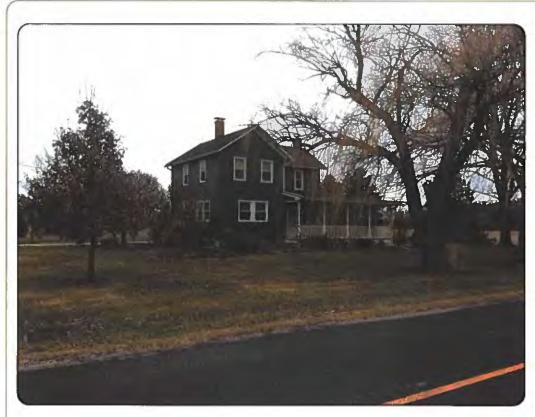
Resource Name: A two-story vernacular residence.

Meets NRHP Eligibility Criteria: No

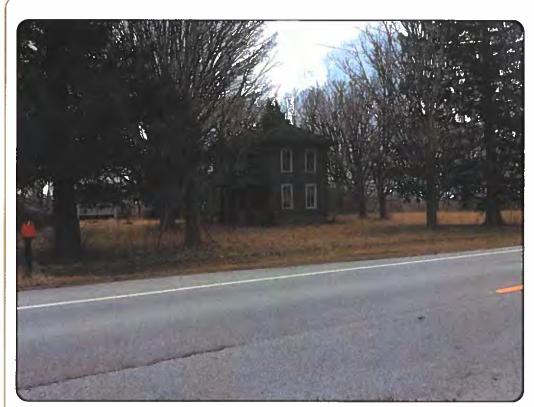
Resource Name: A two-story vernacular residence.

Meets NRHP Eligibility
Criteria: No

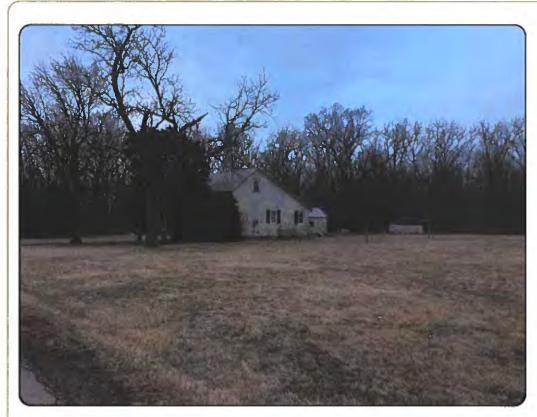
Resource Name: A oneand-one-half-story saltbox residence.

Meets NRHP Eligibility Criteria: No

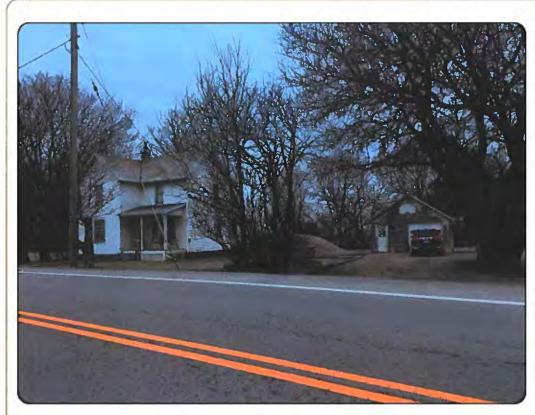
Resource Name: A two-story vernacular residence.

Meets NRHP Eligibility Criteria: No

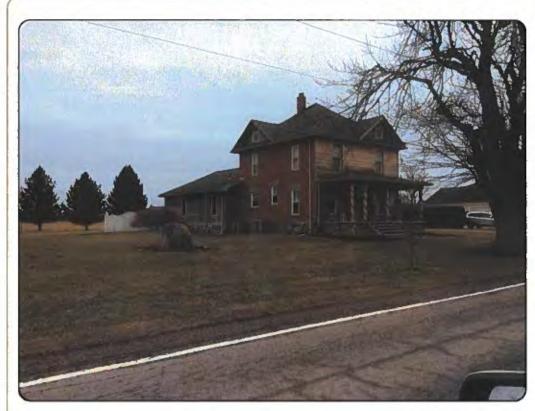
Resource Name: A two-story Queen Anne-style residence.

Meets NRHP Eligibility Criteria: No

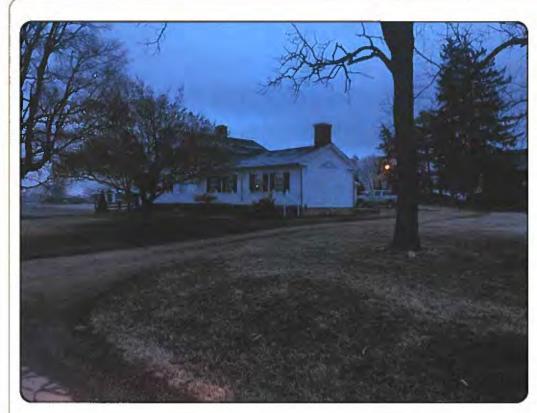
Resource Name: A twostory Greek Revival-style residence.

Meets NRHP Eligibility Criteria: No

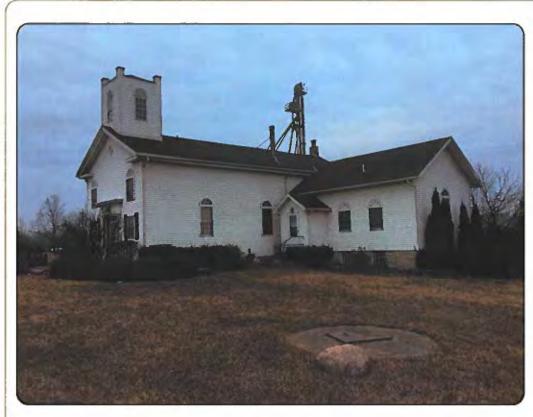
Resource Name: A two-story Gothic Revival-style church.

Meets NRHP Eligibility

Criteria: No

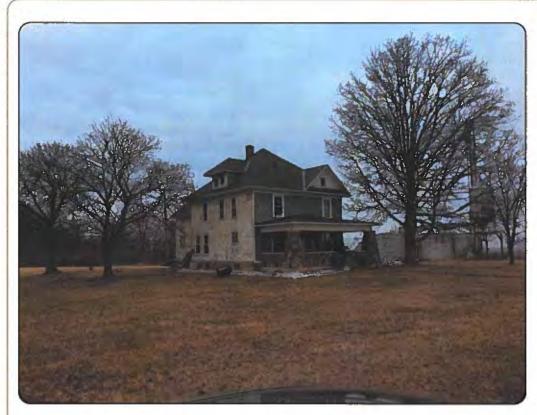
Resource Name: A two-story Foursquare-style residence.

Meets NRHP Eligibility Criteria: No

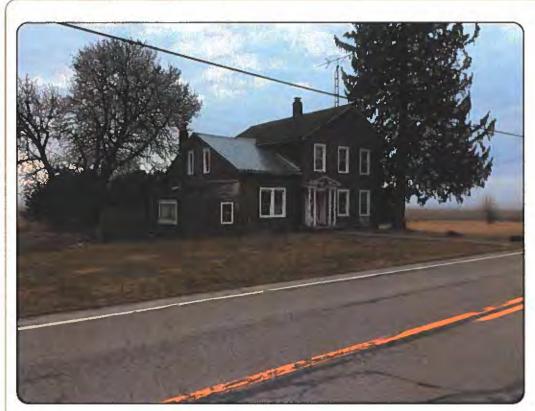
Resource Name: A two-story vernacular residence.

Meets NRHP Eligibility

Criteria: No

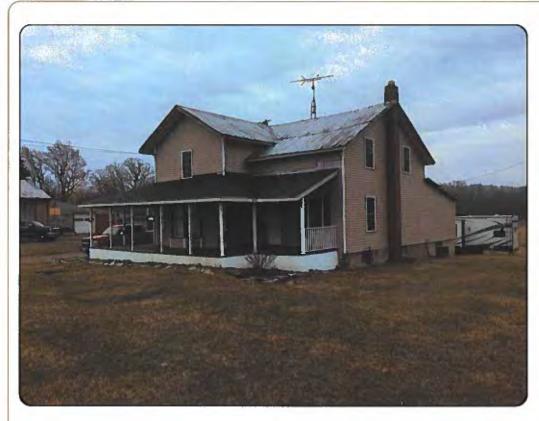
Resource Name: A two-story vernacular residence.

Meets NRHP Eligibility

Criteria: No

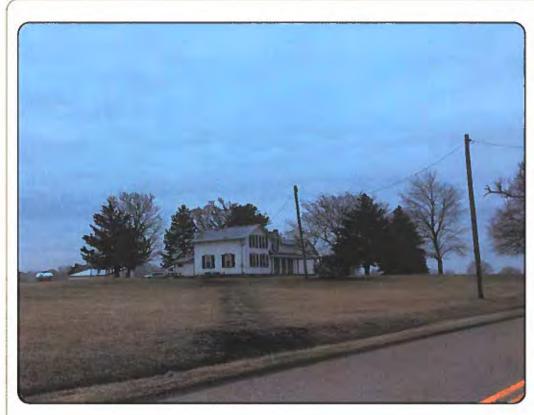
Resource Name: A two-story vernacular residence.

Meets NRHP Eligibility Criteria: No

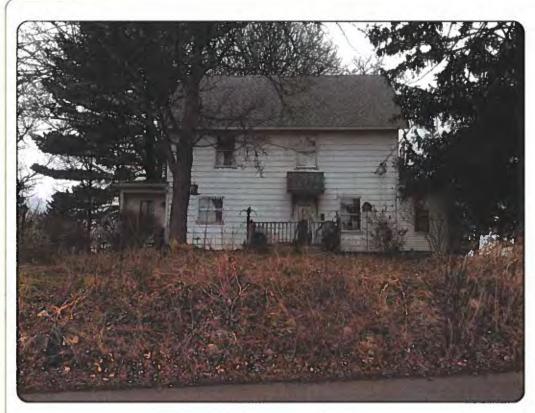
Resource Name: A two-story vernacular residence.

Meets NRHP Eligibility

Criteria: No

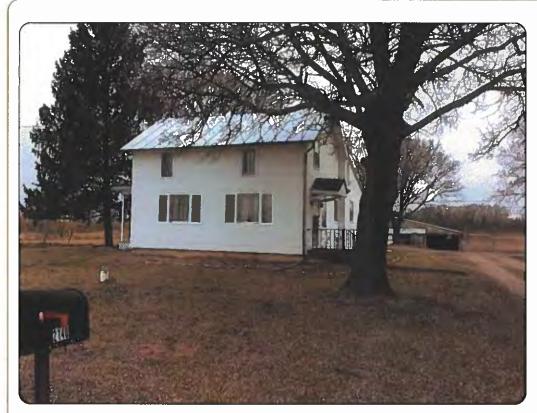
Resource Name: A one-andone-half-story vernacular residence.

Meets NRHP Eligibility Criteria: No

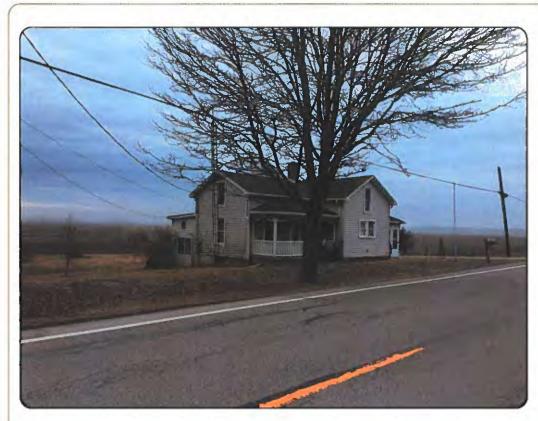
Resource Name: A two-story vernacular residence.

Meets NRHP Eligibility

Criteria: No

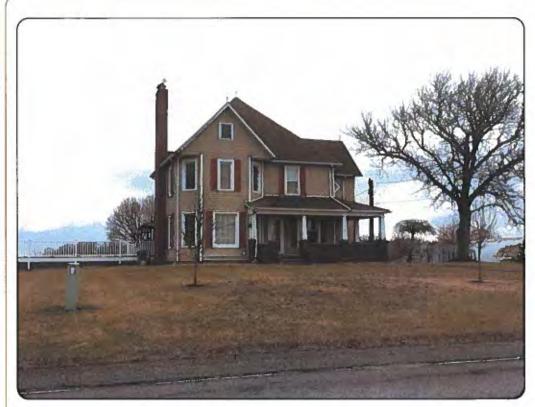
Resource Name: A two-story vernacular residence.

Meets NRHP Eligibility

Criteria: No

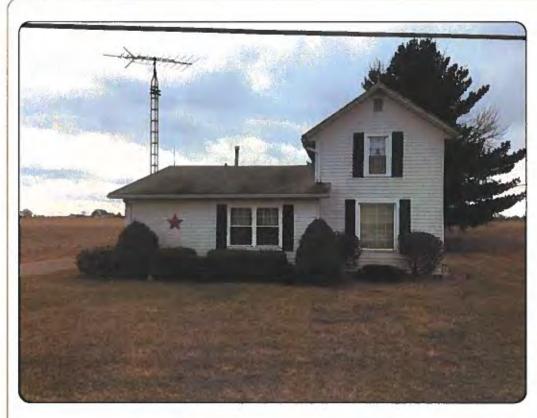
Resource Name: A two-story vernacular residence.

Meets NRHP Eligibility

Criteria: No

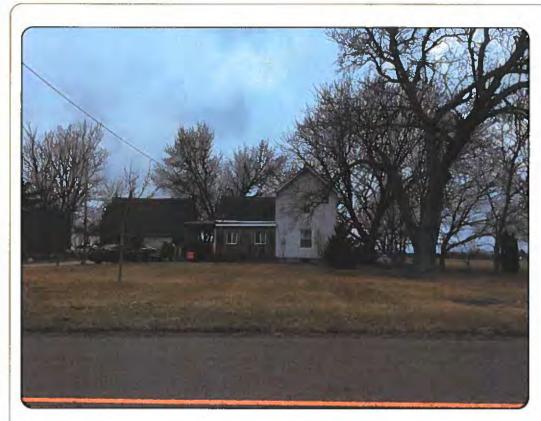
Resource Name: A two-story vernacular residence.

Meets NRHP Eligibility

Criteria: No

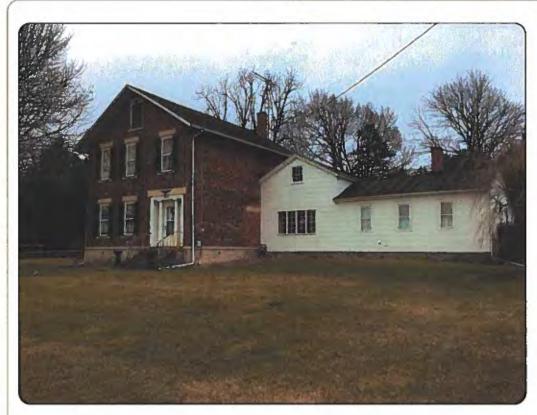
Resource Name: A twostory Greek Revival-style residence.

Meets NRHP Eligibility Criteria: Yes

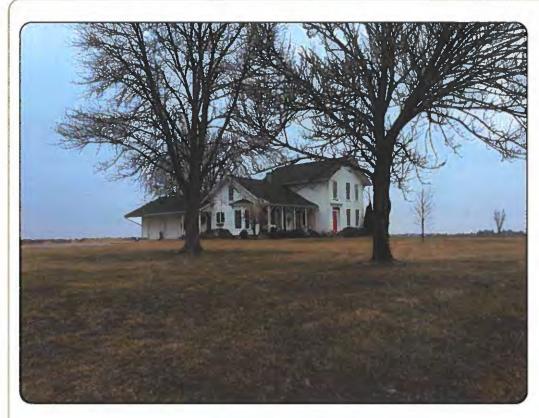
Resource Name: A twostory Greek Revival-style residence.

Meets NRHP Eligibility

Criteria: No

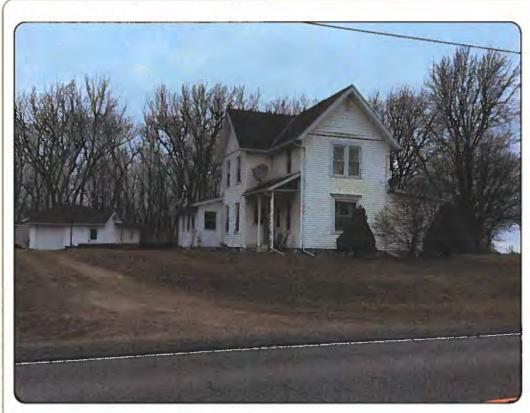
Resource Name: A two-story vernacular residence.

Meets NRHP Eligibility

Criteria: No

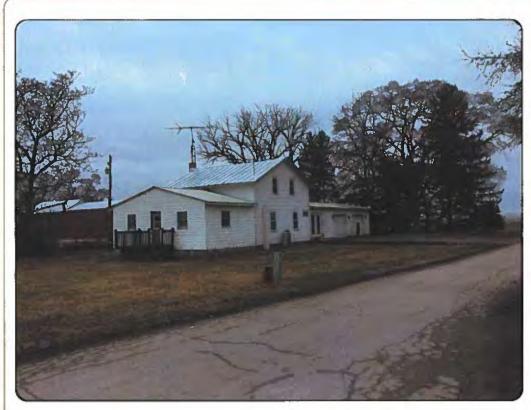
Resource Name: A two-story vernacular residence.

Meets NRHP Eligibility

Criteria: No

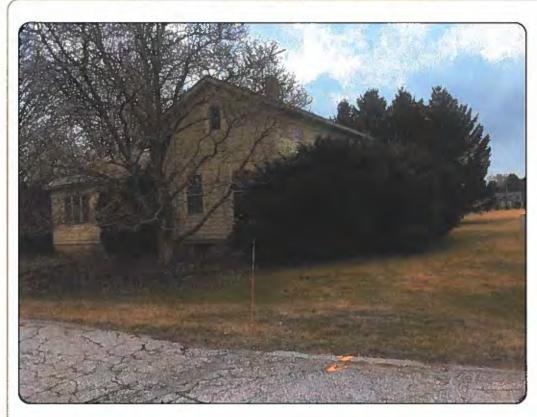
Resource Name: A one-andone-half-story vernacular residence.

Meets NRHP Eligibility

Criteria: No

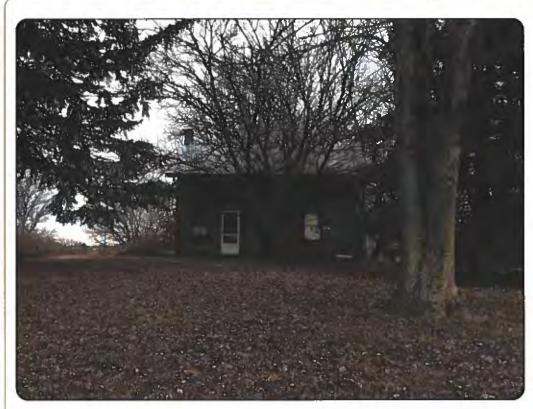
Resource Name: A one-story vernacular residence.

Meets NRHP Eligibility Criteria: No

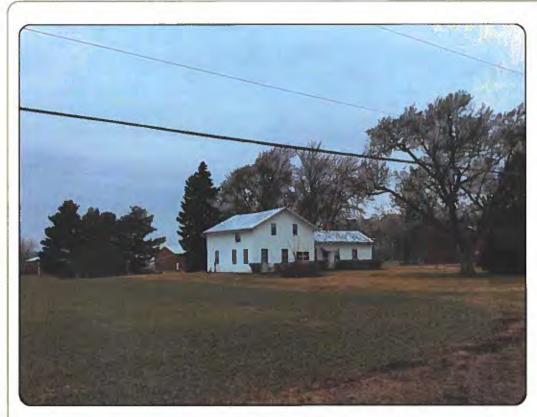
Resource Name: A two-story vernacular residence.

Meets NRHP Eligibility

Criteria: No

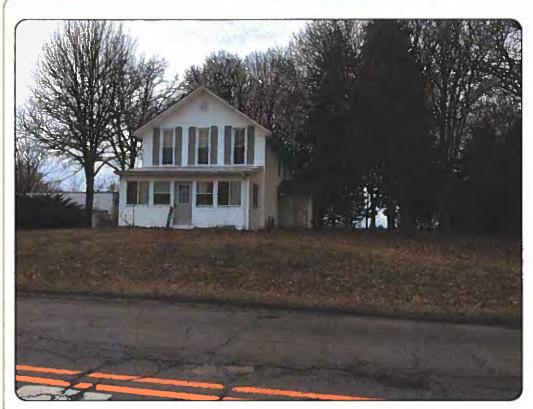
Sheet 78 of 355

Resource Name: A two-story vernacular residence.

Criteria: No

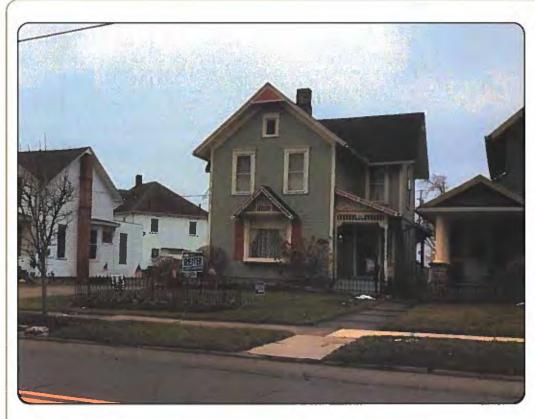
Sheet 80 of 355

Resource Name: A two-story vernacular residence with decorative brackets.

Meets NRHP Eligibility Criteria: Yes

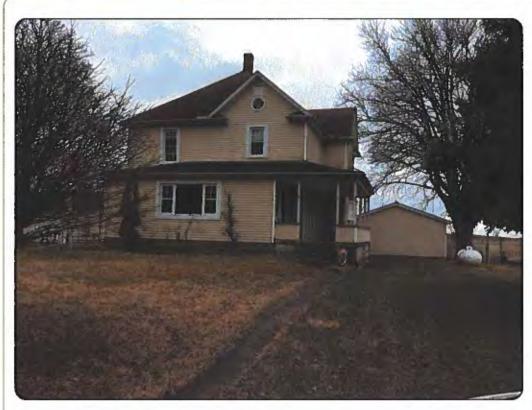
Resource Name: A two-story vernacular residence.

Meets NRHP Eligibility

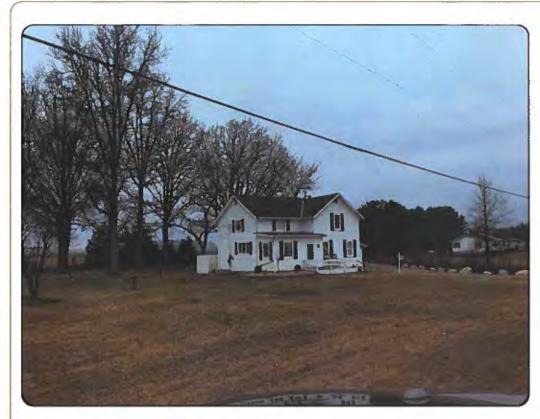
Sheet 82 of 355

Resource Name: A two-story vernacular residence.

Meets NRHP Eligibility Criteria: No

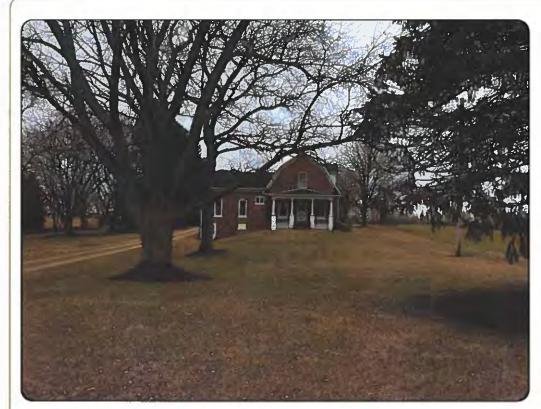
Sheet 83 of 355

Resource Name: A oneand-one-half-story Colonial Revival-style residence.

Criteria: No

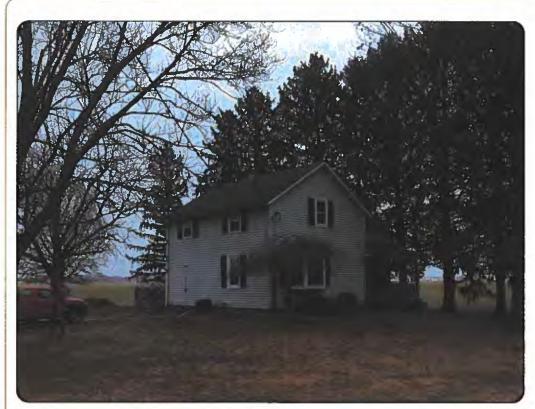
Sheet 84 of 355

Resource Name: A two-story vernacular residence.

Criteria: No

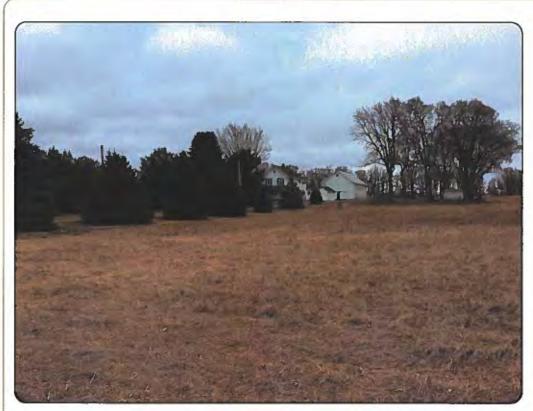
Sheet 85 of 355

Resource Name: A two-story vernacular residence.

Criteria: No

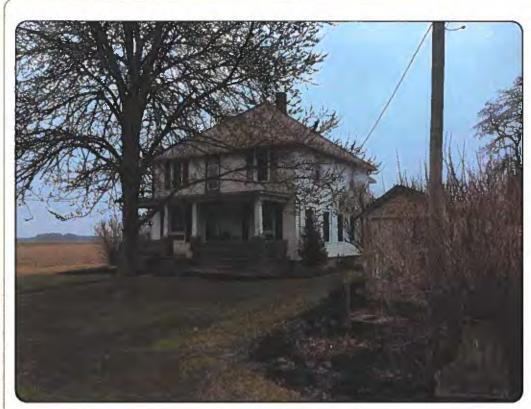
Sheet 86 of 355

Resource Name: A two-story Foursquare-style residence.

Criteria: No

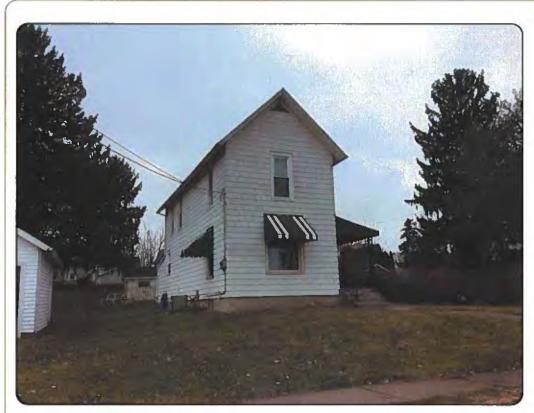
Sheet 87 of 355

Resource Name: A two-story vernacular residence.

Criteria: No

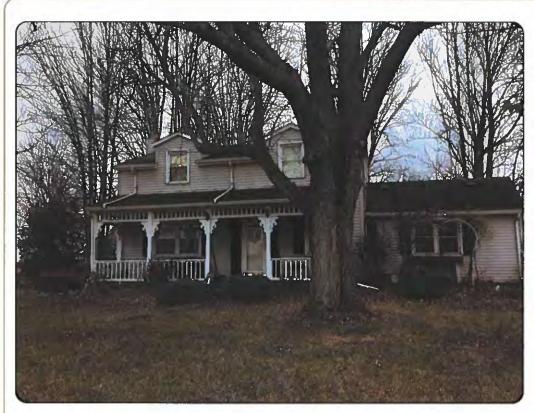
Sheet 88 of 355

Resource Name: A oneand-one-half-story Colonial Revival-style residence.

Meets NRHP Eligibility Criteria: No

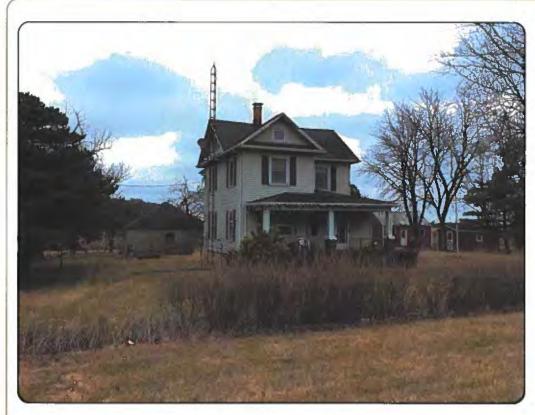
Sheet 89 of 355

Resource Name: A two-story vernacular residence.

Meets NRHP Eligibility Criteria: No

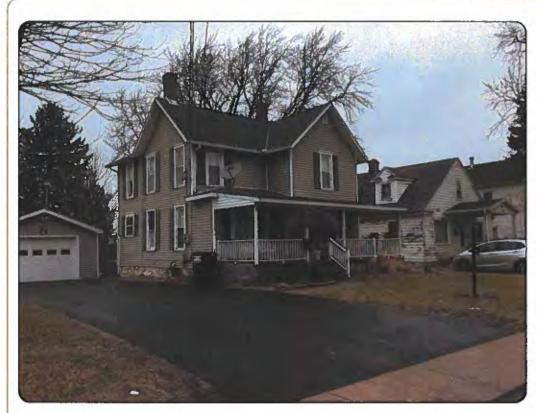
Sheet 90 of 355

Resource Name: A two-story vernacular residence.

Meets NRHP Eligibility Criteria: No

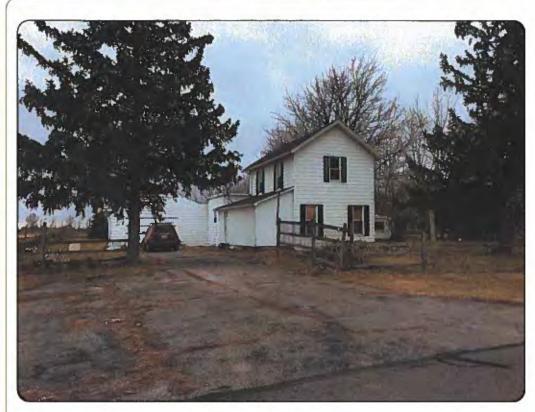
Sheet 91 of 355

Resource Name: A two-story vernacular residence.

Criteria: No

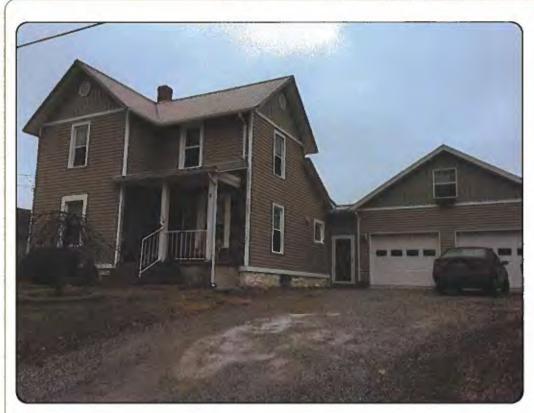
Sheet 92 of 355

Resource Name: A two-story vernacular residence.

Meets NRHP Eligibility
Criteria: No

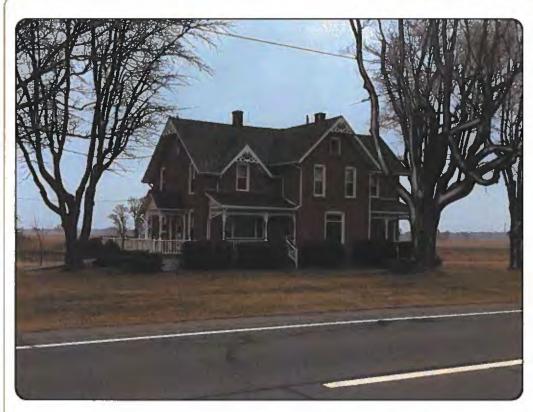
Sheet 93 of 355

Resource Name: A two-story residence with decorative brackets and Italianate elements.

Meets NRHP Eligibility Criteria: Yes

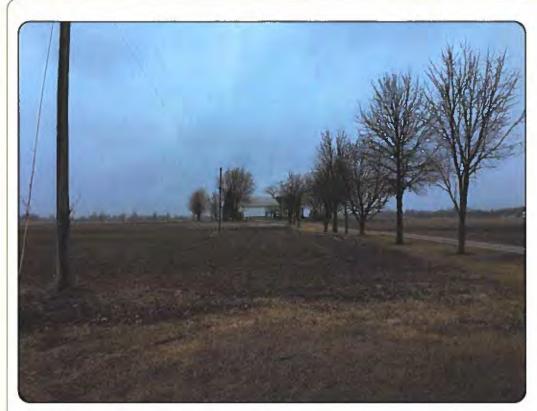
Sheet 94 of 355

Resource Name: A two-story vernacular residence.

Meets NRHP Eligibility
Criteria: Unable to determine

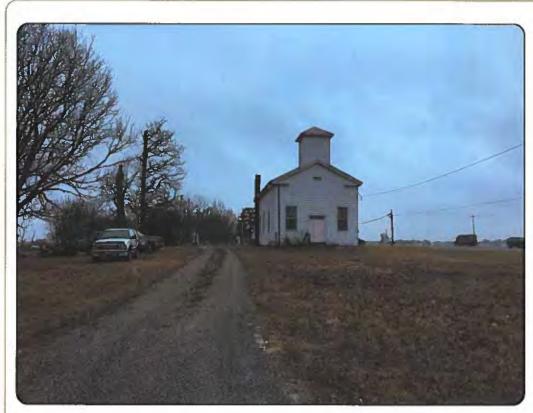
Sheet 95 of 355

Resource Name: A one-story Greek Revival-style church.

Criteria: No

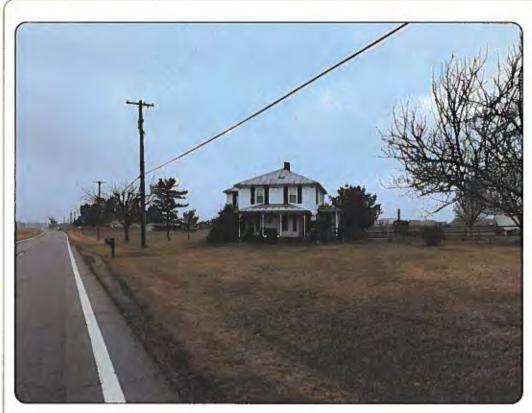
Sheet 96 of 355

Resource Name: A two-story Italianate residence.

Meets NRHP Eligibility Criteria: No

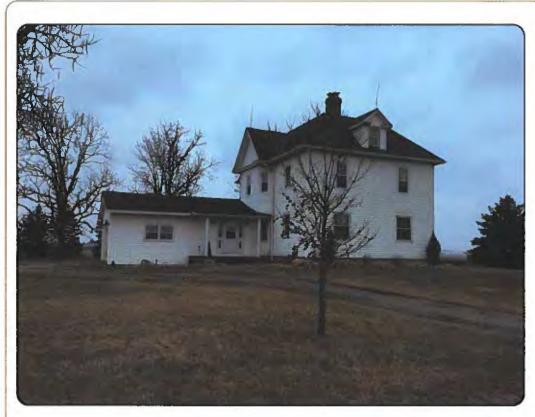
Sheet 97 of 355

Resource Name: A two-story Foursquare-style residence.

Criteria: No

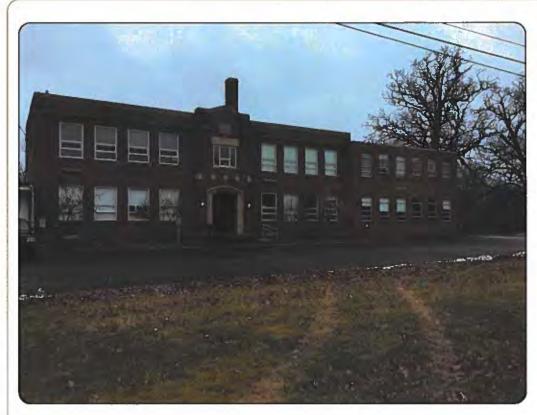
Sheet 98 of 355

Resource Name: A two-story Art Deco-style school.

Meets NRHP Eligibility Criteria: No

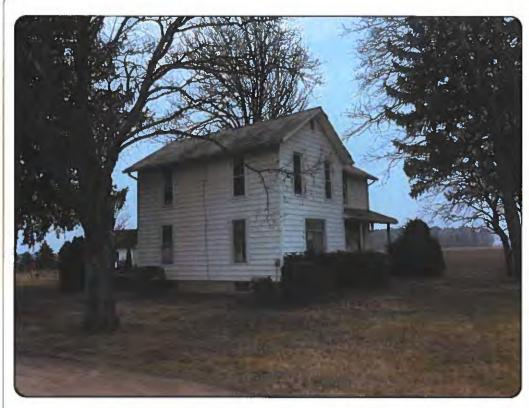
Sheet 99 of 355

Resource Name: A two-story vernacular residence.

Meets NRHP Eligibility Criteria: No

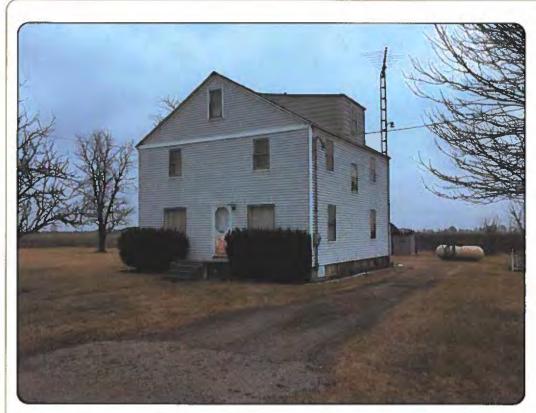
Sheet 100 of 355

Resource Name: A two-story vernacular residence.

Meets NRHP Eligibility Criteria: No

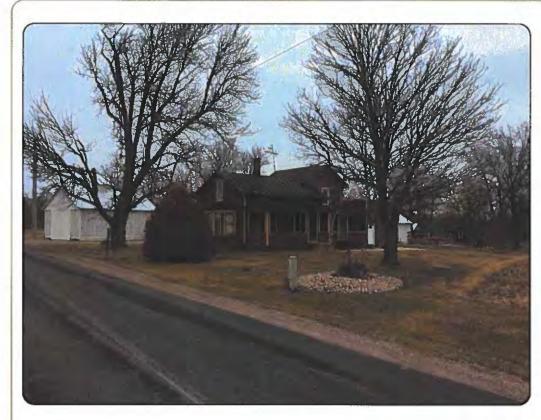
Sheet 101 of 355

Resource Name: A farmstead consisting of a oneand-one-half-story residence, three barns, and two sheds.

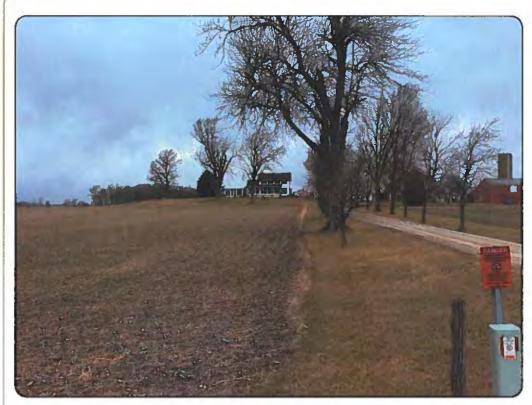
Sheet 102 of 355

Resource Name: A farmstead consisting of a oneand-one-half-story residence

Meets NRHP Eligibility
Criteria: Unable to determine

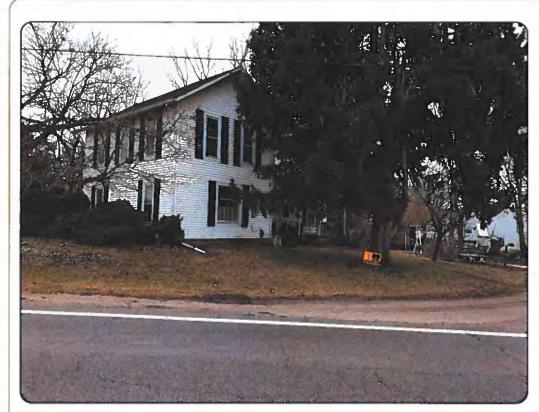
Sheet 103 of 355

Resource Name: A two-story vernacular residence.

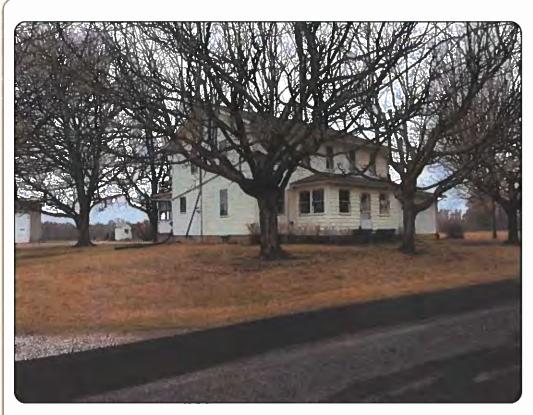
Sheet 104 of 355

Resource Name: A two-story vernacular residence.

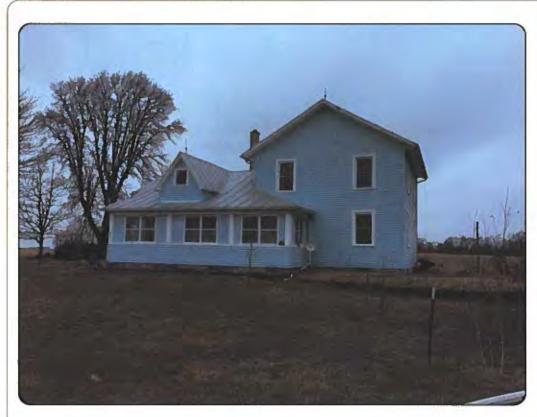
Sheet 105 of 355

Resource Name: A two-story vernacular residence.

Meets NRHP Eligibility Criteria: No

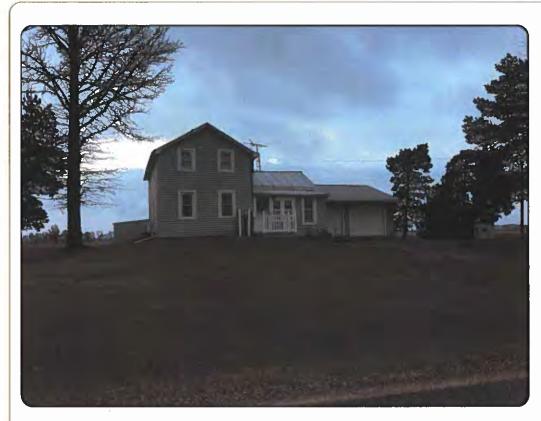
Sheet 106 of 355

Resource Name: A one-andone-half-story vernacular residence.

Meets NRHP Eligibility Criteria: No

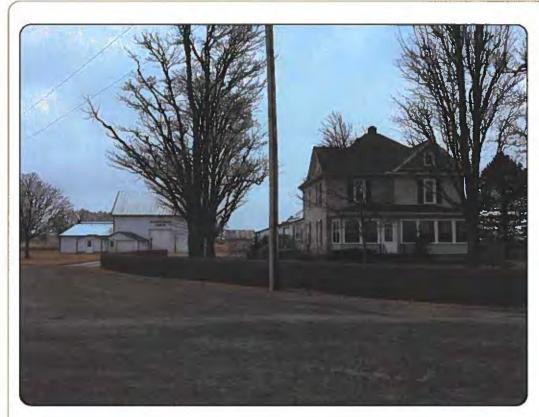
Sheet 107 of 355

Resource Name: A two-story vernacular residence with

Meets NRHP Eligibility Criteria: No

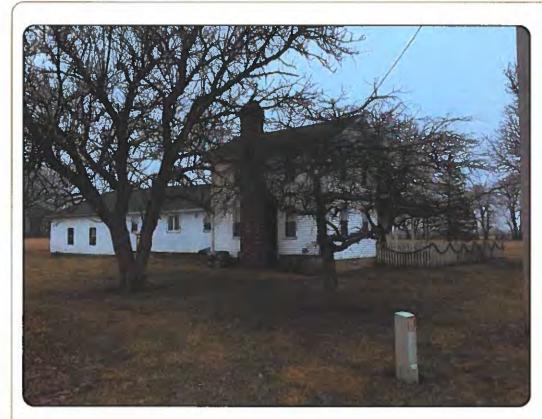
Sheet 108 of 355

Resource Name: A one-andone-half-story vernacular residence.

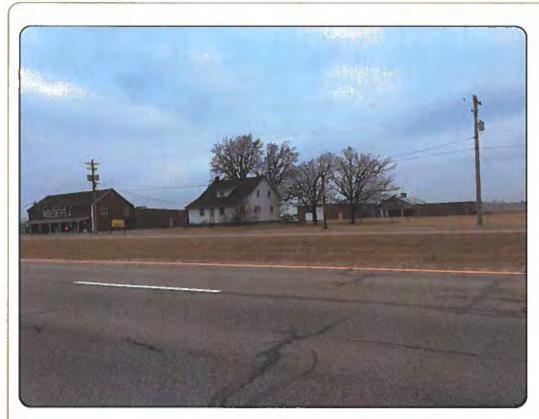
Sheet 109 of 355

Resource Name: A one-andone-half-story vernacular residence with a farmstand.

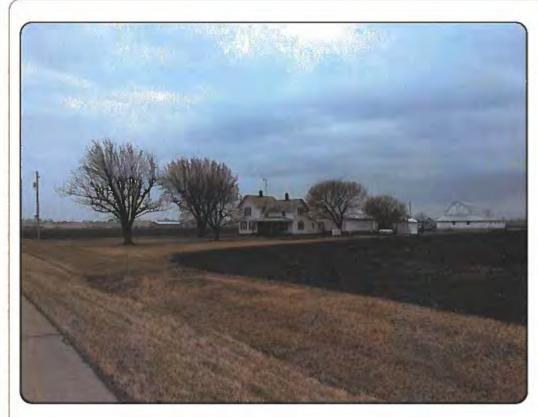
Sheet 110 of 355

Resource Name: A two-story vernacular residence with

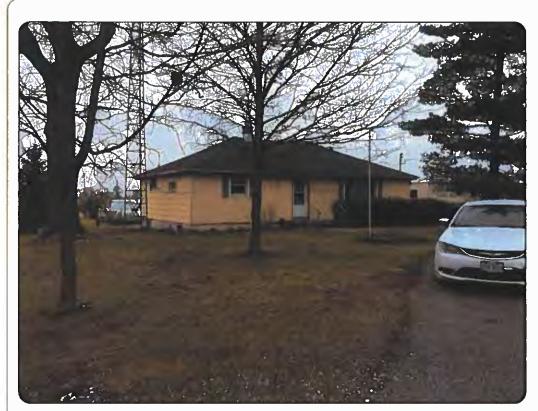
Sheet 111 of 355

Resource Name: A one-story Ranch type residence.

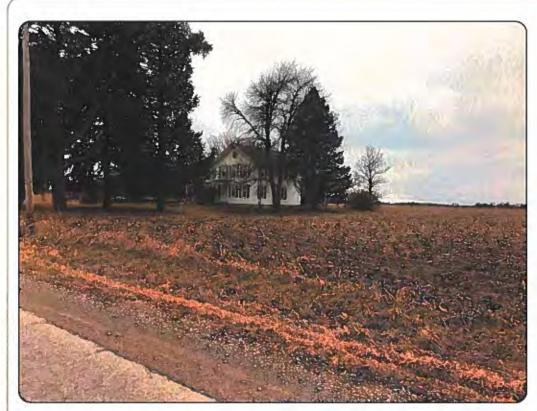
Sheet 112 of 355

Resource Name: A two-story vernacular residence.

Meets NRHP Eligibility Criteria: No

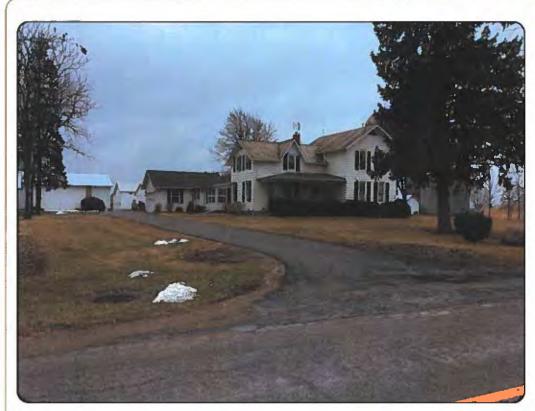
Sheet 113 of 355

Resource Name: A farmstead consisting of a oneand-one-half-story residence, four barns, and a garage.

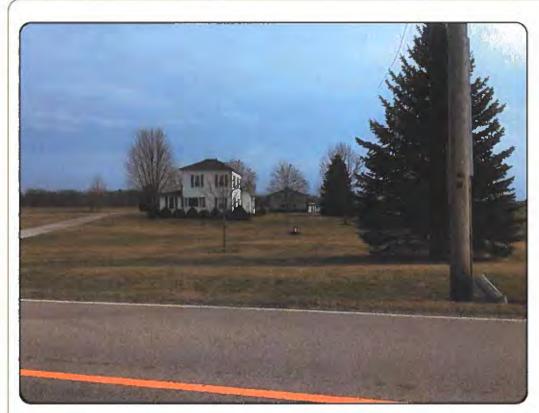
Sheet 114 of 355

Resource Name: A two-story Italianate residence.

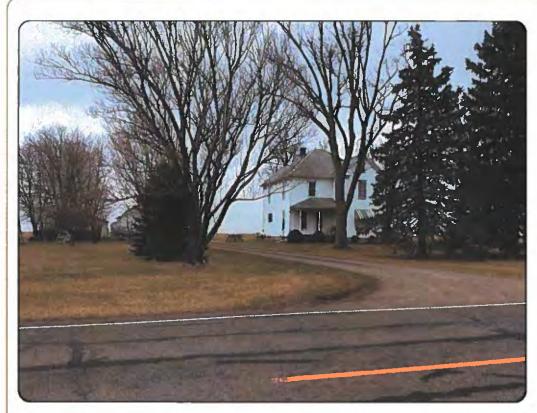
Sheet 115 of 355

Resource Name: A two-story vernacular residence with barn.

Meets NRHP Eligibility Criteria: No

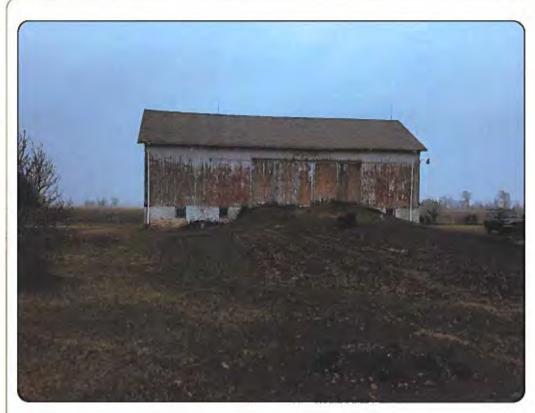
Sheet 116 of 355

Resource Name: A two-story vernacular residence with barn.

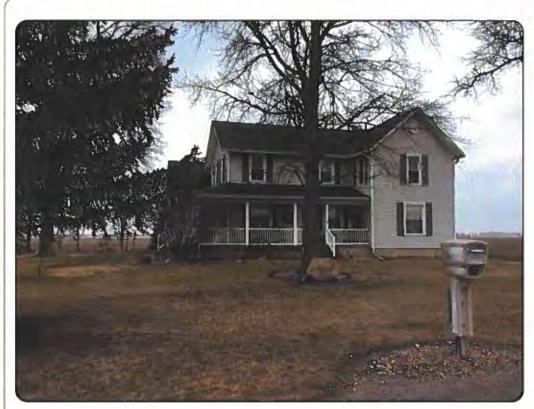
Sheet 117 of 355

Resource Name: A two-story vernacular residence.

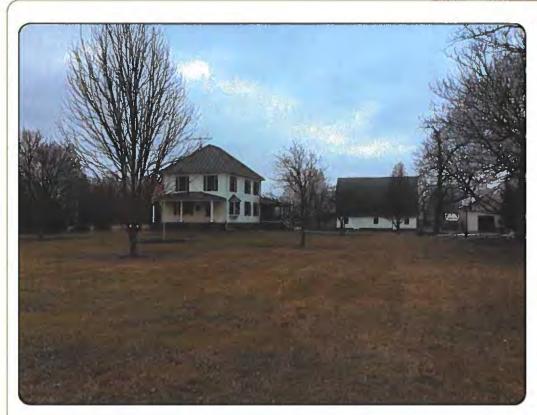
Sheet 118 of 355

Resource Name: A two-story Foursquare type residence.

Criteria: No

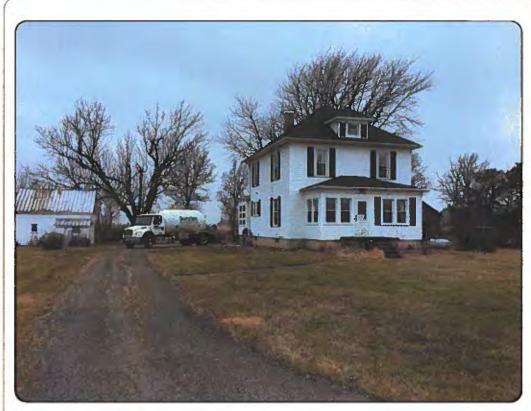
Sheet 119 of 355

Resource Name: A two-story Foursquare type residence.

Criteria: No

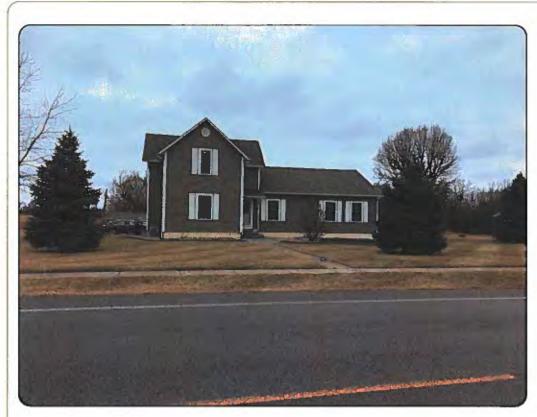
Sheet 120 of 355

Resource Name: A two-story vernacular residence.

Meets NRHP Eligibility Criteria: No

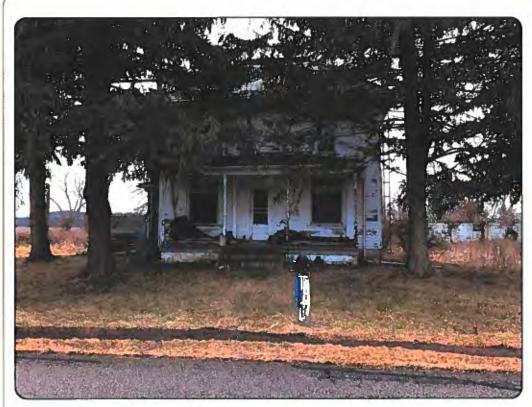
Sheet 121 of 355

Resource Name: A two-story Foursquare type residence.

Criteria: No

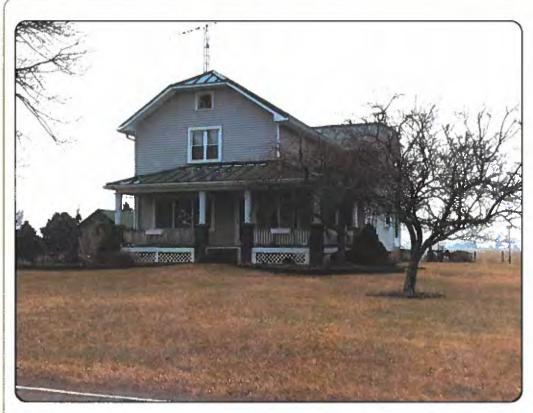
Sheet 122 of 355

Resource Name: A two-story vernacular residence.

Meets NRHP Eligibility Criteria: No

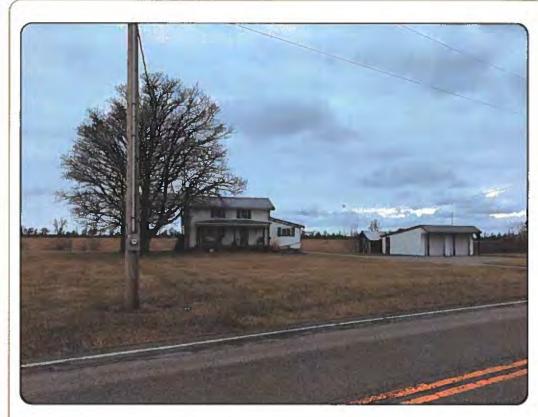
Sheet 123 of 355

Resource Name: A one-andone-half-story vernacular house.

Meets NRHP Eligibility Criteria: No

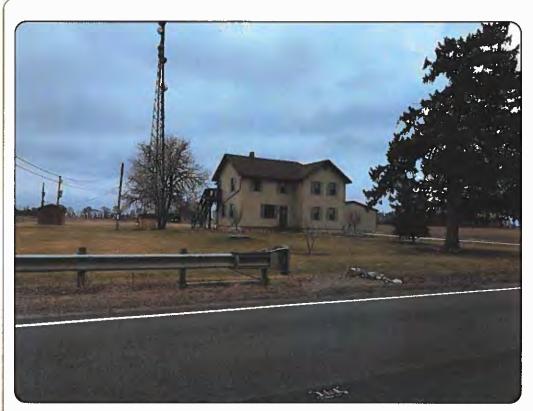
Sheet 124 of 355

Resource Name: The twostory vernacular residence.

Meets NRHP Eligibility Criteria: No

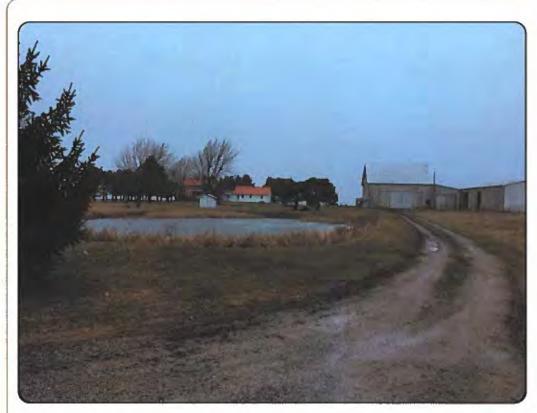
Sheet 125 of 355

Resource Name: A one-andone-half-story vernacular house with barn.

Criteria: Unable to determine

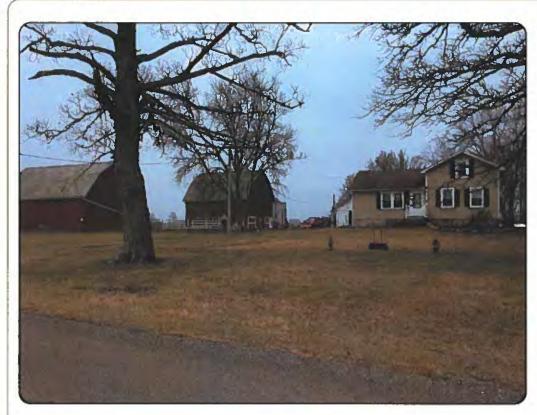
Sheet 126 of 355

Resource Name: A one-andone-half-story vernacular house with barns.

Criteria: No

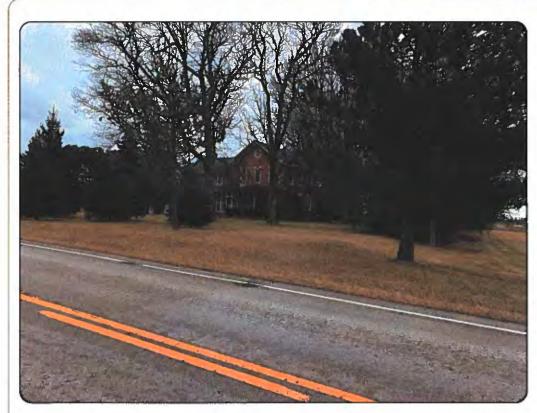
Sheet 127 of 355

Resource Name: A farmstead consisting of a two-story Greek Revival-style house and three barns.

Criteria: Yes

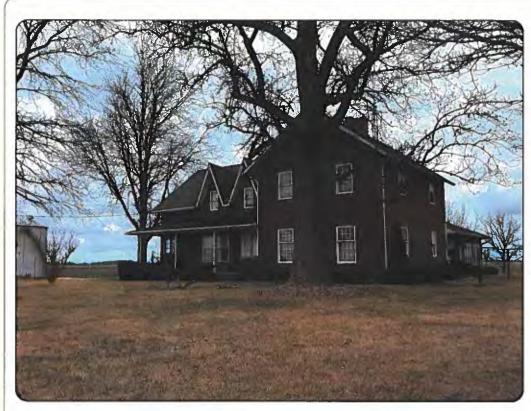
Sheet 128 of 355

Resource Name: A two-story Greek Revival-style residence with Gothic Revival-style lateral projection.

Criteria: No

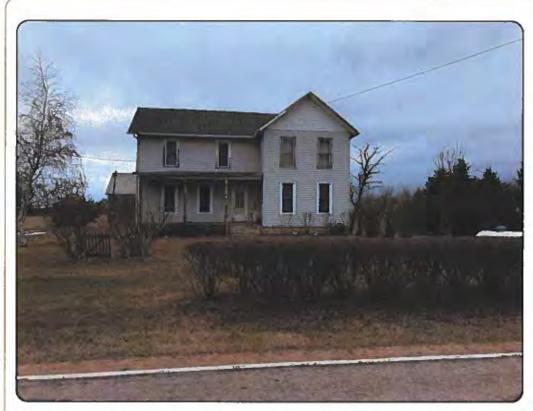
Sheet 129 of 355

Resource Name: A two-story vernacular residence.

Criteria: No

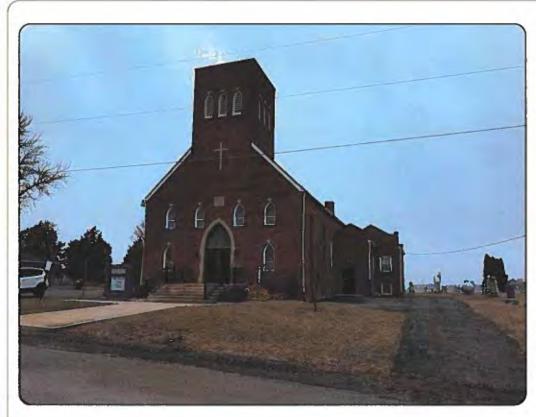
Sheet 130 of 355

Resource Name: A midcentury, brick church.

Meets NRHP Eligibility Criteria: No

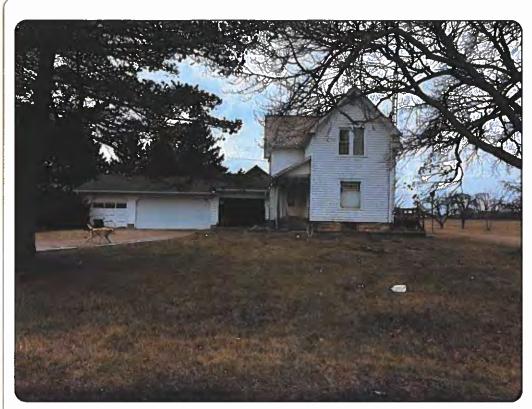
Sheet 131 of 355

Resource Name: A two-story vernacular residence.

Meets NRHP Eligibility
Criteria: No
