Historic Resources Survey
October 2020
Environmental Design & Research
(Submitted to State Historic Preservation Office
January 5, 2021)

RE: Emerson Creek Wind Farm

Our office has reviewed the revised Historic Resources Survey Report, Emerson Creek Wind Farm, Groton and Oxford Townships, Erie County, Ohio, Lyme, Ridgefield, Sherman, Norwich, and Richmond Townships, Huron County, Ohio, prepared by Environmental Design and Research (EDR) in October 2020. The project is a 297.66-megawatt wind energy facility consisting of up to 87 wind turbine generators and associated infrastructure.

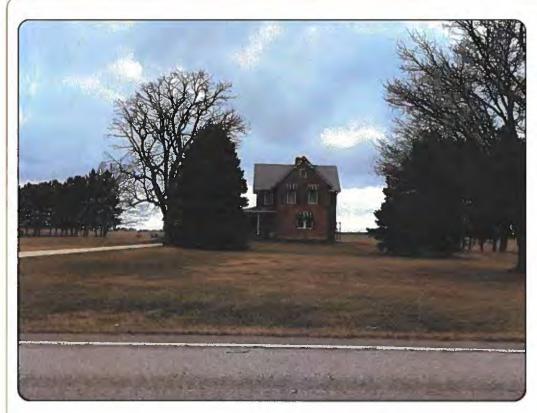
Sheet 132 of 355

Resource Name: A two-story brick vernacular house with

Criteria: No

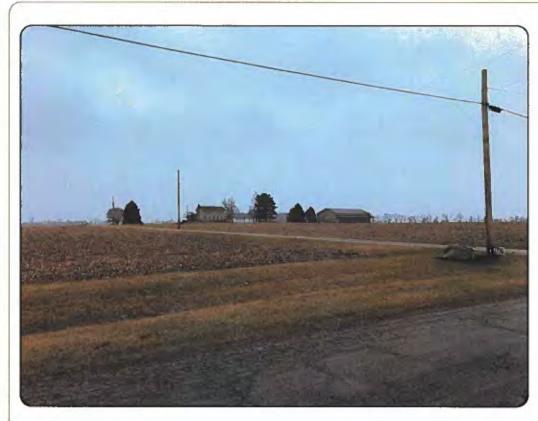
Sheet 133 of 355

Resource Name: A oneand-one-half-story stone residence.

Meets NRHP Eligibility
Criteria: Unable to determine

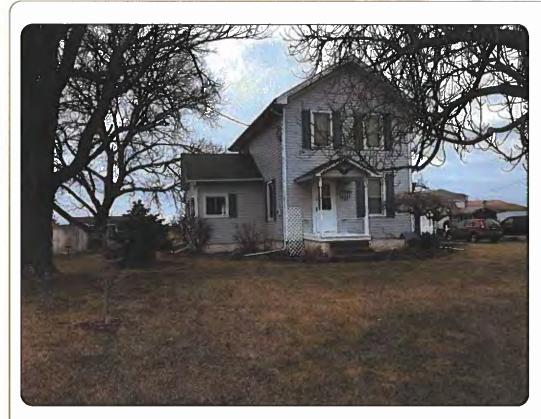
Sheet 134 of 355

Resource Name: A two-story vernacular residence.

Meets NRHP Eligibility Criteria: No

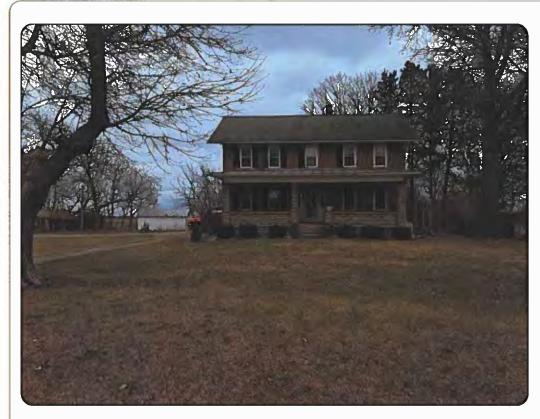
Sheet 135 of 355

Resource Name: A two-story brick vernacular house with barns.

Meets NRHP Eligibility
Criteria: No

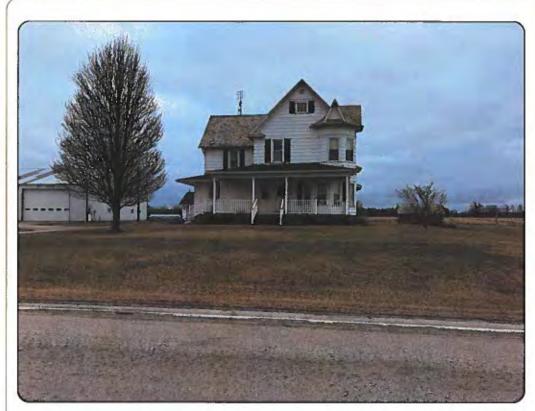
Sheet 136 of 355

Resource Name: A two-story Queen Anne-style residence.

Criteria: No

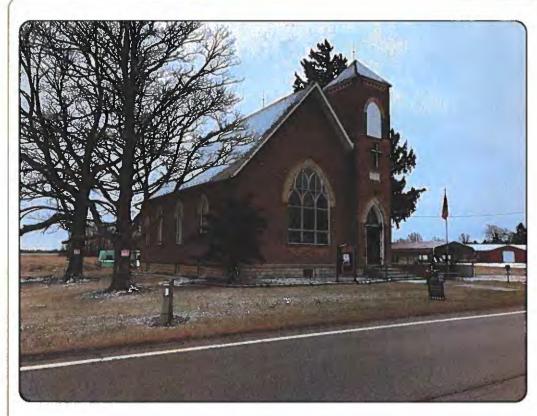
Sheet 137 of 355

Resource Name: A one-story, brick Gothic Revival-style church.

Meets NRHP Eligibility Criteria: Yes

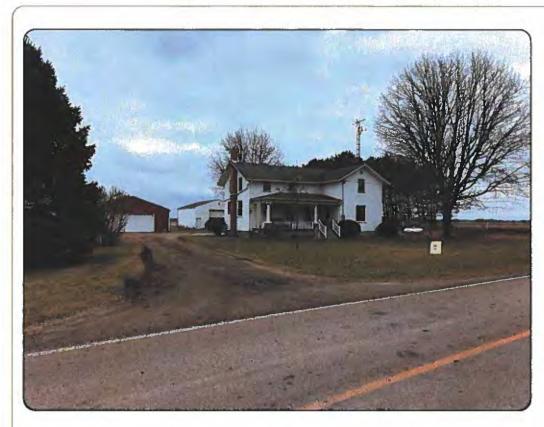
Sheet 138 of 355

Resource Name: A one-andone-half-story vernacular residence.

Meets NRHP Eligibility Criteria: No

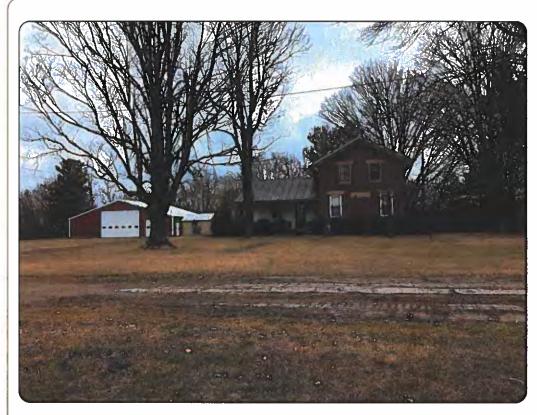
Sheet 139 of 355

Resource Name: A one-andone-half-story brick residence with barns.

Meets NRHP Eligibility Criteria: No

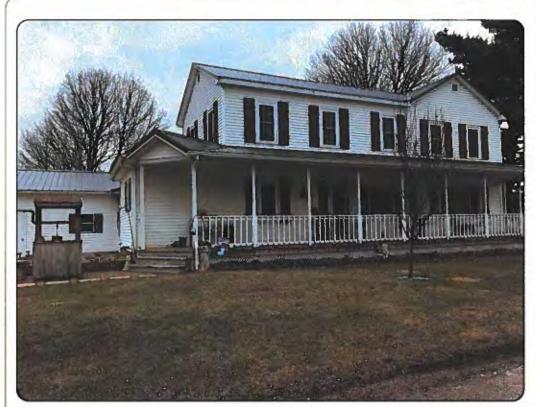
Sheet 140 of 355

Resource Name: A two-story vernacular residence.

Meets NRHP Eligibility

Criteria: No

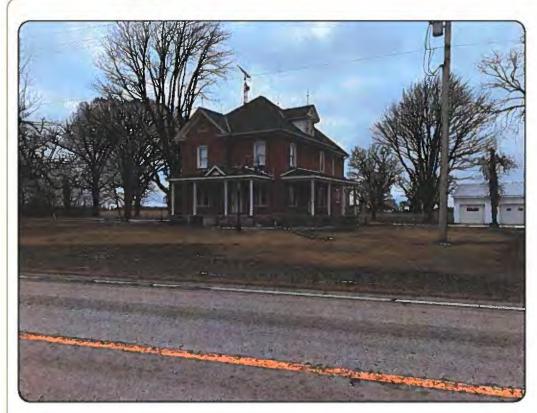
Sheet 141 of 355

Resource Name: A two-story vernacular residence.

Meets NRHP Eligibility

Criteria: No

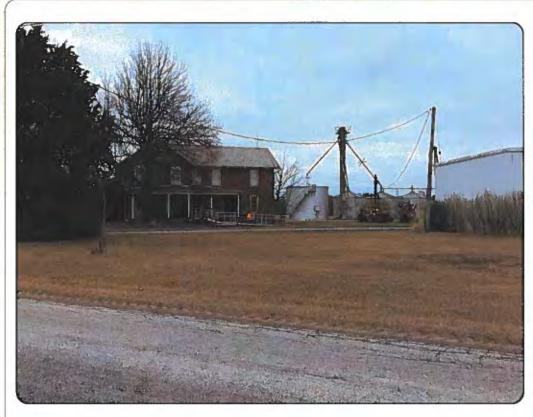
Sheet 142 of 355

Resource Name: A two-story brick vernacular residence

Meets NRHP Eligibility

Criteria: No

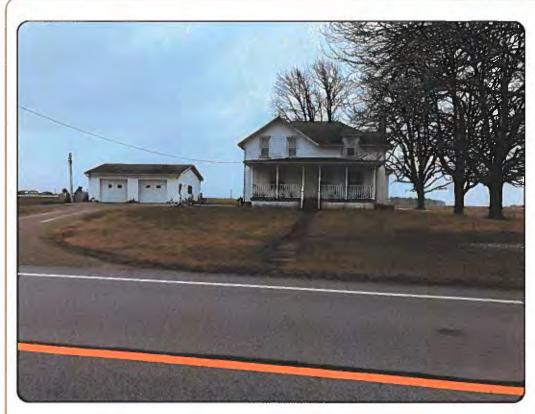
Sheet 143 of 355

Resource Name: A farmstead consisting of a oneand-one-half-story vernacular house and three barns.

Meets NRHP Eligibility Criteria: No

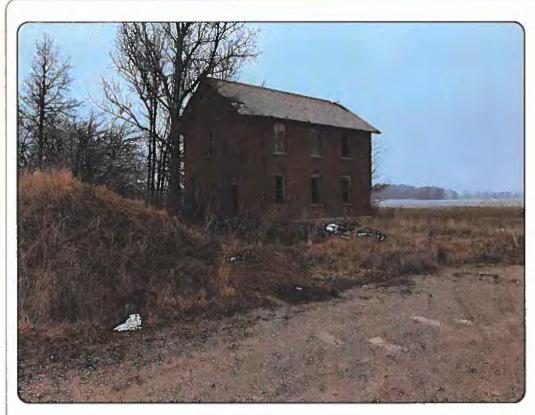
Sheet 144 of 355

Resource Name: A two-story brick former schoolhouse.

Meets NRHP Eligibility Criteria: Yes

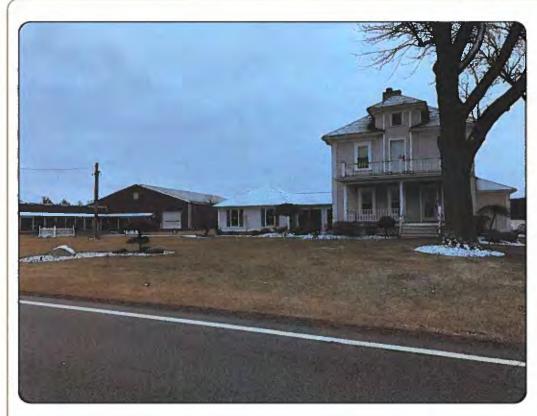
Sheet 145 of 355

Resource Name: A two-story vernacular residence.

Meets NRHP Eligibility

Criteria: No

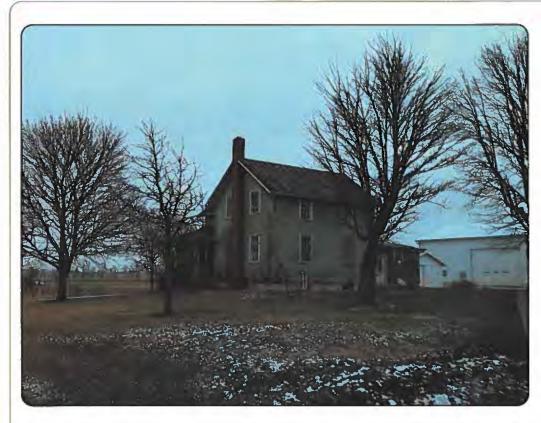
Sheet 146 of 355

Resource Name: A farmstead consisting of a twostory vernacular residence and barns.

Meets NRHP Eligibility Criteria: No

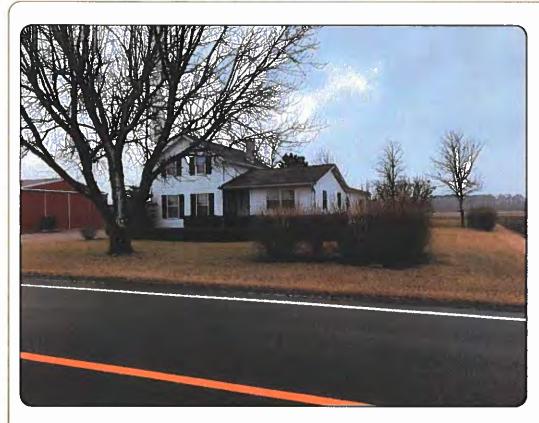
Resource Name: A one-andone-half-story vernacular residence.

Meets NRHP Eligibility

Criteria: No

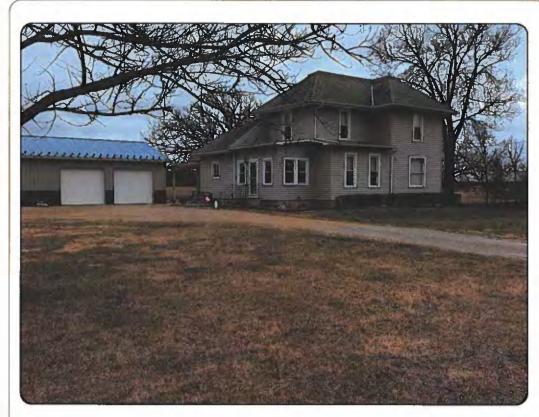
Sheet 148 of 355

Resource Name: A two-story vernacular residence.

Meets NRHP Eligibility Criteria: No

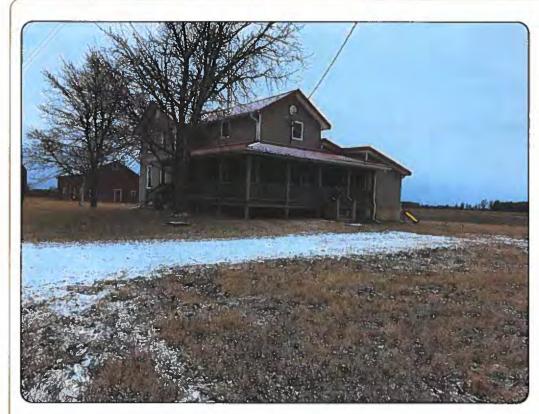
Sheet 149 of 355

Resource Name: A two-story vernacular residence with a

Meets NRHP Eligibility

Criteria: No

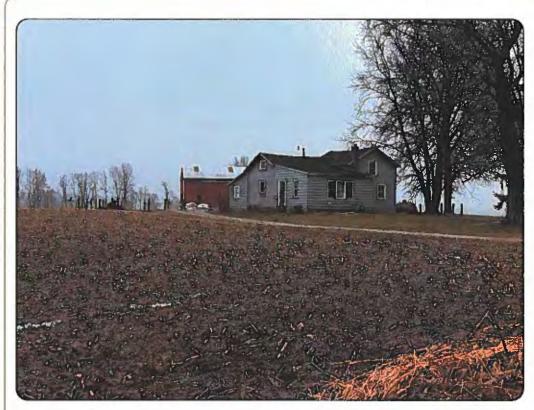
Sheet 150 of 355

Resource Name: A one-andone-half-story vernacular residence and barn.

Meets NRHP Eligibility Criteria: No

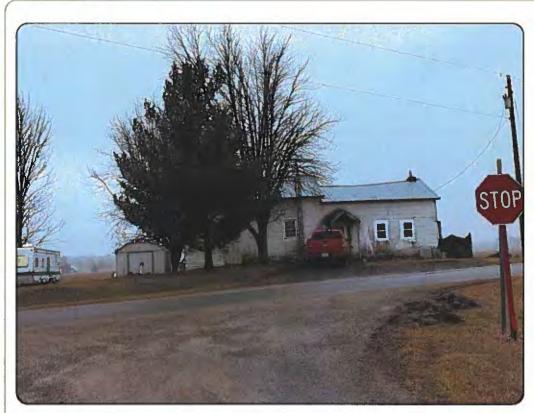
Sheet 151 of 355

Resource Name: A one-story vernacular residence.

Meets NRHP Eligibility
Criteria: No

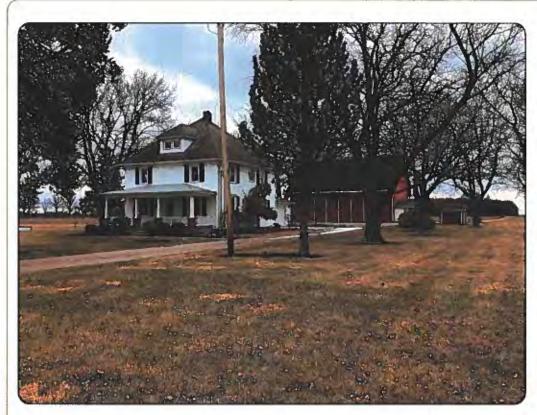
Sheet 152 of 355

Resource Name: A two-story foursquare-style house with a gable-roofed barn.

Meets NRHP Eligibility Criteria: No

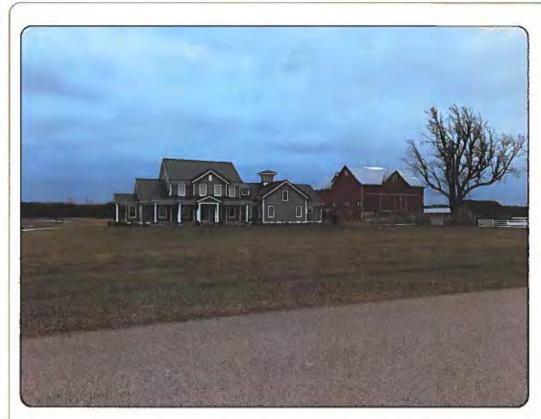
Sheet 153 of 355

Resource Name: A contemporary residence with several historic outbuildings including a large gable-roofed barn

Meets NRHP Eligibility Criteria: No

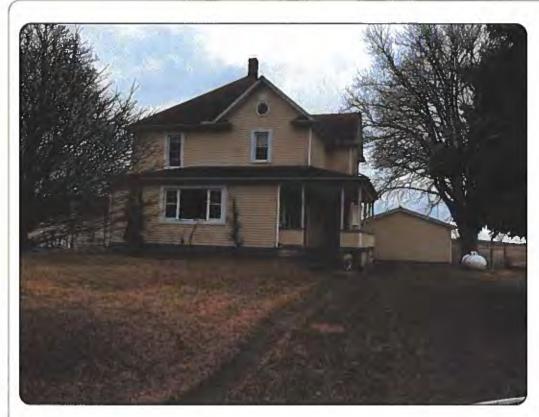
Sheet 154 of 355

Resource Name: A two-story foursquare-style residence with a pole barn.

Meets NRHP Eligibility

Criteria: No

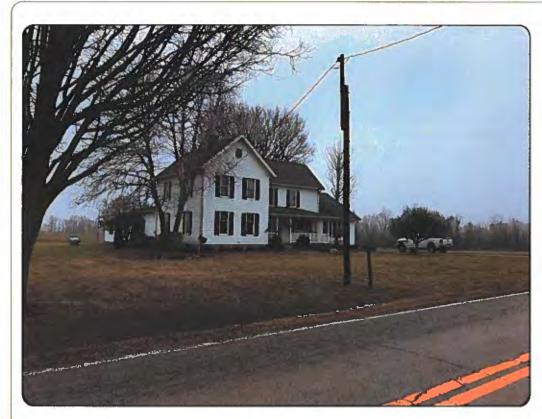
Sheet 155 of 355

Resource Name: A two-story vernacular residence.

Meets NRHP Eligibility

Criteria: No

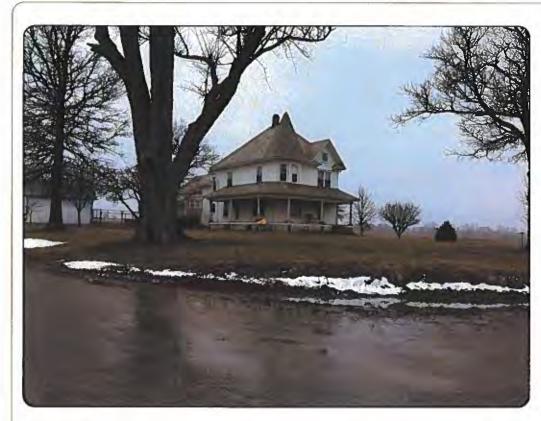
Sheet 156 of 355

Resource Name: A farmstead consisting of a two-story Queen Anne-style residence, three-bay barn, and outbuildings.

Meets NRHP Eligibility Criteria: No

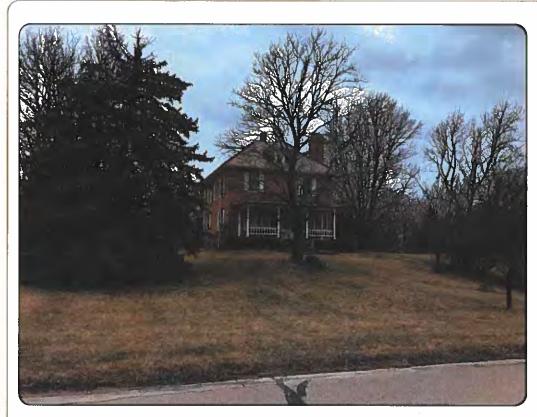
Sheet 157 of 355

Resource Name: A two-story foursquare-style residence with a gambrel-roofed bam.

Meets NRHP Eligibility

Criteria: No

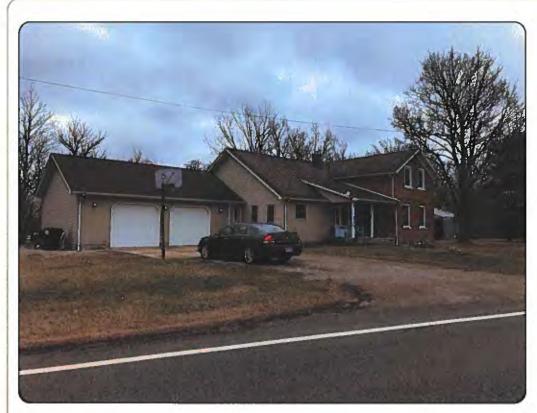
Sheet 158 of 355

Resource Name: A one-andone-half-story vernacular residence.

Meets NRHP Eligibility Criteria: No

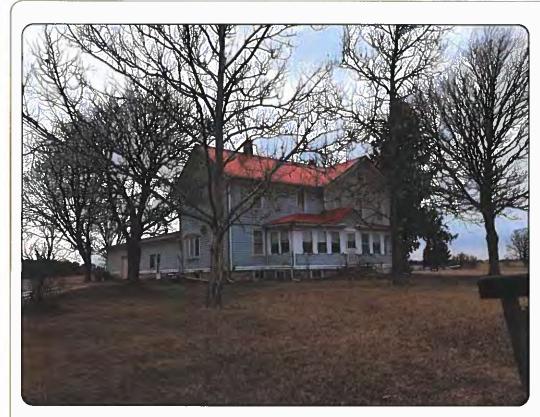
Sheet 159 of 355

Resource Name: A two-story vernacular residence and garage.

Meets NRHP Eligibility Criteria: No

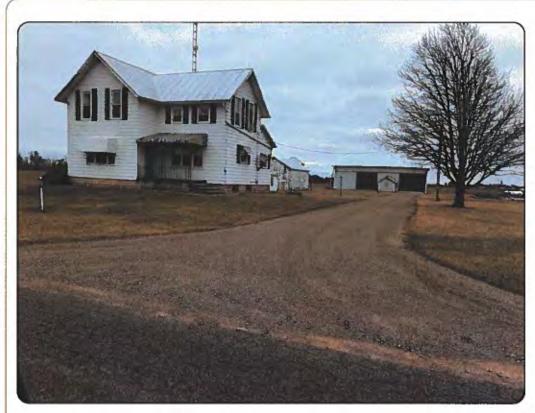
Sheet 160 of 355

Resource Name: A two-story vernacular residence and garage.

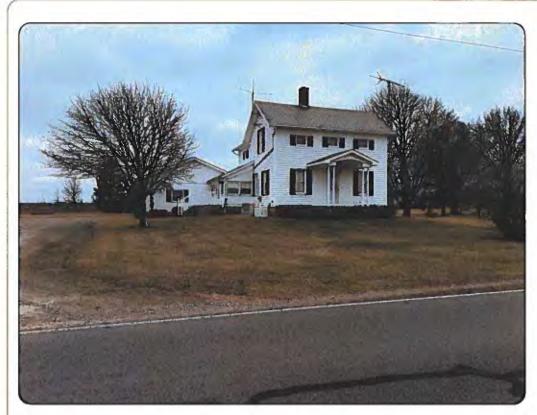
Sheet 161 of 355

Resource Name: A one-andone-half-story vernacular residence with outbuildings.

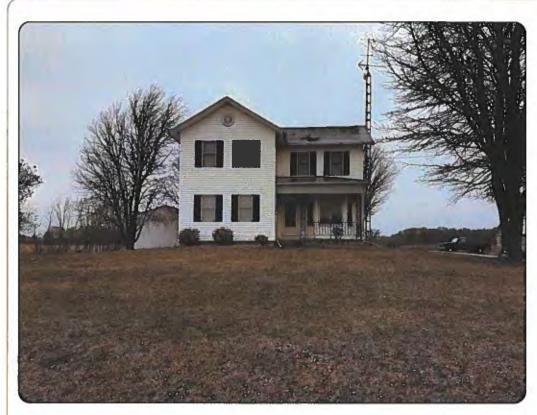
Sheet 162 of 355

Resource Name: A two-story vernacular residence and outbuildings.

Meets NRHP Eligibility Criteria: No

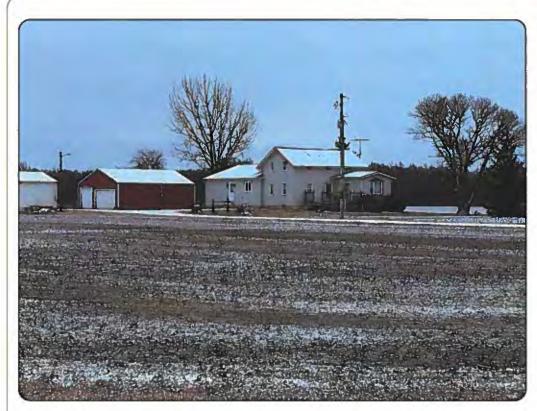
Sheet 163 of 355

Resource Name: A farmstead consisting of a oneand-one-half-story vernacular residence, a Quonset hut, and other outbuildings.

Meets NRHP Eligibility
Criteria: No

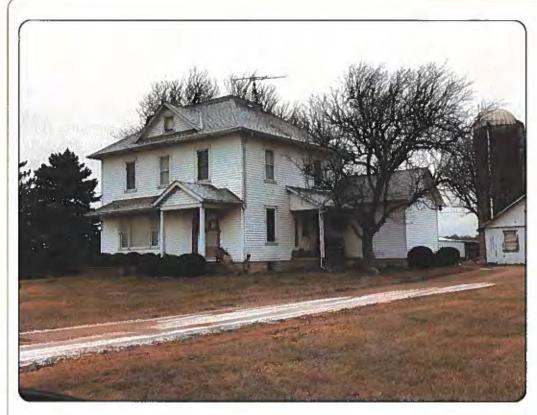
Sheet 164 of 355

Resource Name: A farmstead consisting of a two-story Italianate-style residence and outbuildings.

Meets NRHP Eligibility Criteria: No

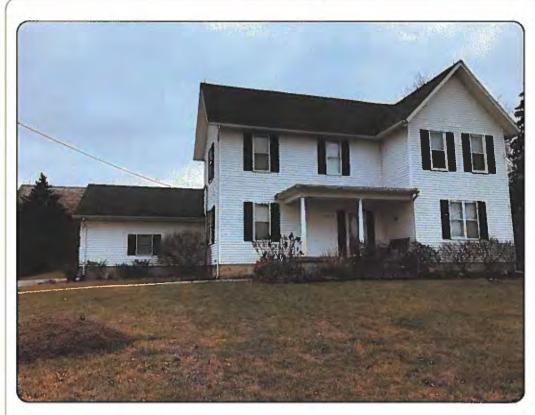
Sheet 165 of 355

Resource Name: A two-story vernacular residence and bank barn.

Meets NRHP Eligibility Criteria: No

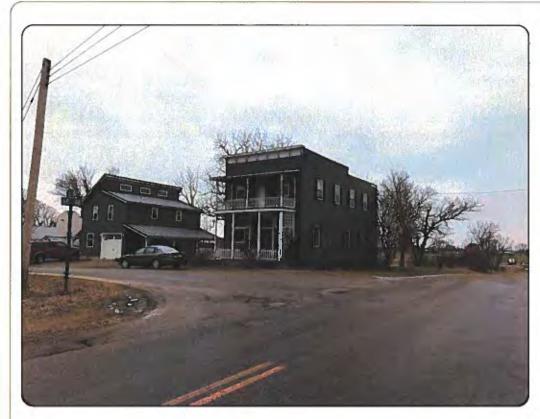
Sheet 166 of 355

Resource Name: A two-story Italianate residence, formerly a storefront, with a modern garage.

Meets NRHP Eligibility Criteria: No

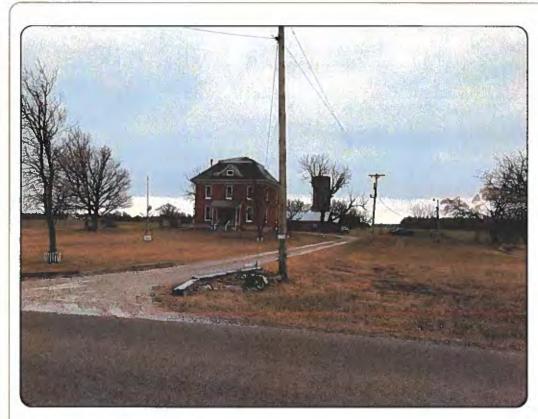
Sheet 167 of 355

Resource Name: A two-story Italianate-style residence with outbuildings.

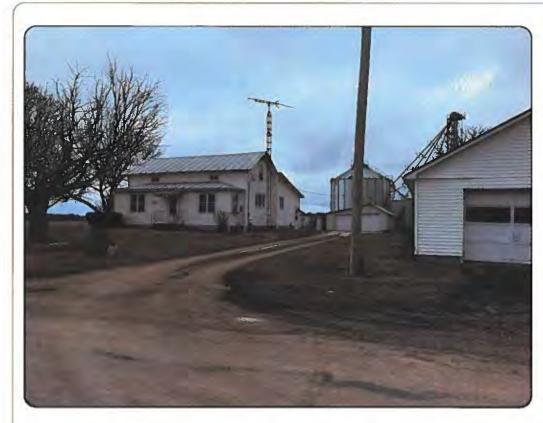
Sheet 168 of 355

Resource Name: A farmstead consisting of a one-and-one-half-story residence, a bank barn, and other outbuildings.

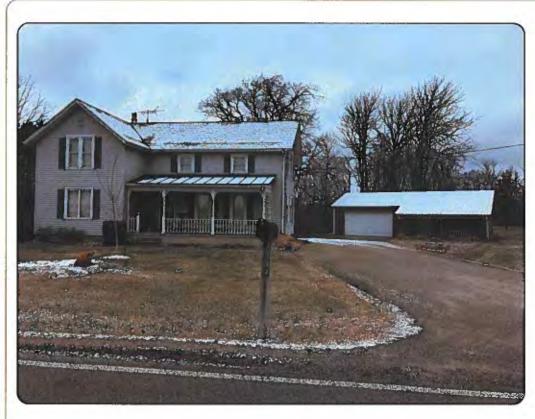
Sheet 170 of 355

Resource Name: A two-story vernacular residence and English barn.

Meets NRHP Eligibility Criteria: No

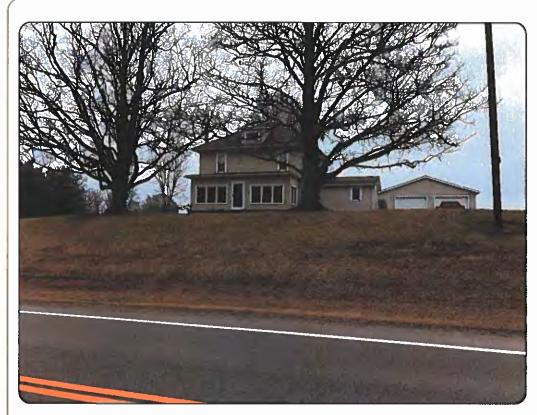
Sheet 171 of 355

Resource Name: A foursquare style residence with a three-bay barn.

Meets NRHP Eligibility Criteria: No

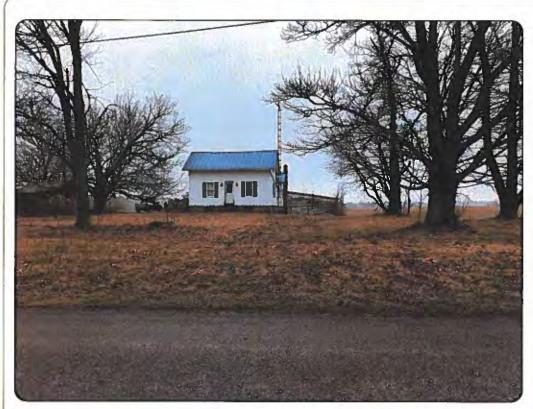
Sheet 172 of 355

Resource Name: A singlestory vernacular residence.

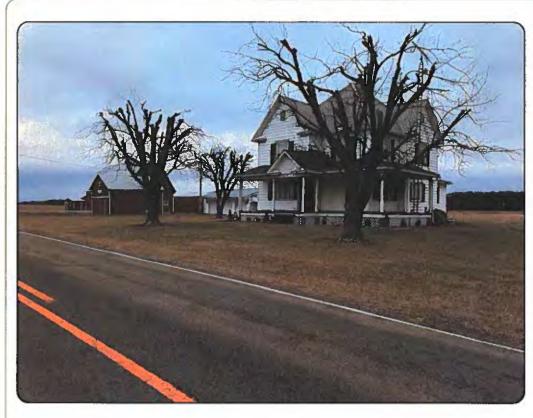
Sheet 173 of 355

Resource Name: A farmstead consisting of an early-twentieth-century residence, a gambrel-roofed barn, and other outbuildings.

Meets NRHP Eligibility Criteria: No

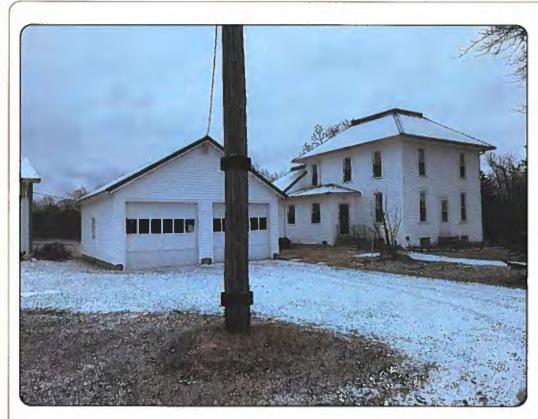
Sheet 174 of 355

Resource Name: A two-story Italianate-style residence with a garage and pole barn.

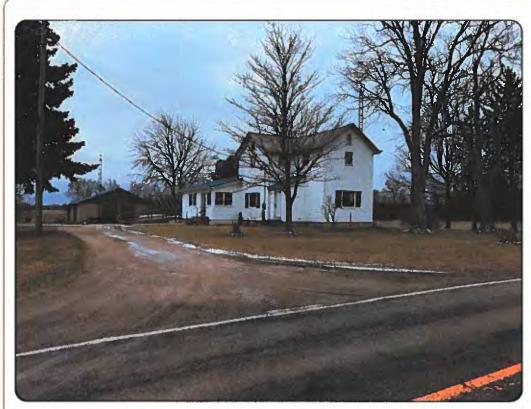
Sheet 175 of 355

Resource Name: A farmstead consisting of a twostory vernacular residence, an English barn, and other outbuildings.

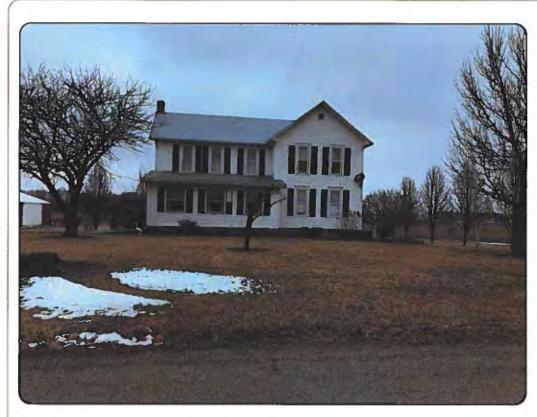
Sheet 176 of 355

Resource Name: A farmstead consisting of a twostory vernacular residence and modern outbuildings.

Meets NRHP Eligibility Criteria: No

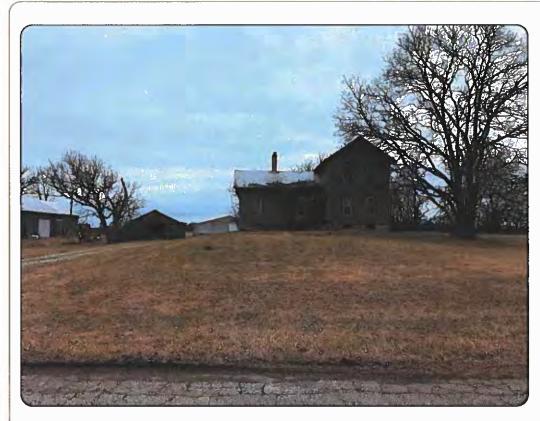
Sheet 177 of 355

Resource Name: A farmstead consisting of a twostory vernacular residence, and English barn, and other outbuildings.

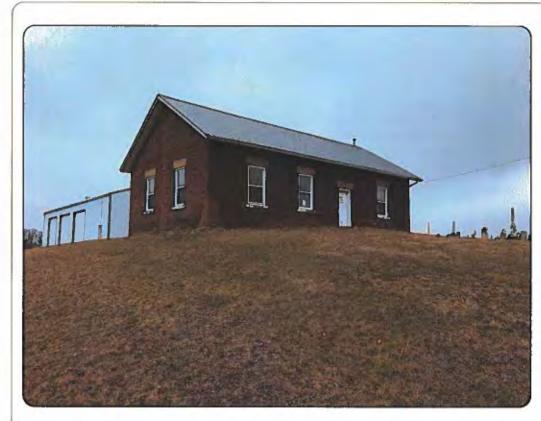
Sheet 178 of 355

Resource Name: A one-story brick former school house with a metal pole barn.

Criteria: Yes

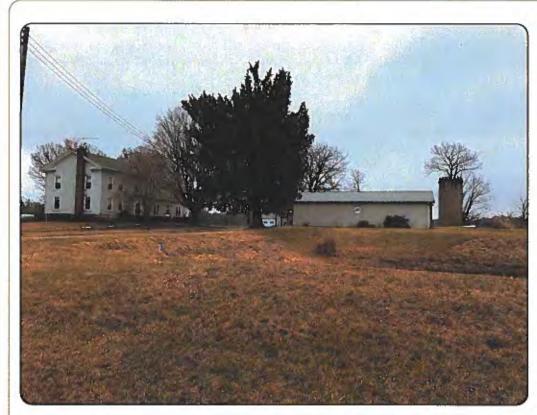
Sheet 179 of 355

Resource Name: A two-story Greek Revival-style residence with outbuildings.

Meets NRHP Eligibility Criteria: No

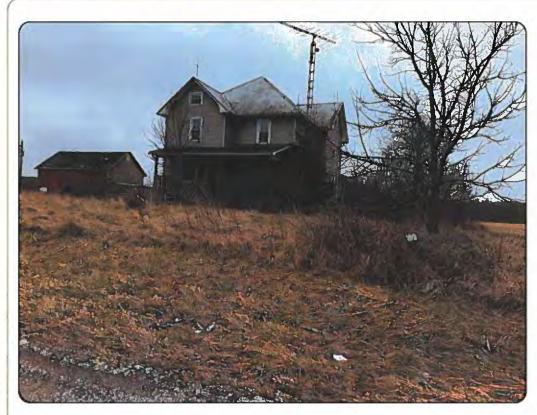
Sheet 180 of 355

Resource Name: A farmstead consisting of a two-story early-twentieth-century residence, an English barn, and other outbuildings.

Criteria: No

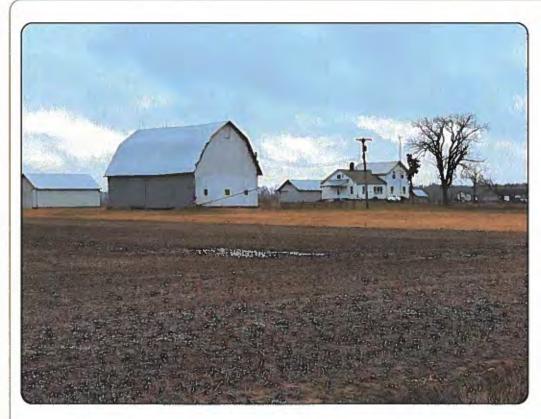
Sheet 181 of 355

Resource Name: A farmstead consisting of a oneand-one-half-story vernacular residence, a gambrel-roofed barn, and other outbuildings.

Criteria: No

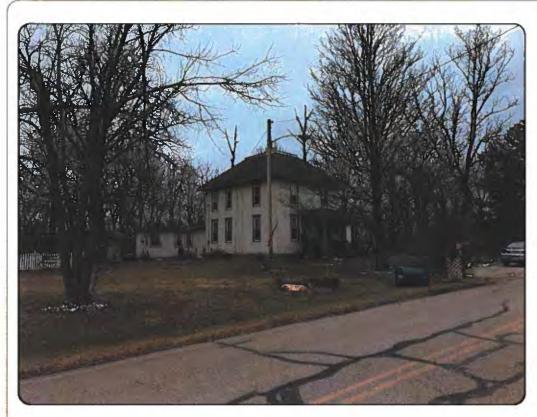
Sheet 182 of 355

Resource Name: A two-story Italianate-style residence and English barn.

Criteria: No

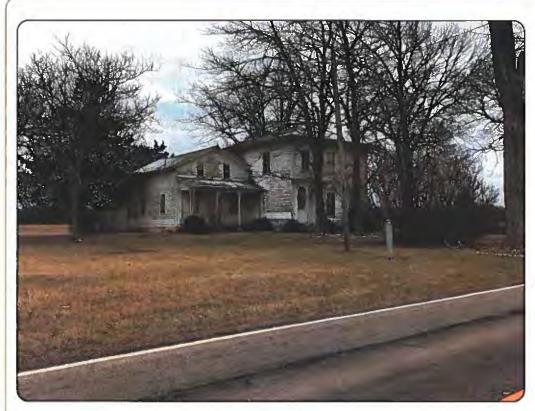
Sheet 183 of 355

Resource Name: A two-story Italianate-style residence with a gable-roofed wing.

Meets NRHP Eligibility Criteria: Yes

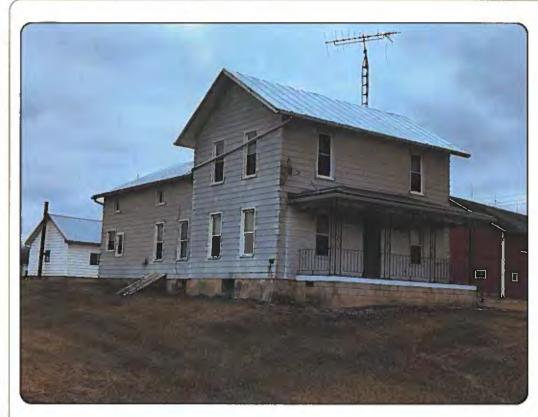
Sheet 184 of 355

Resource Name: A farmstead consisting of a twostory vernacular residence, an English barn, and other outbuildings.

Criteria: No

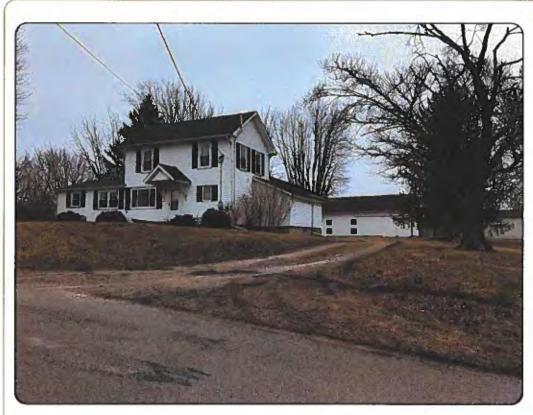
Sheet 185 of 355

Resource Name: A farmstead consisting of a two-story Colonial Revival-style house with an English barn and other outbuildings.

Meets NRHP Eligibility Criteria: No

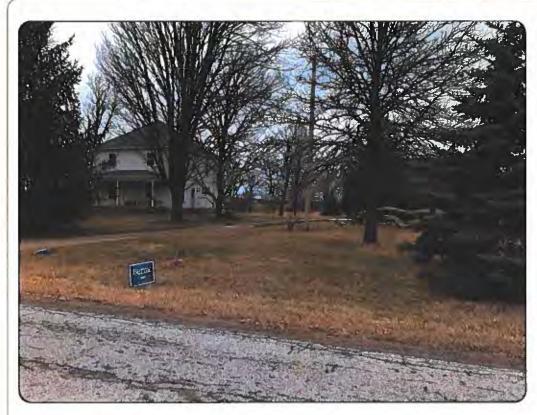
Sheet 186 of 355

Resource Name: A two-story Foursquare-style residence and English barn.

Meets NRHP Eligibility Criteria: No

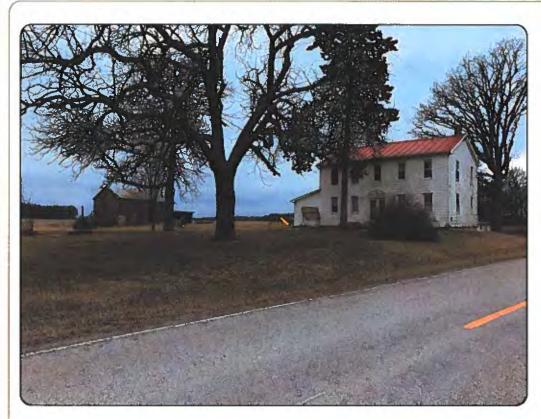
Sheet 187 of 355

Resource Name: A two-story Greek Revival-style residence and barn.

Meets NRHP Eligibility Criteria: No

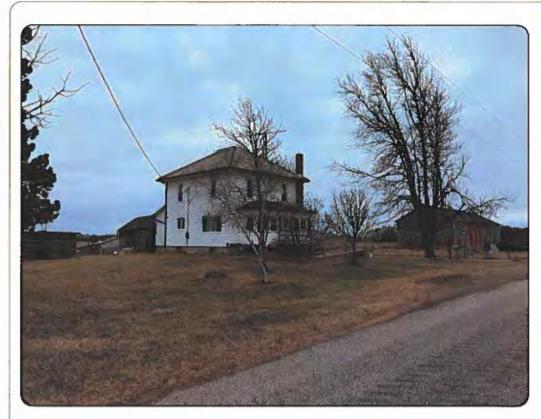
Sheet 188 of 355

Resource Name: A two-story vernacular residence and a hay barn.

Criteria: No

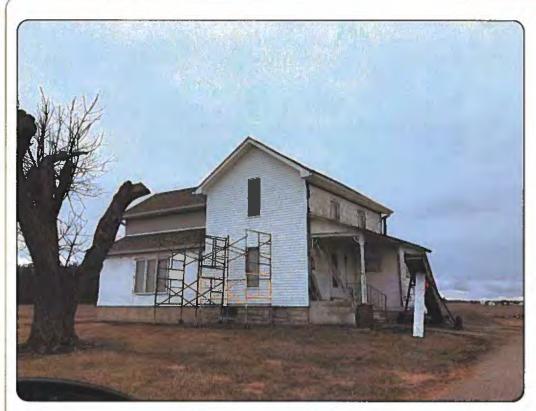
Sheet 189 of 355

Resource Name: A one-andone-half-story vernacular residence.

Criteria: No

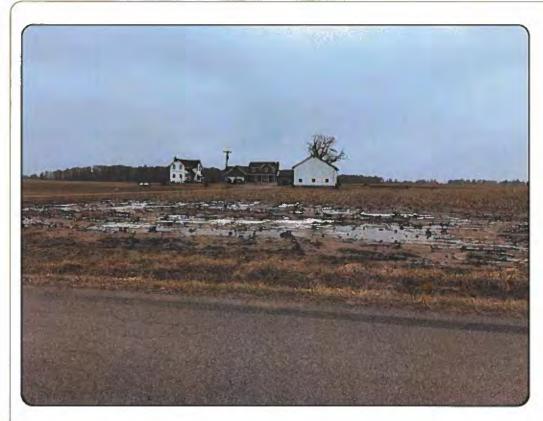
Sheet 190 of 355

Resource Name: A farmstead consisting of a twostory vernacular residence, a newly-built residence, an English barn, and a shed.

Criteria: No

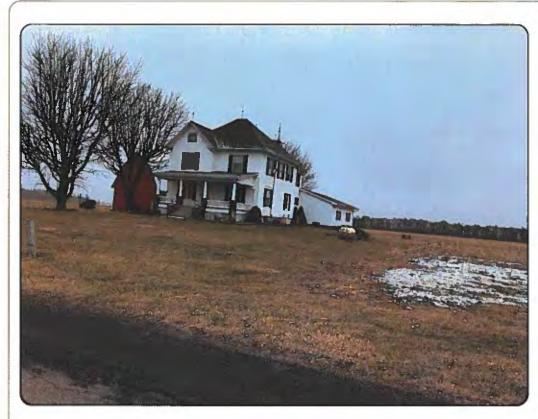
Sheet 191 of 355

Resource Name: A twostory Colonial Revival-style residence with a Gambrelroofed barn and a shed.

Meets NRHP Eligibility Criteria: No

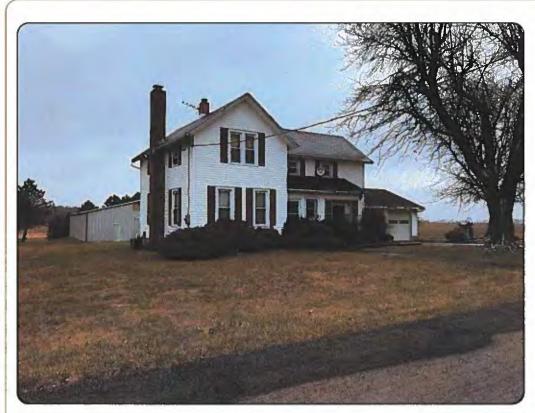
Sheet 192 of 355

Resource Name: A one-andone-half-story vernacular residence with outbuildings.

Criteria: No

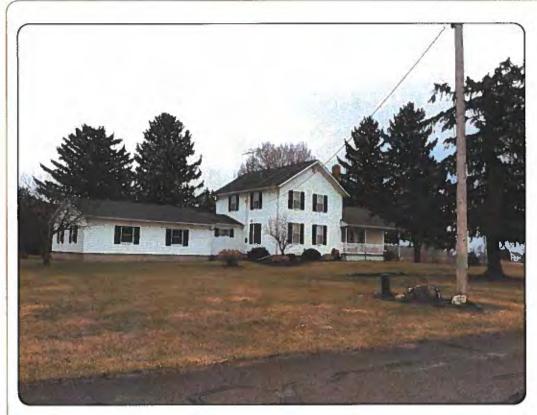
Sheet 193 of 355

Resource Name: A two-story vernacular residence.

Criteria: No

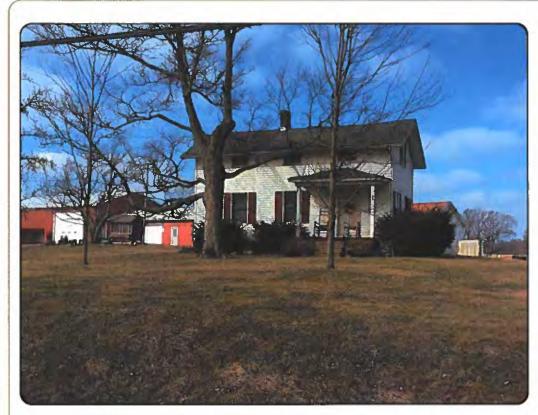
Sheet 194 of 355

Resource Name: A farmstead consisting of a oneand-one-half-story vernacular residence and outbuildings.

Meets NRHP Eligibility Criteria: No

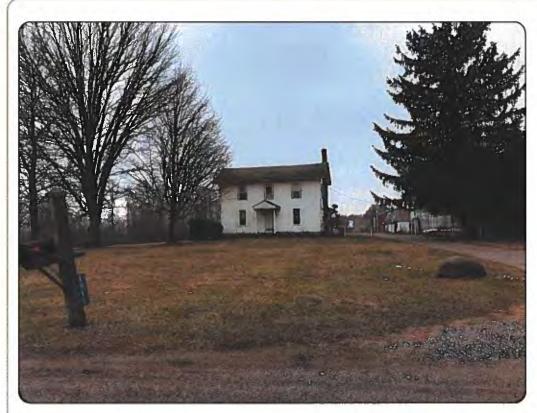
Sheet 195 of 355

Resource Name: A farmstead consisting of a two-story vernacular residence, barns, and outbuildings.

Meets NRHP Eligibility Criteria: No

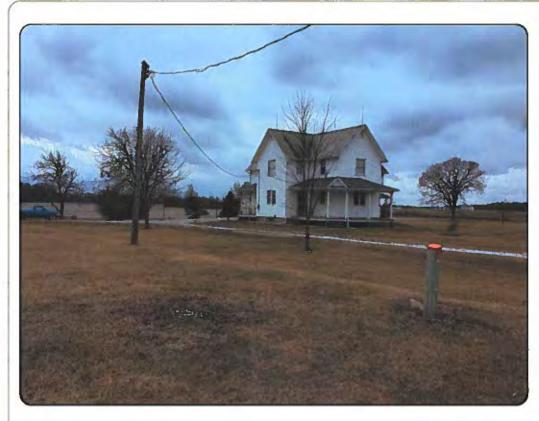
Sheet 196 of 355

Resource Name: A two-story vernacular residence with a bank barn and shed.

Criteria: No

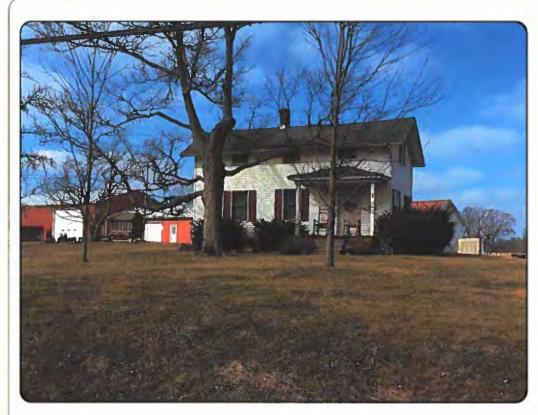
Sheet 197 of 355

Resource Name: A farmstead consisting of a oneand-one-half-story residence and outbuildings.

Criteria: No

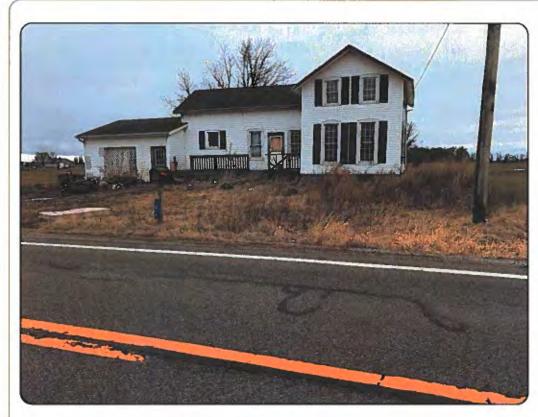
Sheet 198 of 355

Resource Name: A two-story vernacular house over 50 years old and not eligible

Meets NRHP Eligibility Criteria: No

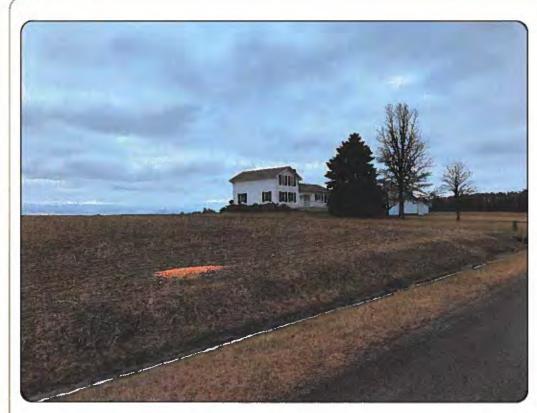
Sheet 199 of 355

Resource Name: A farmstead consisting of a oneand-one-half-story residence and outbuildings.

Meets NRHP Eligibility

Criteria: No

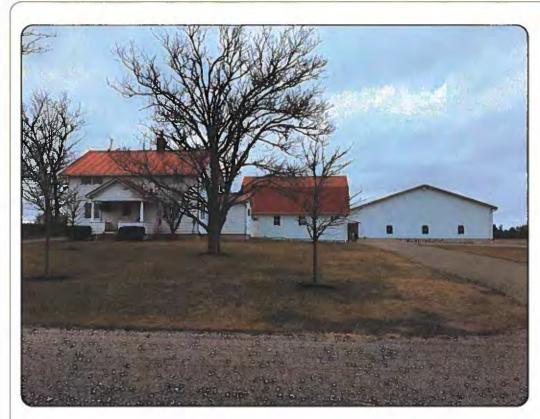
Sheet 200 of 355

Resource Name: A one-andone-half-story vernacular residence with outbuildings.

Meets NRHP Eligibility

Criteria: No

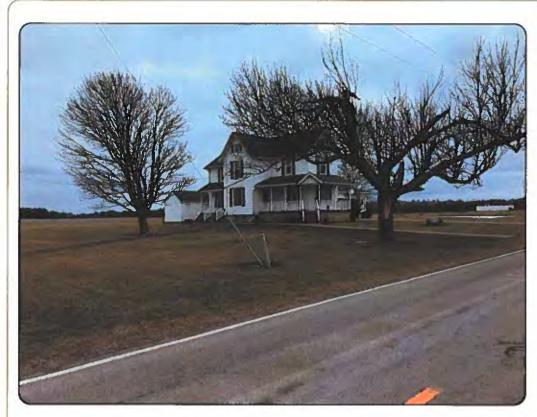
Sheet 201 of 355

Resource Name: A farmstead consisting of a twostory vernacular residence, an English barn, and other outbuildings.

Meets NRHP Eligibility

Criteria: No

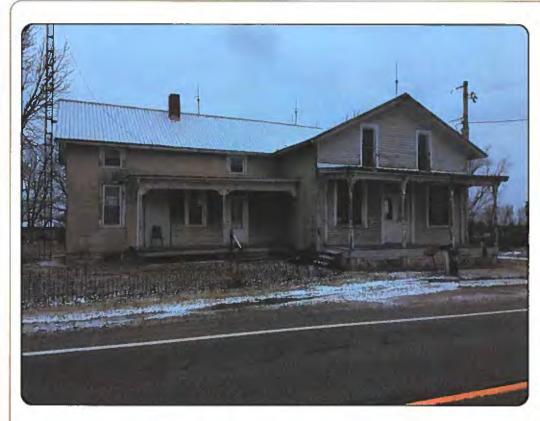
Sheet 202 of 355

Resource Name: A one-andone-half-story Greek Revivalstyle residence and former storefront.

Meets NRHP Eligibility Criteria: No

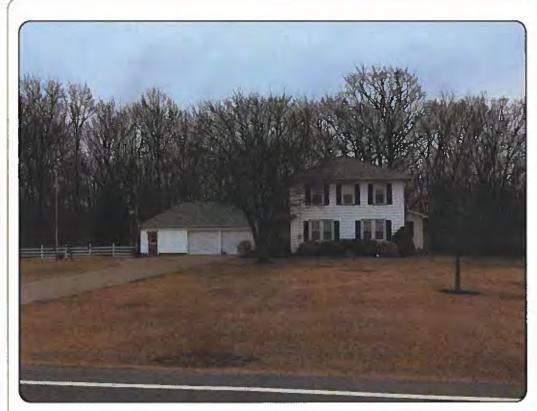
Sheet 203 of 355

Resource Name: A two-story Foursquare-style residence and garage.

Meets NRHP Eligibility Criteria: No

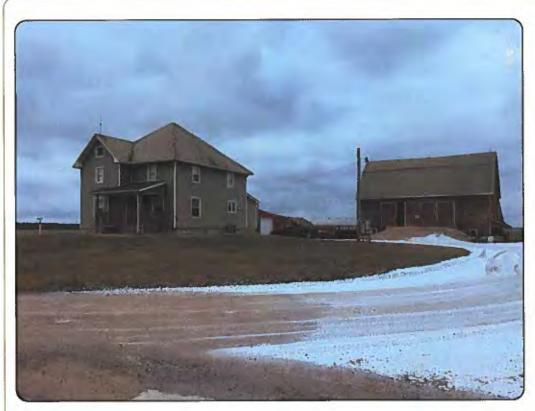
Sheet 204 of 355

Resource Name: A farmstead consisting of a Foursquare-style residence, a gambrel-roofed barn, and other outbuildings.

Meets NRHP Eligibility Criteria: No

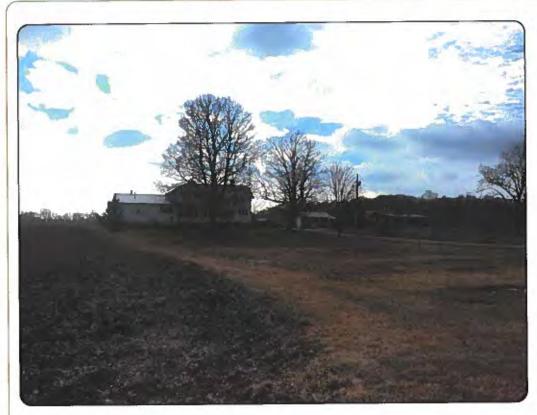
Sheet 205 of 355

Resource Name: A one-andone-half-story vernacular residence with outbuildings.

Meets NRHP Eligibility Criteria: No

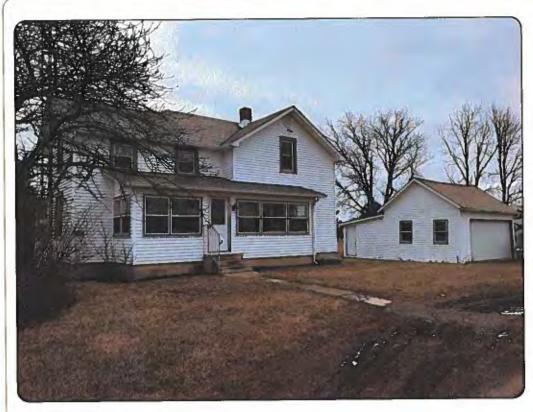
Sheet 206 of 355

Resource Name: A farmstead consisting of a oneand-one-half-story vernacular residence, an English barn, and other outbuildings.

Meets NRHP Eligibility

Criteria: No

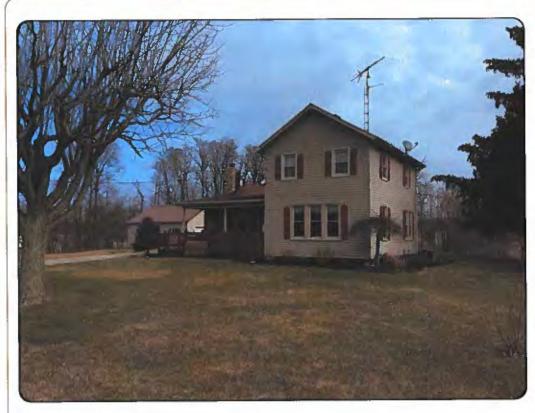
Sheet 207 of 355

Resource Name: A two-story vernacular residence and garage.

Meets NRHP Eligibility Criteria: No

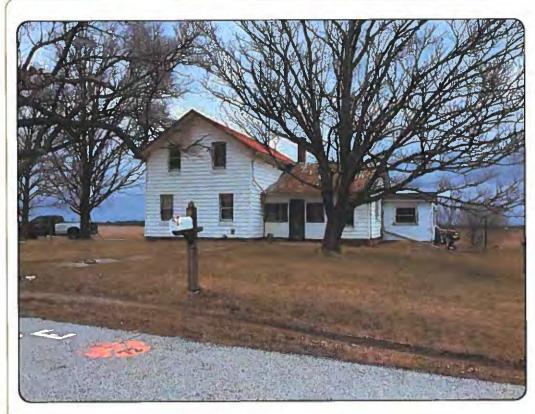
Sheet 208 of 355

Resource Name: A one-andone-half-story vernacular residence with a barn and other outbuildings.

Meets NRHP Eligibility Criteria: No

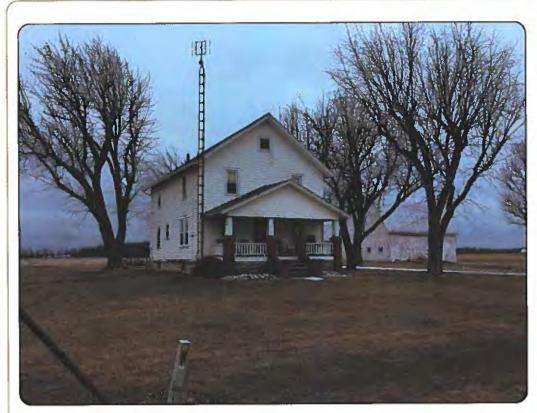
Sheet 209 of 355

Resource Name: A farmstead consisting of a two-story vernacular residence, a gambrel-roofed barn, and other outbuildings.

Meets NRHP Eligibility Criteria: No

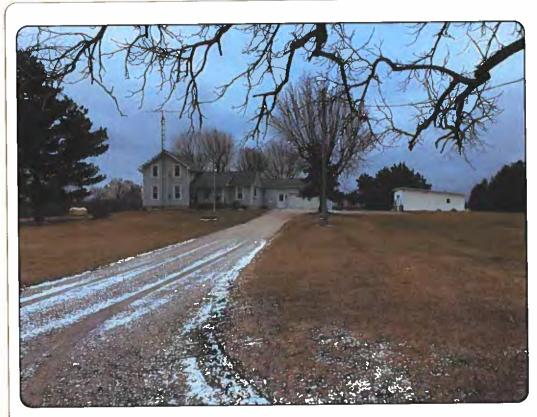
Sheet 210 of 355

Resource Name: A two-story vernacular residence and garage.

Meets NRHP Eligibility

Criteria: No

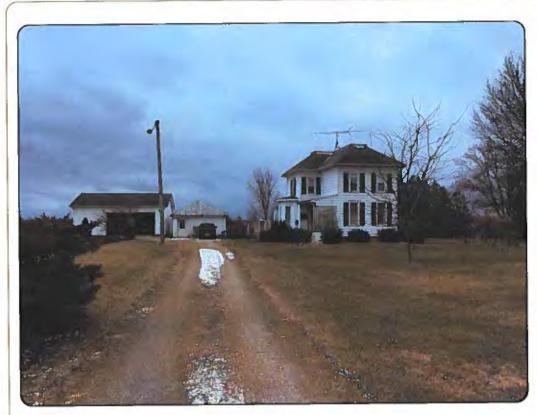
Sheet 211 of 355

Resource Name: A two-story Italianate-style residence and outbuildings.

Meets NRHP Eligibility
Criteria: No

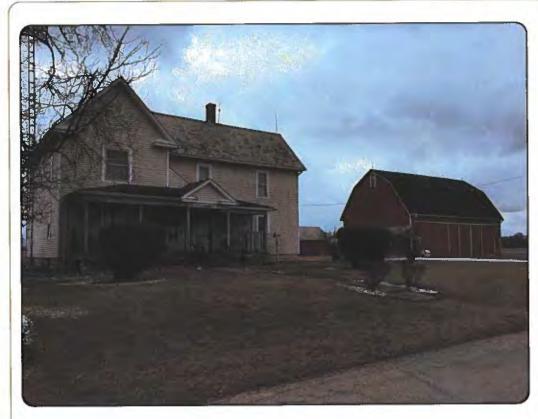
Sheet 212 of 355

Resource Name: A farmstead consisting of a twostory vernacular residence with a gambrel-roofed barn and other outbuildings.

Meets NRHP Eligibility

Criteria: No

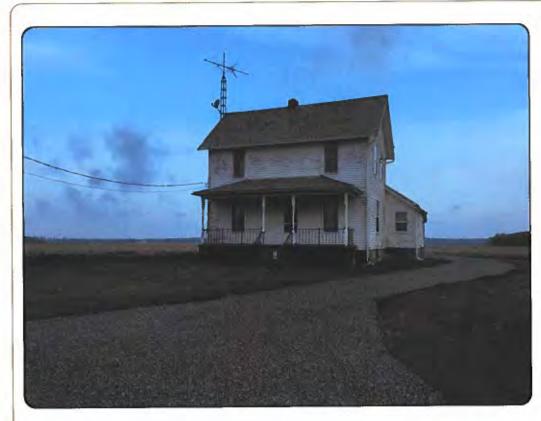
Sheet 213 of 355

Resource Name: A two-story vernacular residence.

Meets NRHP Eligibility Criteria: No

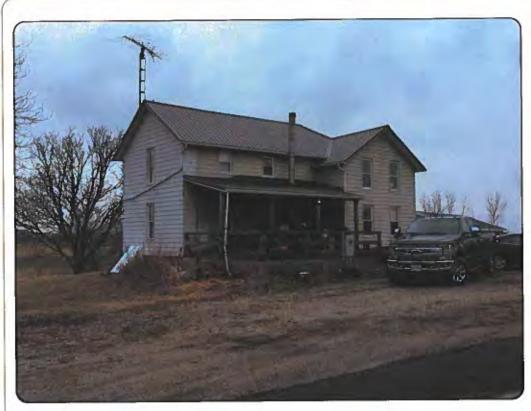
Sheet 214 of 355

Resource Name: A two-story vernacular residence.

Meets NRHP Eligibility
Criteria: No

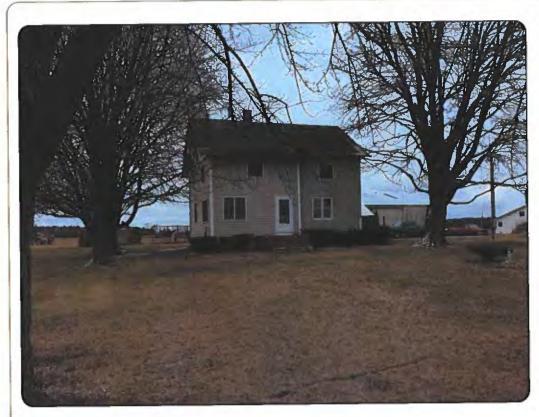
Sheet 215 of 355

Resource Name: A two-story vernacular residence with a barn and outbuildings.

Meets NRHP Eligibility Criteria: No

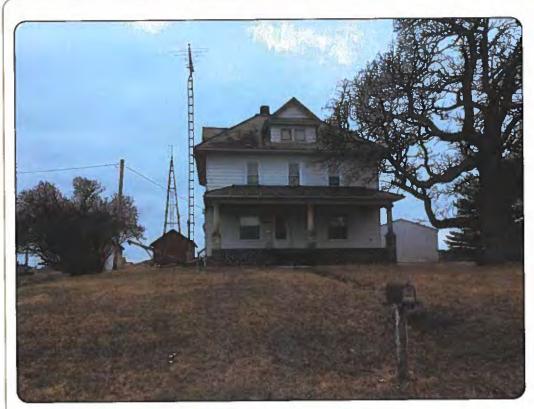
Sheet 216 of 355

Resource Name: A two-story Foursquare-style residence with outbuildings.

Meets NRHP Eligibility

Criteria: No

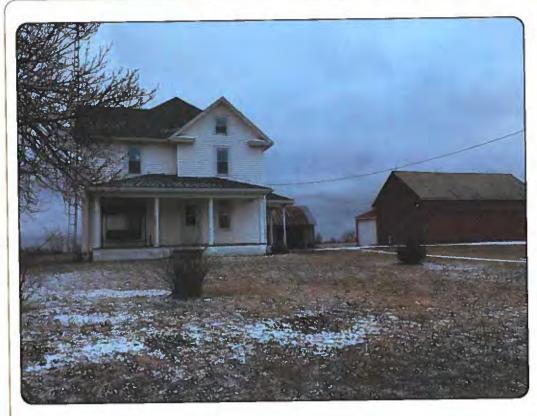
Sheet 217 of 355

Resource Name: A farmstead consisting of a twostory vernacular residence, an English barn, and outbuildings.

Meets NRHP Eligibility

Criteria: No

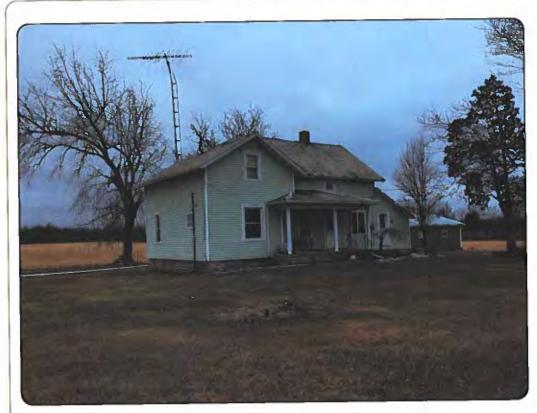
Sheet 218 of 355

Resource Name: A one-andone-half-story vernacular residence and English barn.

Criteria: No

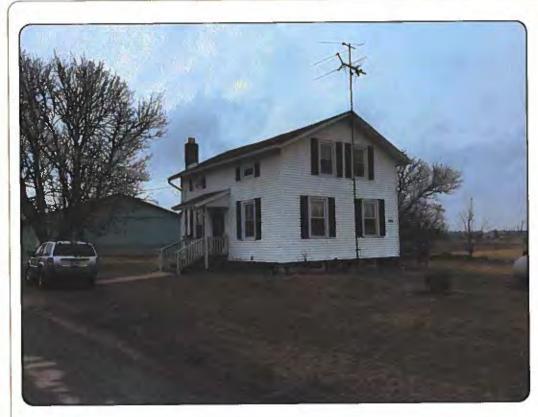
Sheet 219 of 355

Resource Name: A one-andone-half-story vernacular residence.

Meets NRHP Eligibility Criteria: No

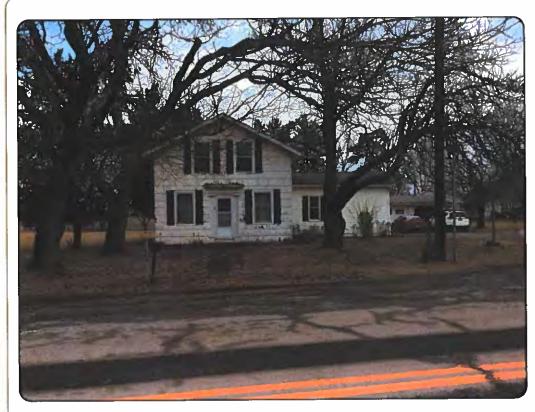
Sheet 220 of 355

Resource Name: A one-andone-half-story Greek Revivalstyle residence.

Meets NRHP Eligibility
Criteria: No
