Historic Resources Survey
October 2020
Environmental Design & Research
(Submitted to State Historic Preservation Office
January 5, 2021)

RE: Emerson Creek Wind Farm

Our office has reviewed the revised Historic Resources Survey Report, Emerson Creek Wind Farm, Groton and Oxford Townships, Erie County, Ohio, Lyme, Ridgefield, Sherman, Norwich, and Richmond Townships, Huron County, Ohio, prepared by Environmental Design and Research (EDR) in October 2020. The project is a 297.66-megawatt wind energy facility consisting of up to 87 wind turbine generators and associated infrastructure.

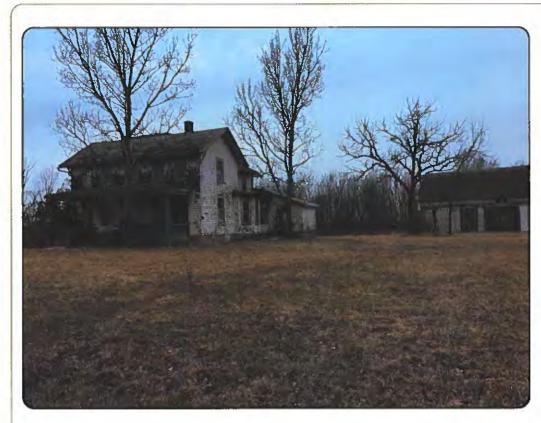
Sheet 221 of 355

Resource Name: A two-story Folk Victorian-style residence and English barn.

Meets NRHP Eligibility
Criteria: Yes

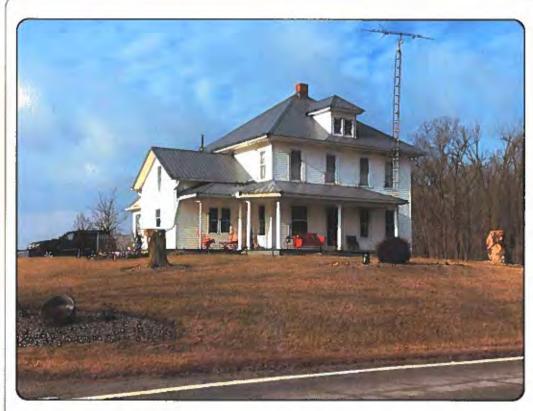
Sheet 222 of 355

Resource Name: A two-story Foursquare-style residence.

Meets NRHP Eligibility
Criteria: No

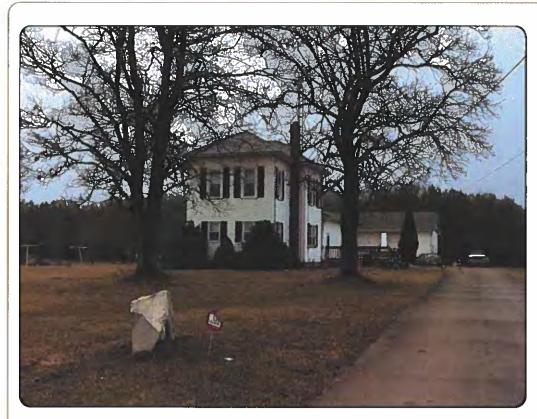
Sheet 223 of 355

Resource Name: A two-store Italianate-style residence and barn.

Meets NRHP Eligibility Criteria: No

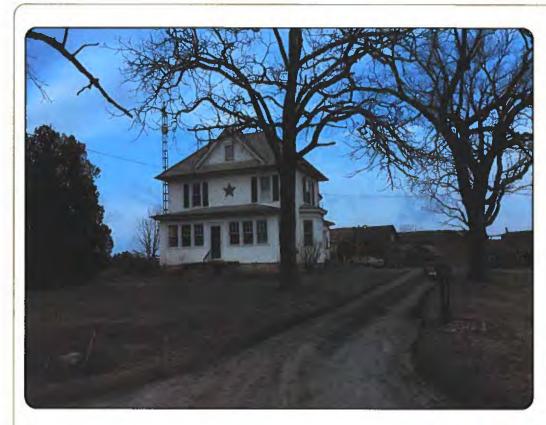
Sheet 224 of 355

Resource Name: A farmstead consisting of a Foursquarestyle residence, barns, and other outbuildings.

Criteria: No

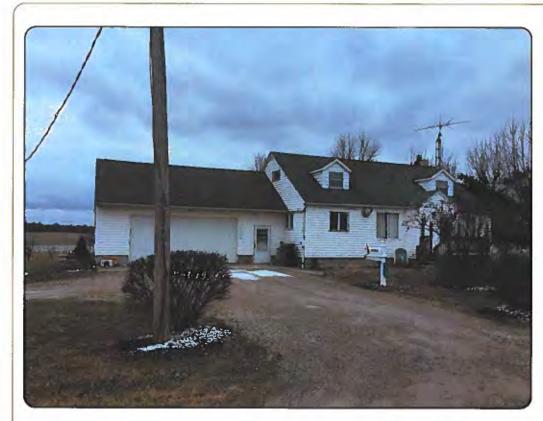
Sheet 225 of 355

Resource Name: A one-andone-half-story Cape Cod-style residence.

Meets NRHP Eligibility Criteria: No

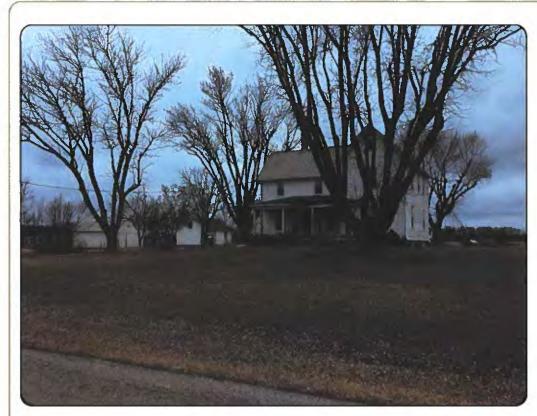
Sheet 226 of 355

Resource Name: A farmstead consisting of a twostory Folk Victorian residence, an English barn, and other outbuildings.

Criteria: No

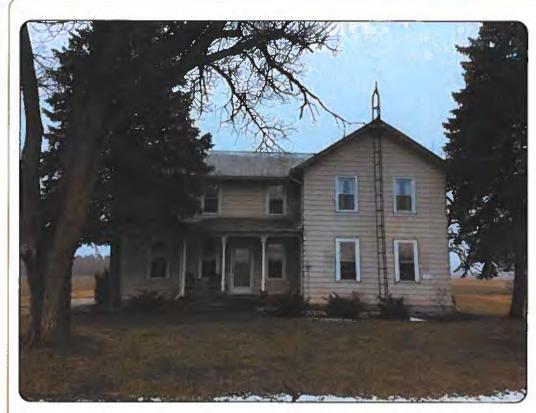
Sheet 227 of 355

Resource Name: A two-story Folk Victorian-style residence.

Meets NRHP Eligibility
Criteria: No

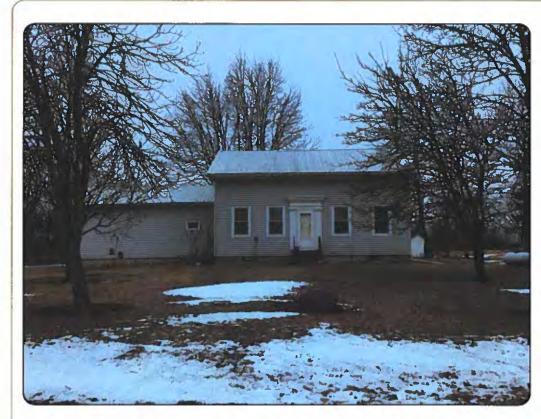
Sheet 228 of 355

Resource Name: A singlestory Greek Revival-Style residence.

Meets NRHP Eligibility
Criteria: No

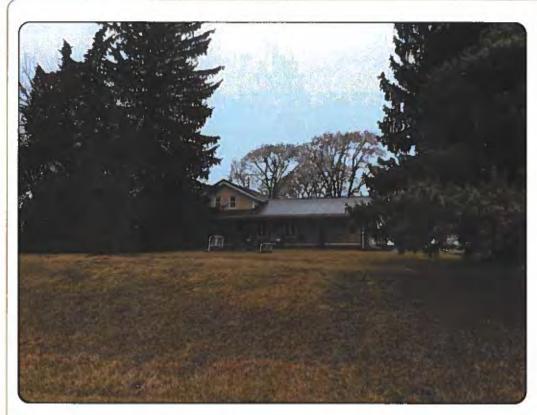
Sheet 229 of 355

Resource Name: A one-andone-half-story vernacular residence.

Criteria: No

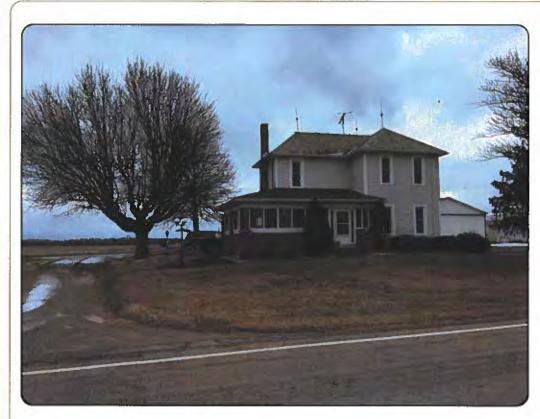
Sheet 230 of 355

Resource Name: A two-story Italianate-style residence and outbuildings.

Meets NRHP Eligibility Criteria: No

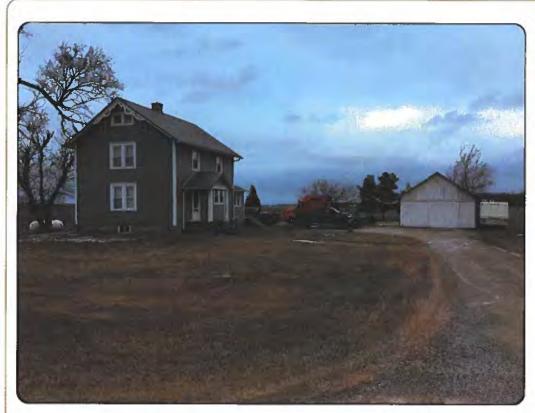
Sheet 231 of 355

Resource Name: A two-story vernacular residence, English barn, and shed.

Criteria: No

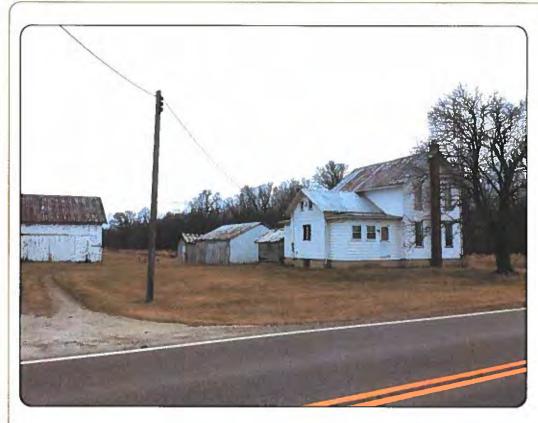
Sheet 232 of 355

Resource Name: A farmstead consisting of a two-story vernacular residence, English barn, and other outbuildings.

Criteria: No

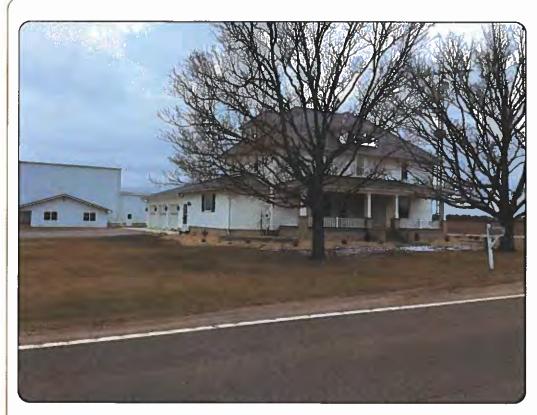
Sheet 233 of 355

Resource Name: A farmstead consisting of a Colonial Revival-style residence and pole barns.

Meets NRHP Eligibility Criteria: No

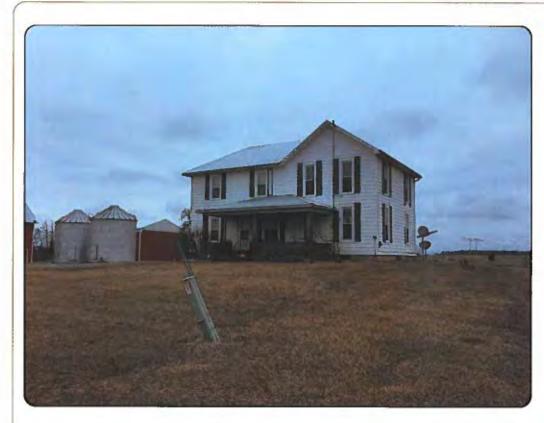
Sheet 234 of 355

Resource Name: A farmstead consisting of a twostory vernacular residence and outbuildings.

Meets NRHP Eligibility Criteria: No

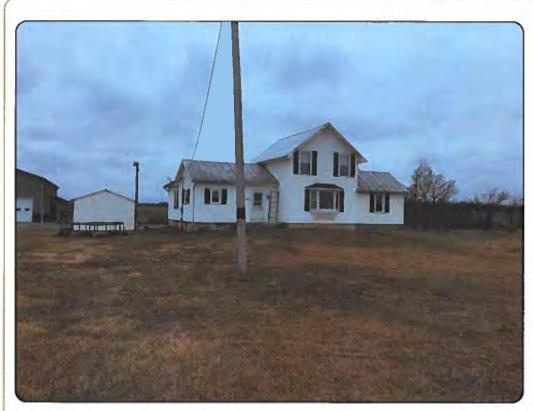
Sheet 235 of 355

Resource Name: A one-andone-half-story vernacular residence with outbuildings.

Criteria: No

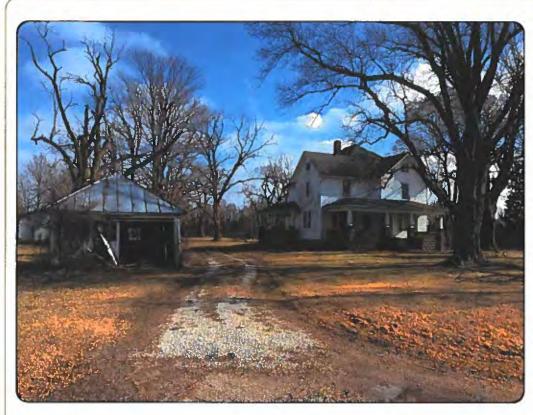
Sheet 236 of 355

Resource Name: A two-story vernacular residence and garage.

Criteria: No

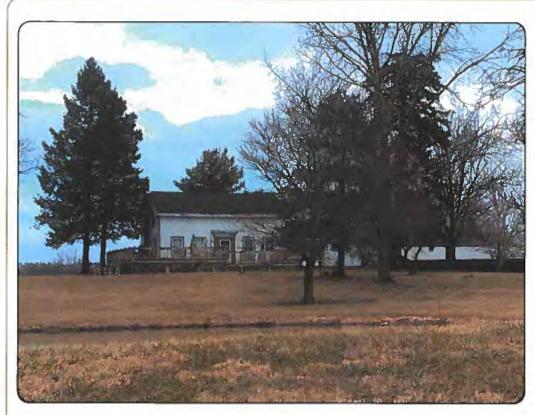
Sheet 237 of 355

Resource Name: A one-story vernacular residence with outbuildings.

Criteria: No

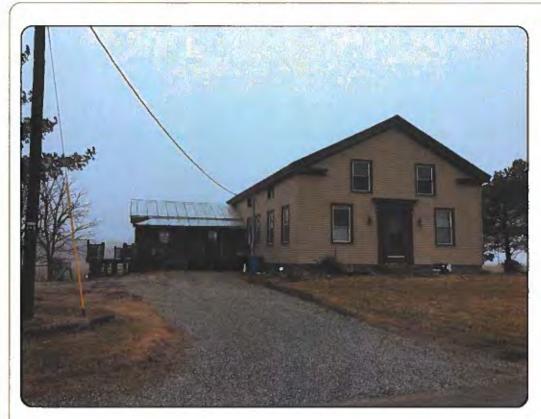
Sheet 238 of 355

Resource Name: A one-andone-half-story Greek Revivalstyle residence and garage.

Meets NRHP Eligibility Criteria: No

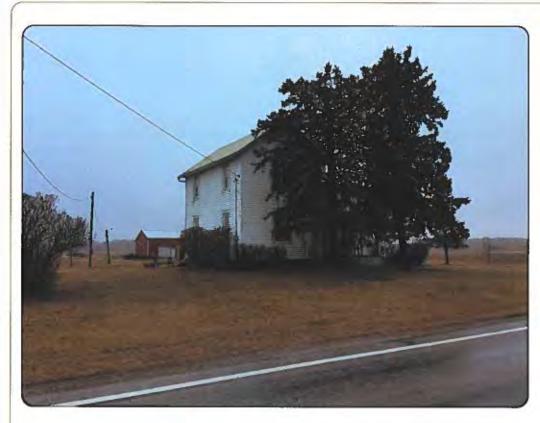
Sheet 239 of 355

Resource Name: A two-story vernacular residence and outbuildings.

Meets NRHP Eligibility Criteria: No

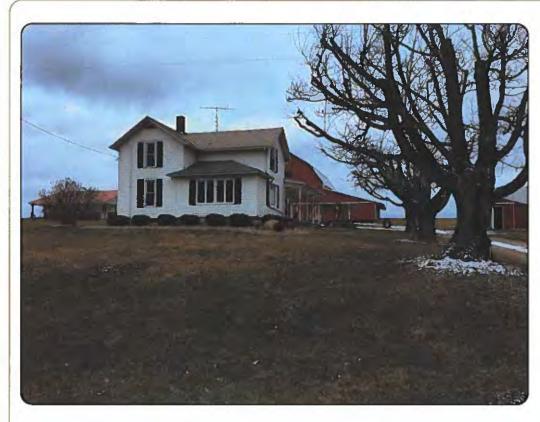
Sheet 240 of 355

Resource Name: A farmstead consisting of a twostory vernacular residence, a gambrel-roofed barn, and other outbuildings.

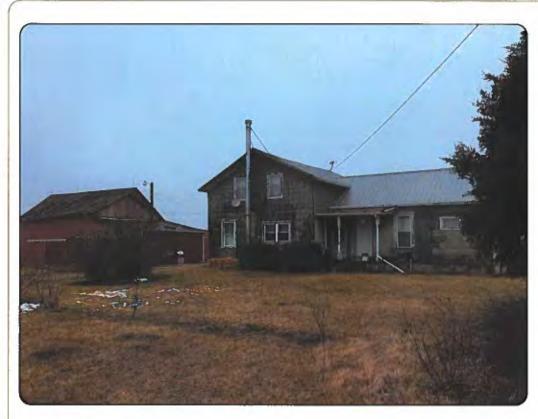
Sheet 241 of 355

Resource Name: A one-andone-half-story vernacular residence and an English barn.

Meets NRHP Eligibility Criteria: No

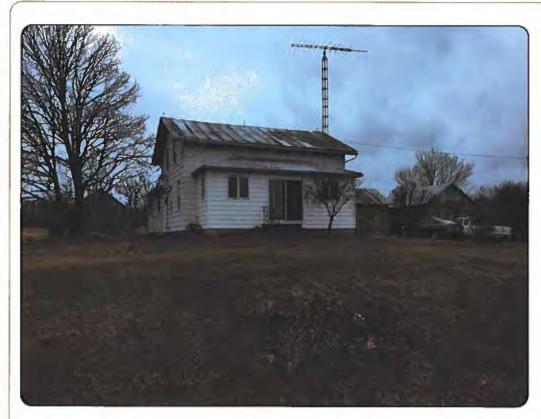
Sheet 242 of 355

Resource Name: A oneand-one-half-story Greek Revival-style residence and outbuildings.

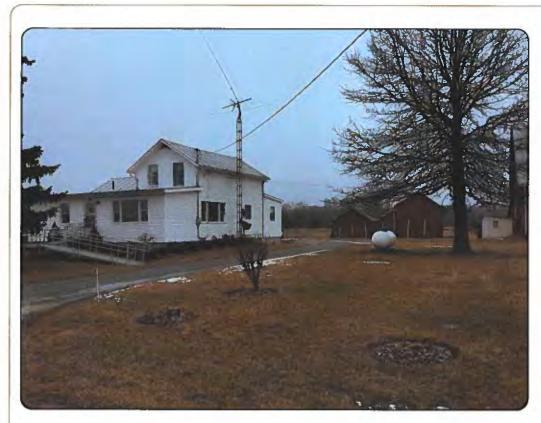
Sheet 243 of 355

Resource Name: A farmstead consisting of a oneand-one-half-story vernacular residence, a gambrel-roofed barn, and other outbuildings.

Meets NRHP Eligibility Criteria: No

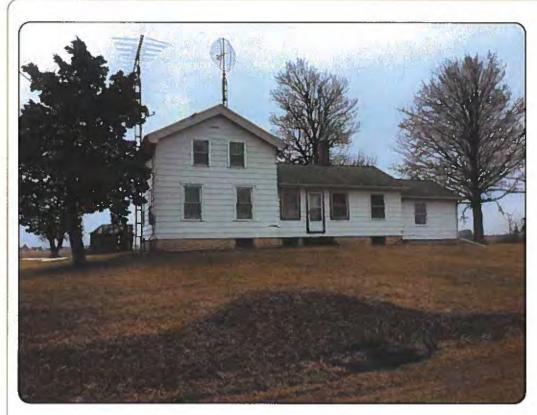
Sheet 244 of 355

Resource Name: A one-andone-half-story vernacular residence.

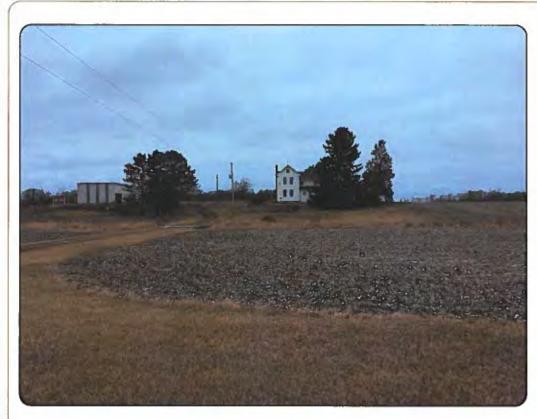
Sheet 245 of 355

Resource Name: A farmstead consisting of a twostory vernacular residence and outbuildings.

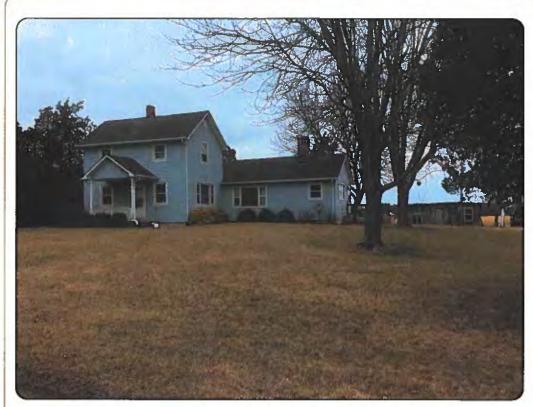
Sheet 246 of 355

Resource Name: A two-story vernacular residence.

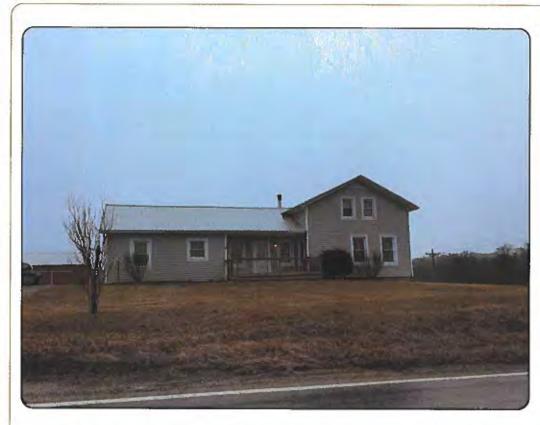
Sheet 247 of 355

Resource Name: A one-andone-half-story vernacular residence and barn.

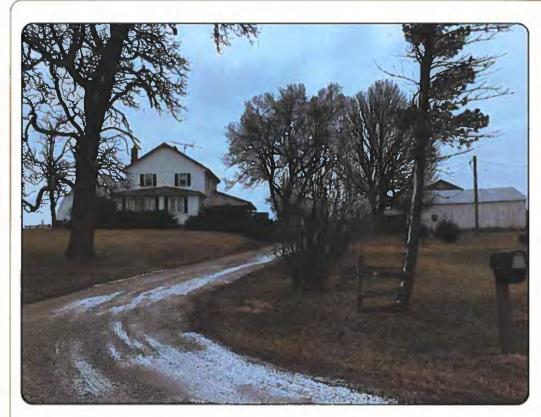
Sheet 248 of 355

Resource Name: A farmstead consisting of a twostory vernacular residence, a Quonset hut, an English barn, and other outbuildings.

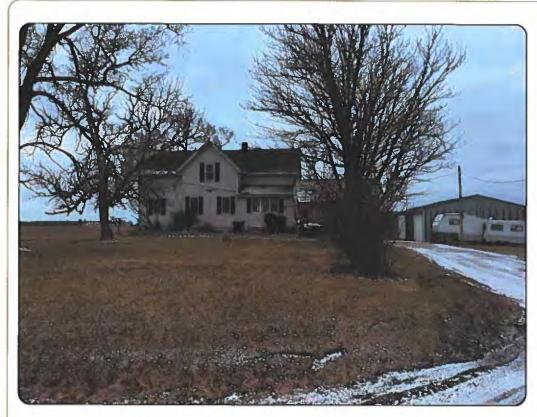
Sheet 249 of 355

Resource Name: A one-andone-half-story vernacular residence with two barns.

Meets NRHP Eligibility Criteria: No

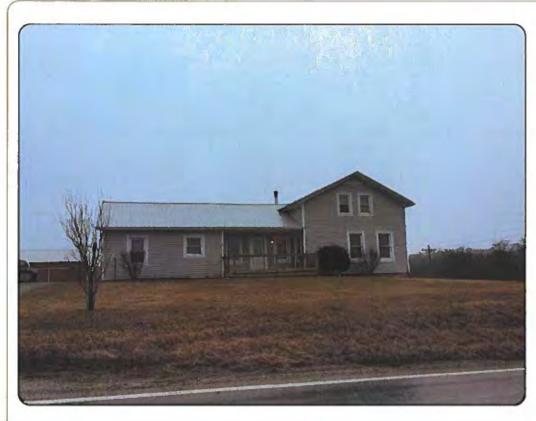
Sheet 250 of 355

Resource Name: A one-andone-half-story vernacular residence.

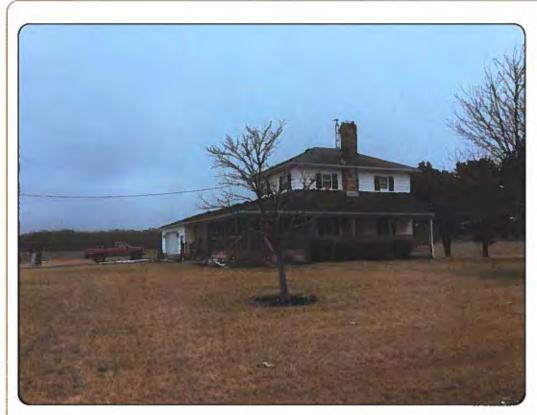
Sheet 251 of 355

Resource Name: A two-story vernacular residence.

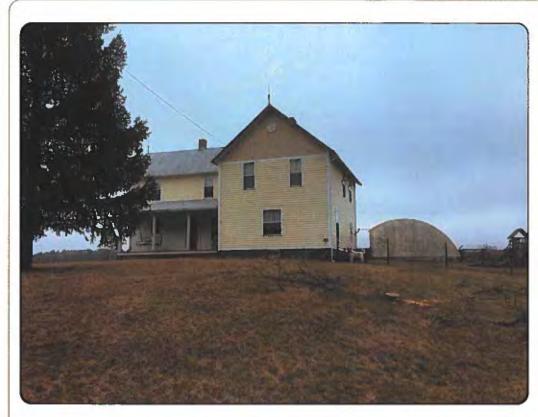
Sheet 252 of 355

Resource Name: A two-story vernacular residence.

Meets NRHP Eligibility
Criteria: No

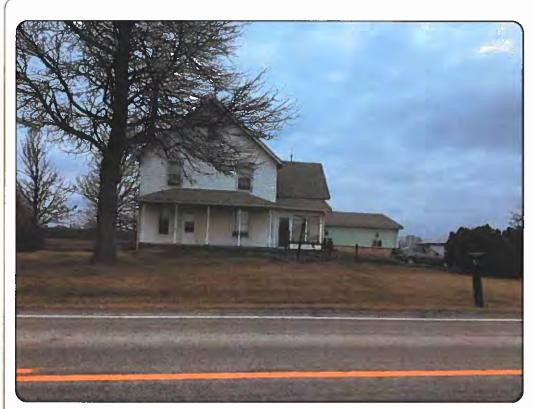
Sheet 253 of 355

Resource Name: A two-story vernacular residence.

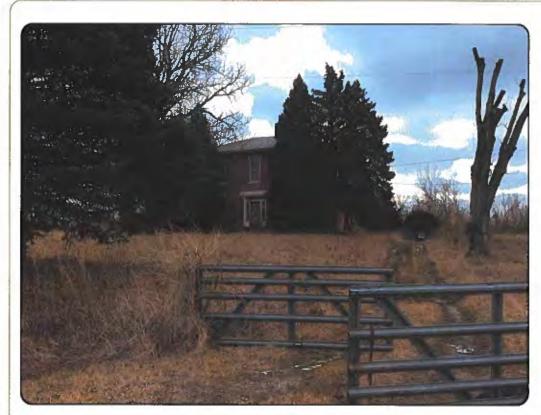
Sheet 254 of 355

Resource Name: A farmstead consisting of a one-and-one-half-story Greek Revival-style residence and two barns.

Meets NRHP Eligibility

Criteria: Yes

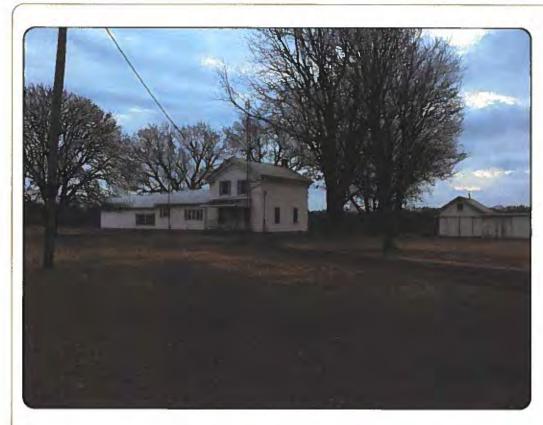
Sheet 255 of 355

Resource Name: A one-andone-half-story Greek Revivalstyle residence.

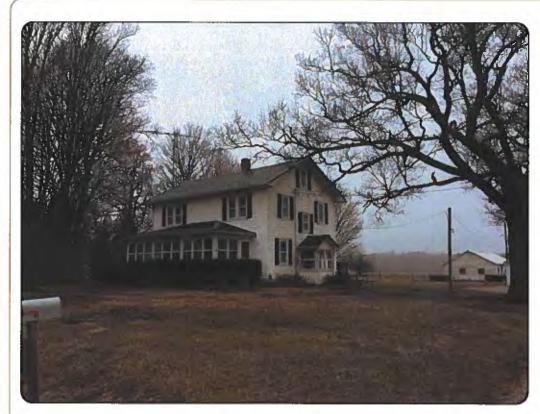
Sheet 256 of 355

Resource Name: A two-story vernacular residence.

Meets NRHP Eligibility Criteria: No

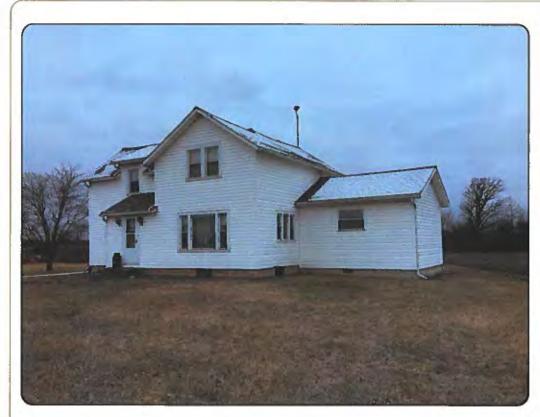
Sheet 257 of 355

Resource Name: A two-story vernacular residence.

Meets NRHP Eligibility Criteria: No

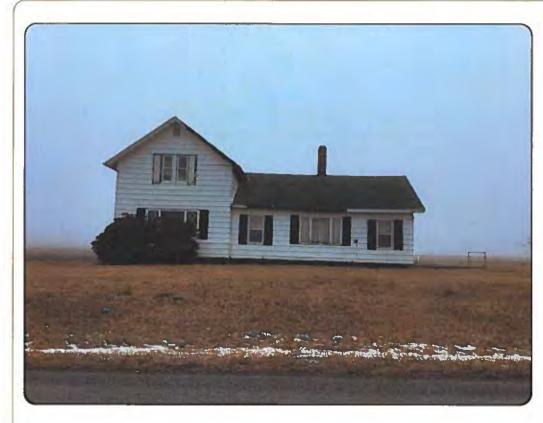
Resource Name: A one-andone-half-story vernacular residence.

Meets NRHP Eligibility
Criteria: No

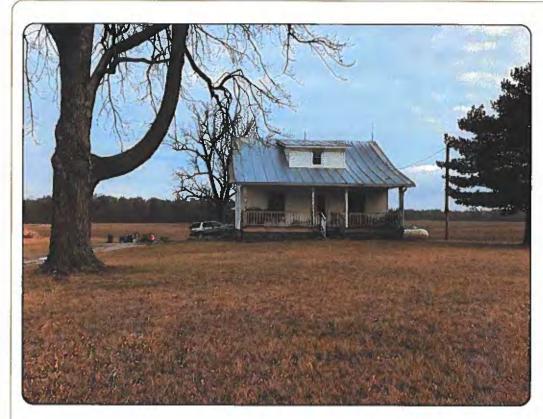
Resource Name: A one-andone-half-story Bungalow-style residence.

Criteria: No

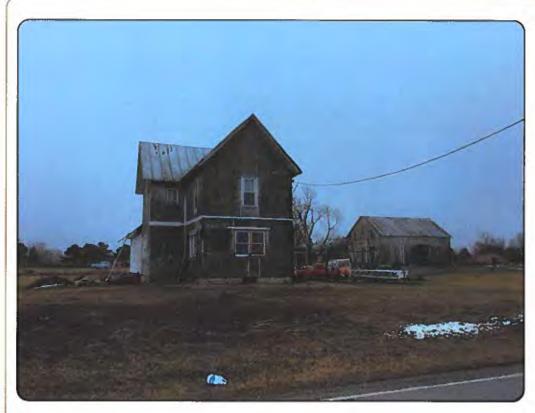
Resource Name: A two-story vernacular residence.

Meets NRHP Eligibility Criteria: No

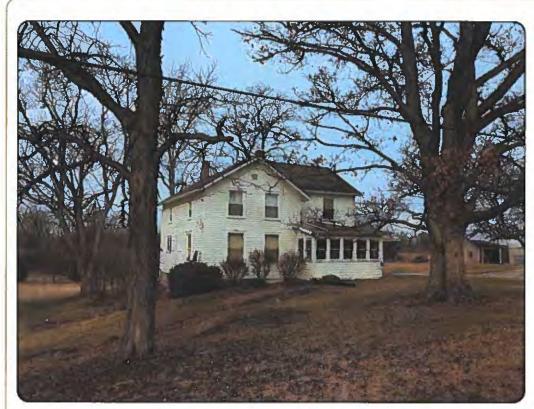
Resource Name: A two-story vernacular residence.

Meets NRHP Eligibility Criteria: No

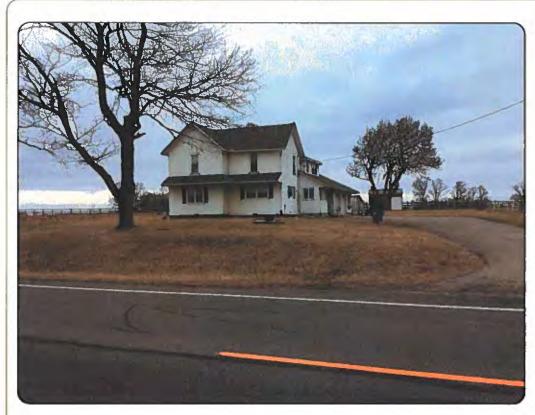
Resource Name: A two-story vernacular residence.

Meets NRHP Eligibility Criteria: No

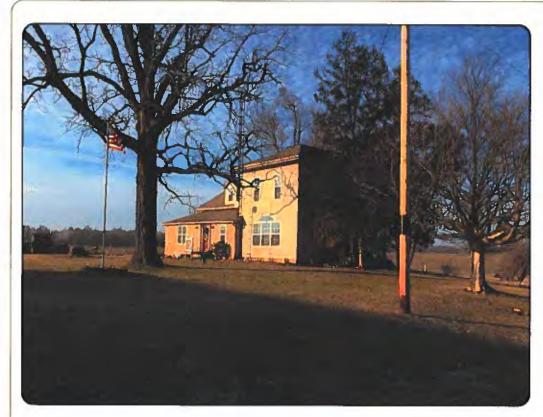
Resource Name: A two-story Italianate residence.

Criteria: No

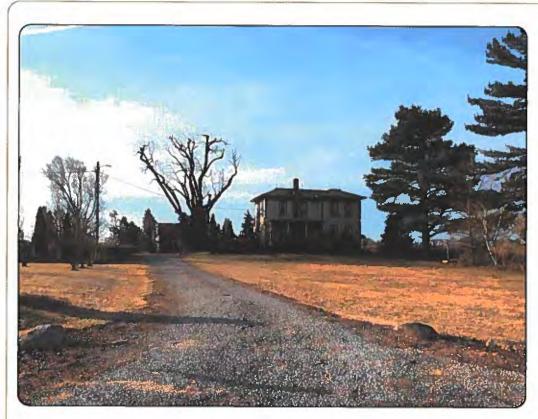
Resource Name: A two-story vernacular residence.

Criteria: No

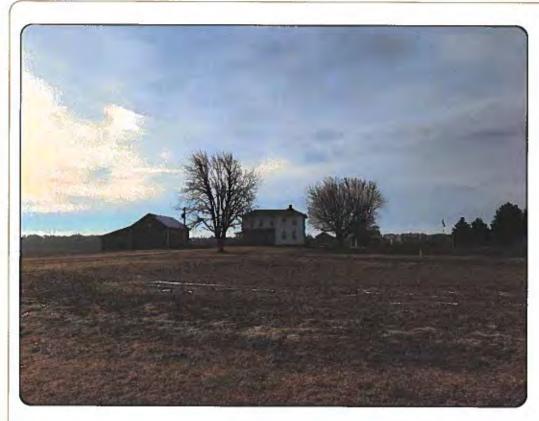
Resource Name: A farmstead consisting of two sheds, a hay barn, and a two-story vernacular residence.

Criteria: No

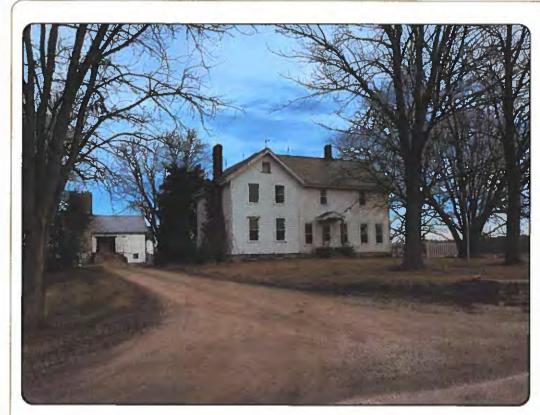
Resource Name: A two-story vernacular residence.

Meets NRHP Eligibility Criteria: No

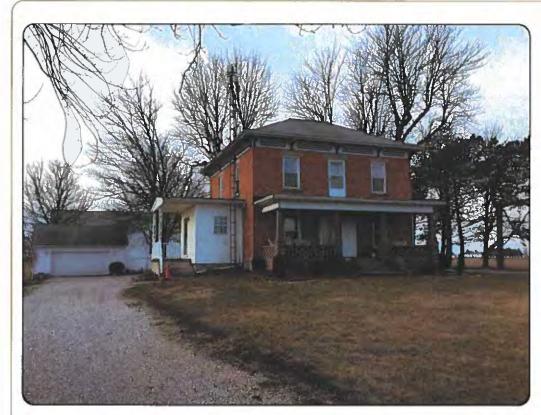
Resource Name: A twostory brick residence with a Foursquare-style form and some Italianate embellishments.

Criteria: Yes

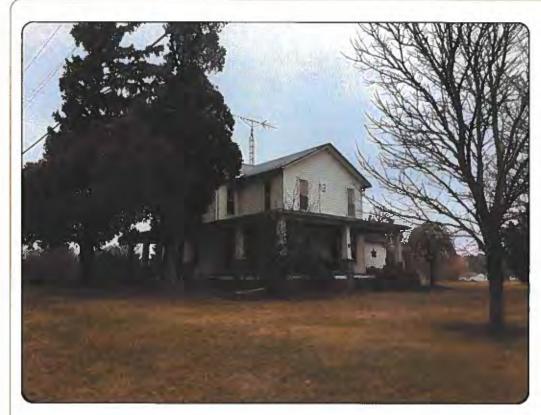
Resource Name: A two-story vernacular residence.

Meets NRHP Eligibility Criteria: No

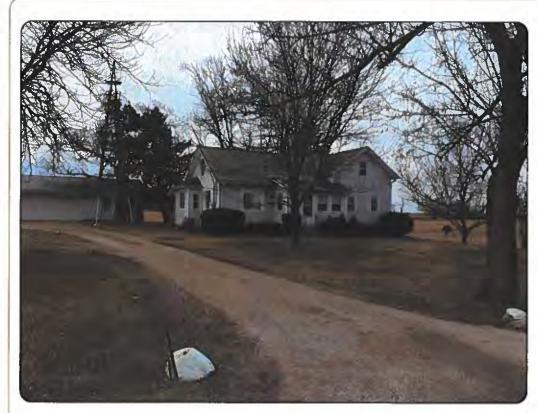
Resource Name: A one-andone-half-story vernacular residence.

Meets NRHP Eligibility Criteria: No

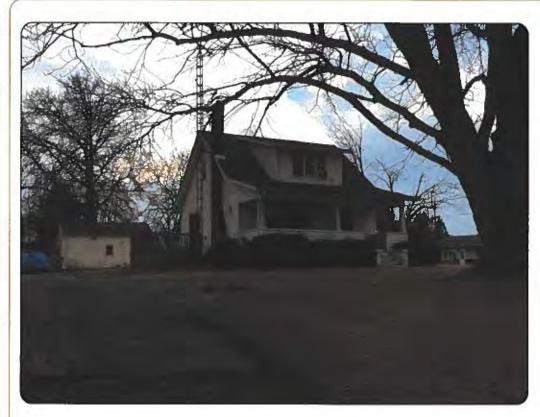
Resource Name: A one-andone-half-story Craftsman-style residence.

Meets NRHP Eligibility Criteria: No

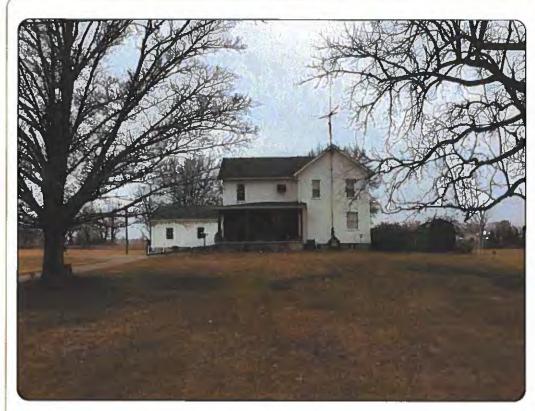
Resource Name: A two-story vernacular residence.

Criteria: No

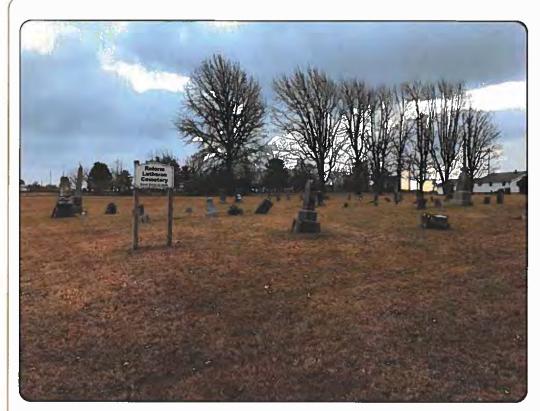
Resource Name: A small cemetery of less than 1 acre consisting of approximately 40 burials, circa 1847 (Reform Lutheran Cemetery).

Criteria: No

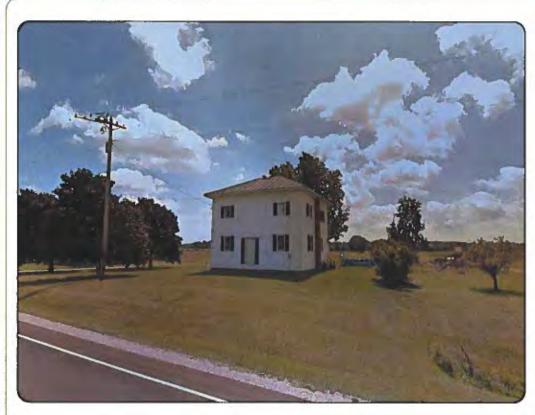
Resource Name: A two-story Italianate residence with two barns.

Meets NRHP Eligibility
Criteria: No

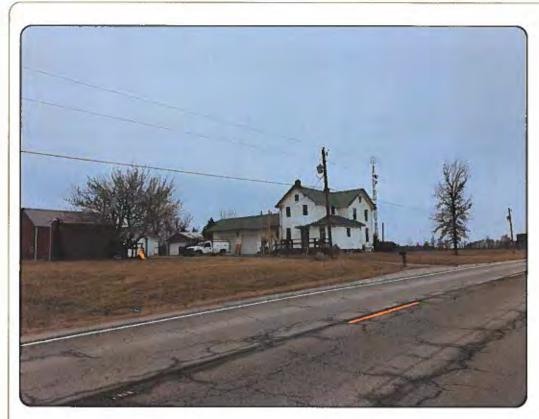
Resource Name: A farmstead consisting of two barns, two sheds, and a two-story vernacular residence.

Meets NRHP Eligibility Criteria: No

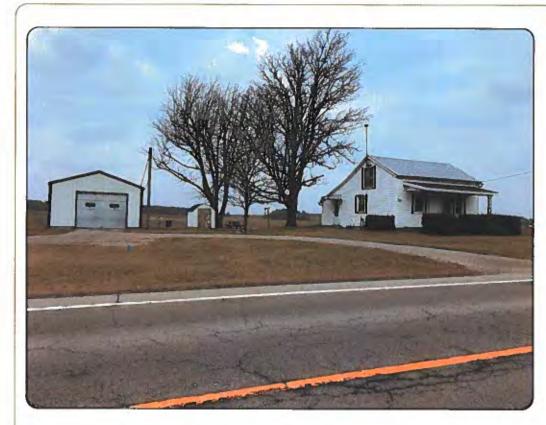
Resource Name: A one-andone-half-story salt box type residence.

Meets NRHP Eligibility Criteria: No

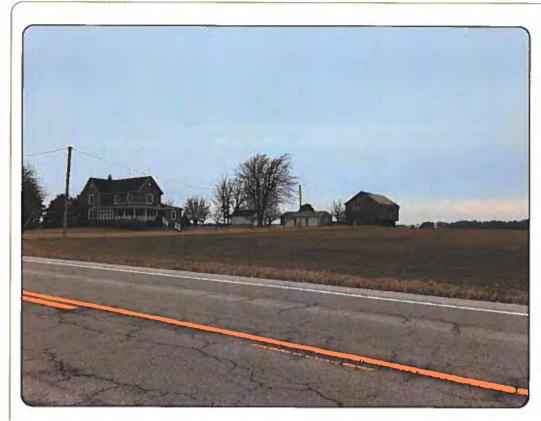
Resource Name: A farmstead consisting of a Dutch barn, a shed, and a two-story vernacular residence.

Meets NRHP Eligibility Criteria: No

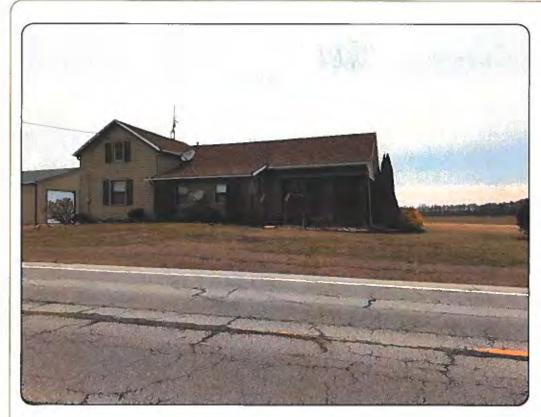
Sheet 318 of 355

Resource Name: A one-andone-half-story vernacular residence.

Meets NRHP Eligibility

Criteria: No

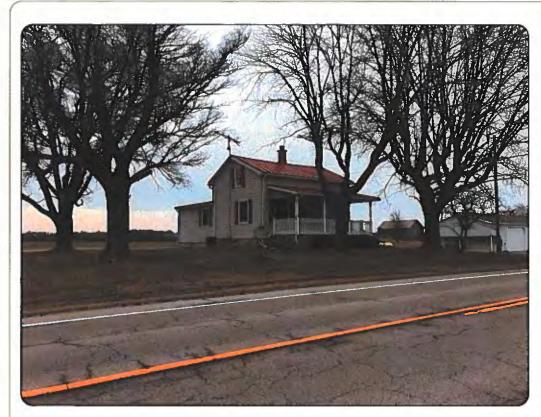
Sheet 319 of 355

Resource Name: A one-andone-half-story vernacular residence.

Meets NRHP Eligibility

Criteria: No

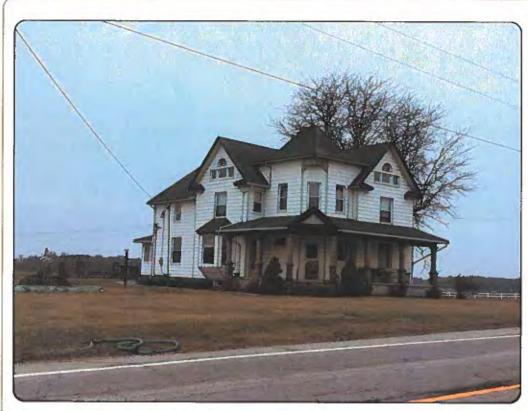
Sheet 320 of 355

Resource Name: A two-story Queen Anne-style residence.

Meets NRHP Eligibility Criteria: No

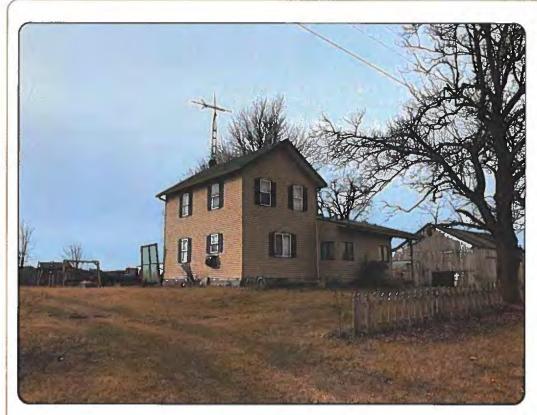
Sheet 321 of 355

Resource Name: A two-story vernacular residence.

Meets NRHP Eligibility Criteria: No

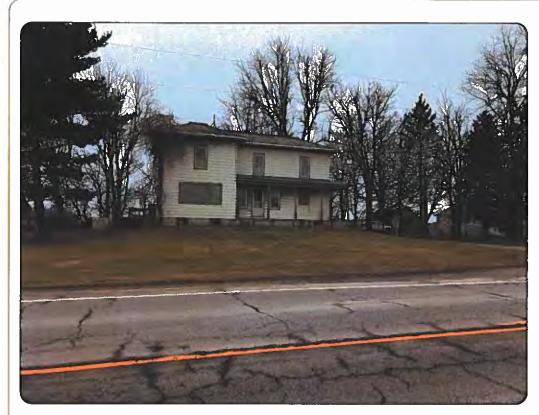
Sheet 322 of 355

Resource Name: A two-story vernacular residence.

Meets NRHP Eligibility Criteria: No

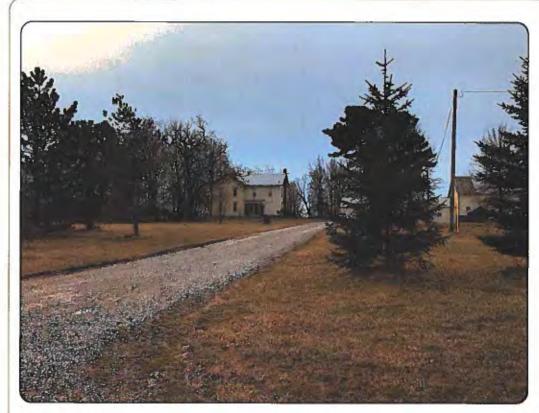
Sheet 323 of 355

Resource Name: A two-story vernacular residence.

Meets NRHP Eligibility Criteria: No

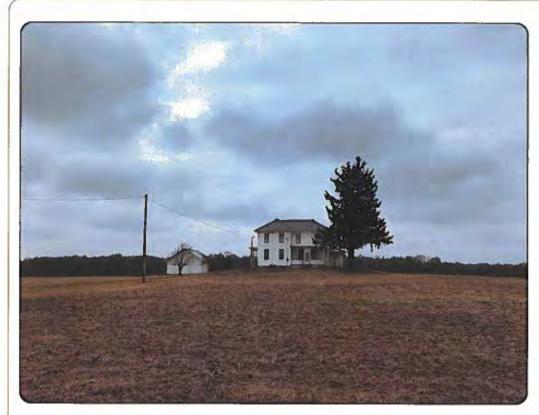
Sheet 324 of 355

Resource Name: A two-story vernacular residence.

Meets NRHP Eligibility

Criteria: No

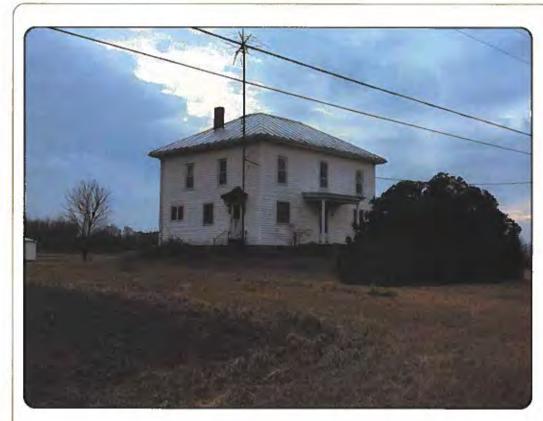
Sheet 325 of 355

Resource Name: A two-story vernacular residence.

Meets NRHP Eligibility Criteria: No

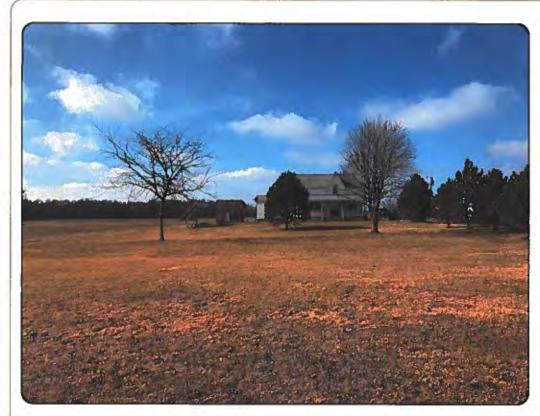
Sheet 326 of 355

Resource Name: A one-andone-half-story Gothic Revivalstyle farm cottage.

Meets NRHP Eligibility

Criteria: No

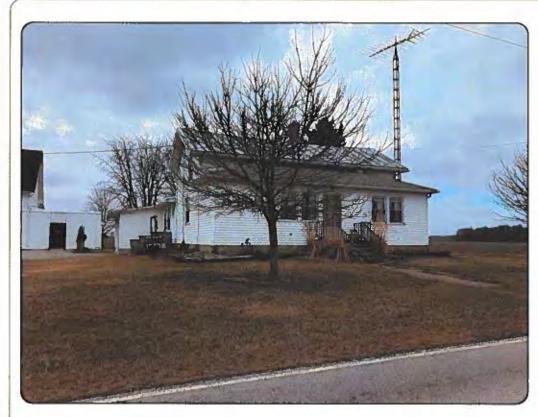
Sheet 327 of 355

Resource Name: A one-andone-half-story vernacular residence.

Meets NRHP Eligibility

Criteria: No

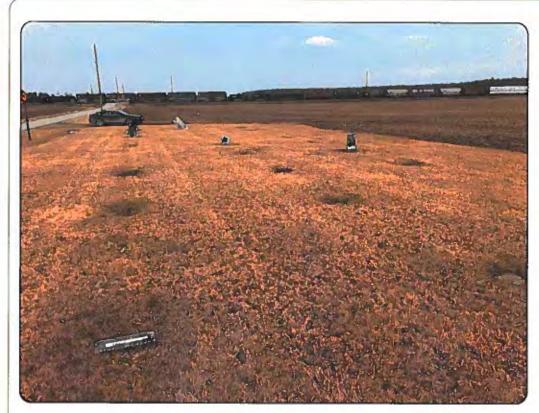
Sheet 328 of 355

Resource Name: A rural cemetery of less than an acre with approximately 22 burials, circa 1832 (Smith Cemetery).

Meets NRHP Eligibility Criteria: No

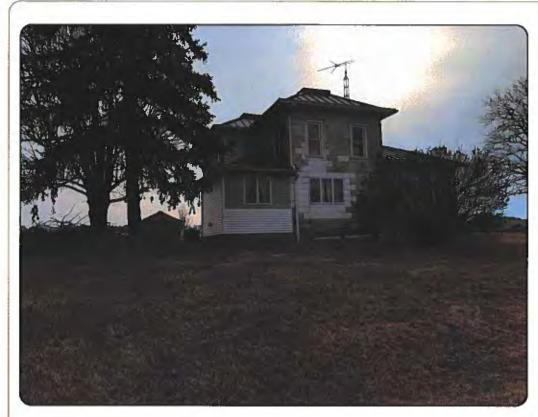
Sheet 329 of 355

Resource Name: A two-story vernacular residence.

Meets NRHP Eligibility

Criteria: No

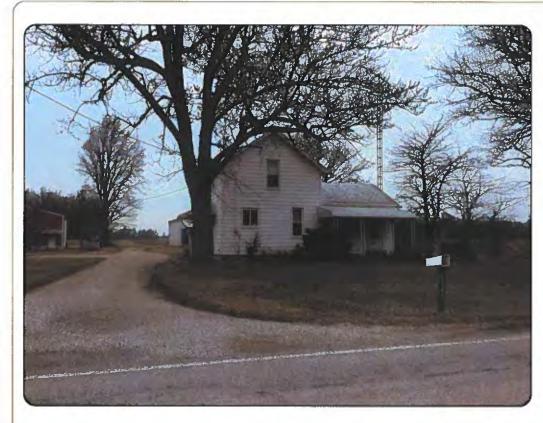
Sheet 330 of 355

Resource Name: A one-andone-half-story vernacular residence.

Meets NRHP Eligibility Criteria: No

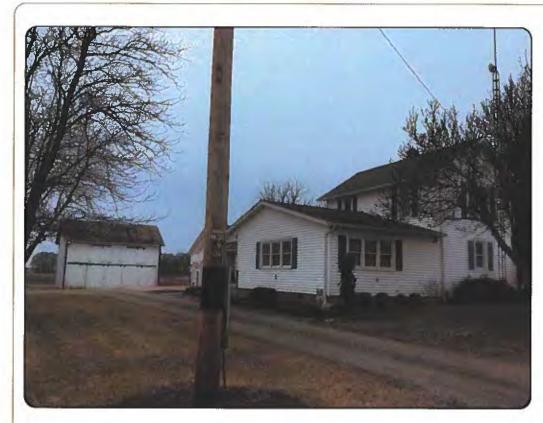
Sheet 331 of 355

Resource Name: A two-story vernacular residence.

Meets NRHP Eligibility Criteria: No

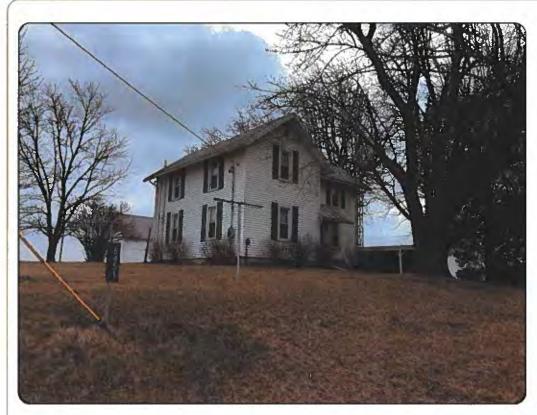
Sheet 332 of 355

Resource Name: A two-story vernacular residence.

Meets NRHP Eligibility Criteria: No

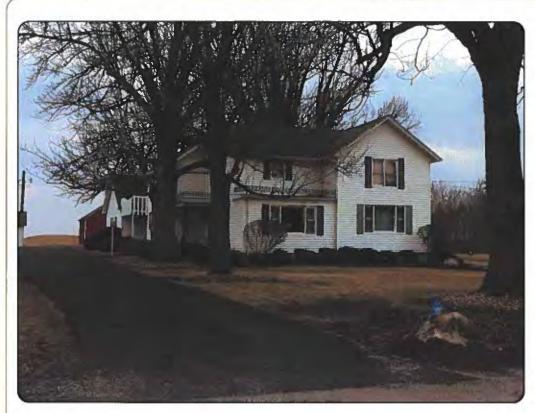
Sheet 333 of 355

Resource Name: A two-story vernacular residence.

Meets NRHP Eligibility

Criteria: No

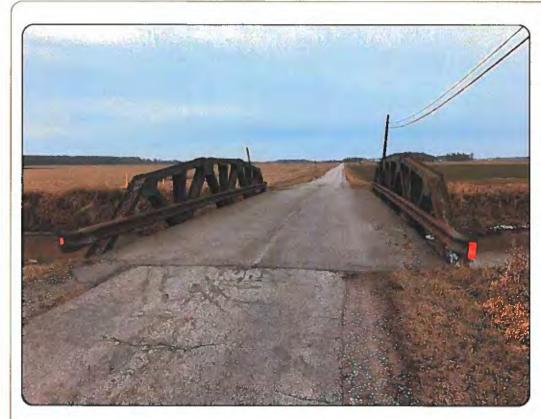
Sheet 334 of 355

Resource Name: A camelback Warren queen truss bridge.

Meets NRHP Eligibility

Criteria: No

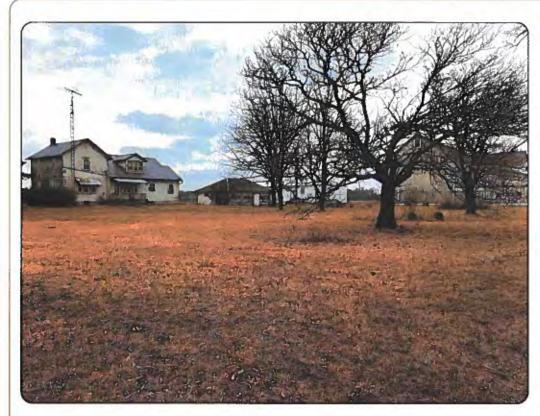
Sheet 335 of 355

Resource Name: A farmstead consisting of two barns, a garage, and a two-story Italianate residence.

Meets NRHP Eligibility

Criteria: No

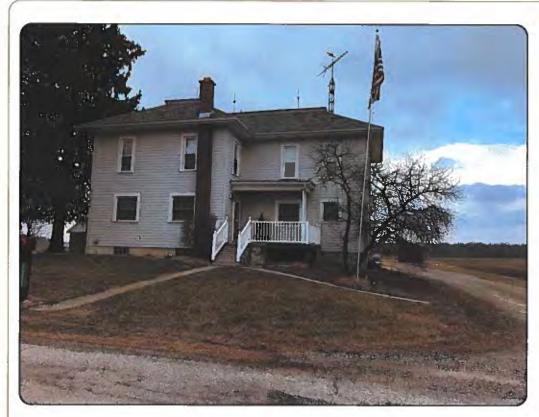
Sheet 336 of 355

Resource Name: A two-story Italianate residence.

Meets NRHP Eligibility

Criteria: No

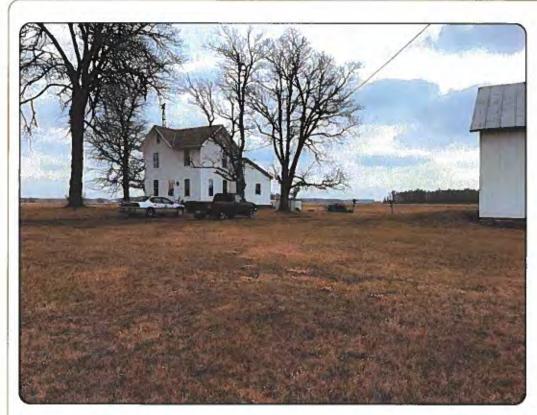
Sheet 337 of 355

Resource Name: A two-story vernacular residence.

Meets NRHP Eligibility

Criteria: No

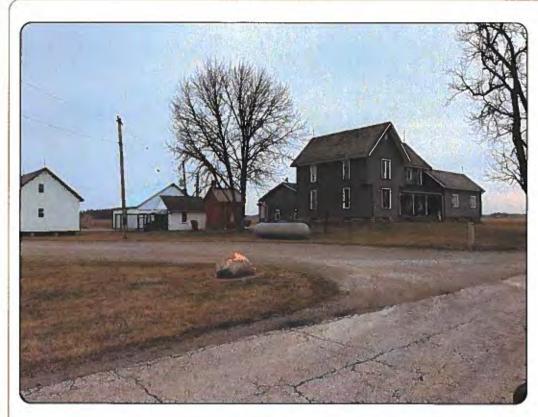
Sheet 338 of 355

Resource Name: A farmstead consisting of three metal pole barns, a poultry house, a brick pump house, two silos, and a two-story vernacular residence.

Meets NRHP Eligibility
Criteria: Unable to determine

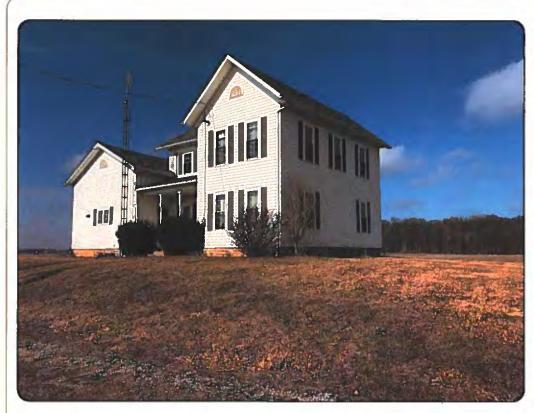
Sheet 339 of 355

Resource Name: A two-story vernacular residence.

Criteria: No

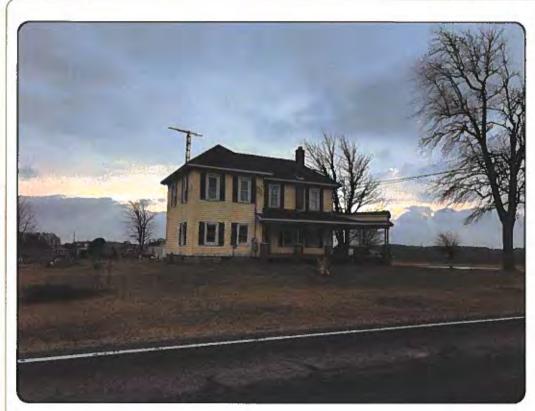
Sheet 340 of 355

Resource Name: A two-story Italianate residence.

Meets NRHP Eligibility Criteria: No

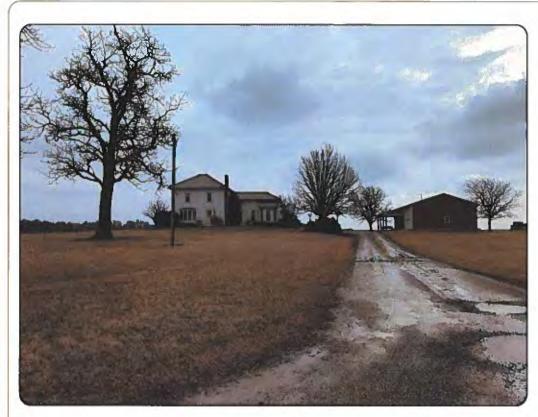
Sheet 341 of 355

Resource Name: A two-story vernacular residence and a metal polebarn.

Meets NRHP Eligibility Criteria: No

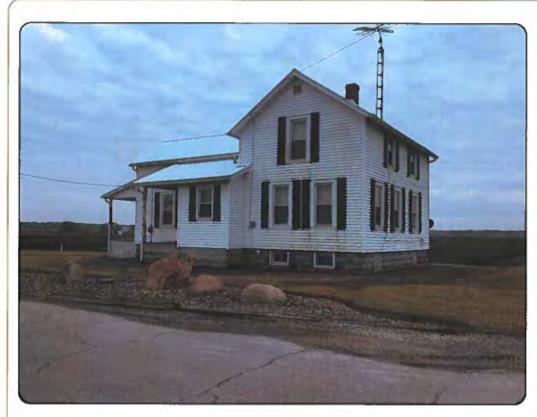
Sheet 342 of 355

Resource Name: A two-story vernacular residence.

Criteria: No

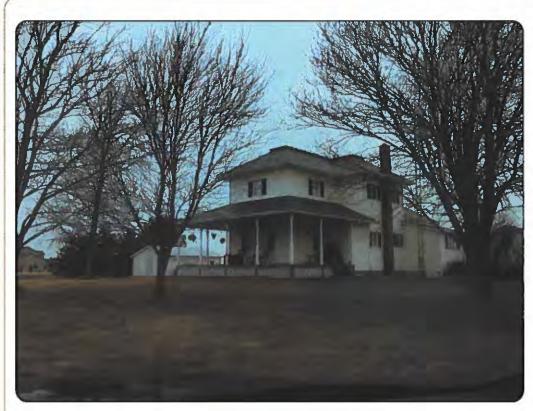
Sheet 343 of 355

Resource Name: A two-story vernacular residence.

Meets NRHP Eligibility Criteria: No

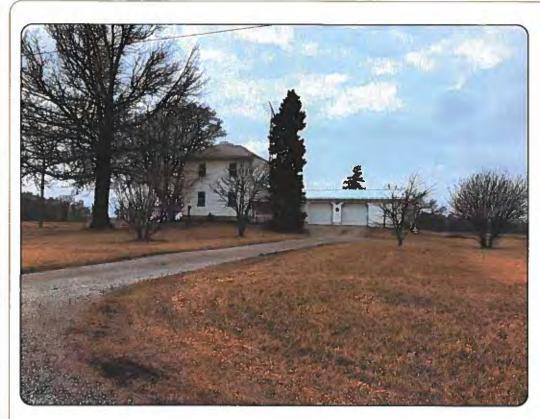
Sheet 344 of 355

Resource Name: A two-story vernacular residence.

Meets NRHP Eligibility Criteria: No

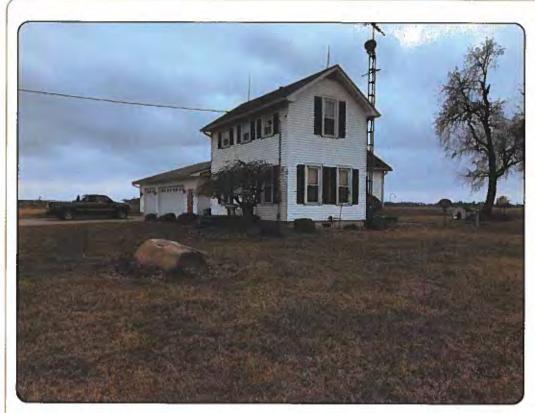
Sheet 345 of 355

Resource Name: A two-story vernacular residence.

Meets NRHP Eligibility Criteria: No

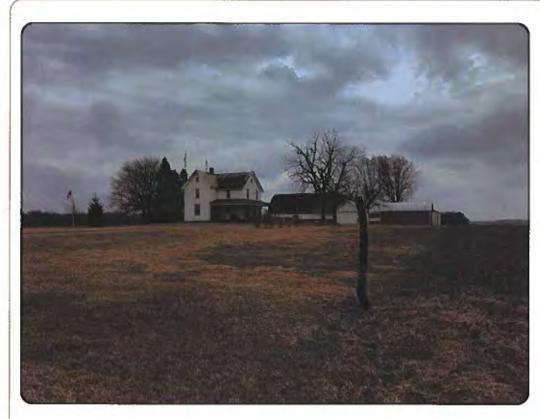
Sheet 346 of 355

Resource Name: A farmstead consisting of a smokehouse, a garage, a hay barn, several small metal pole barns, and a two-story vernacular residence.

Meets NRHP Eligibility Criteria: No

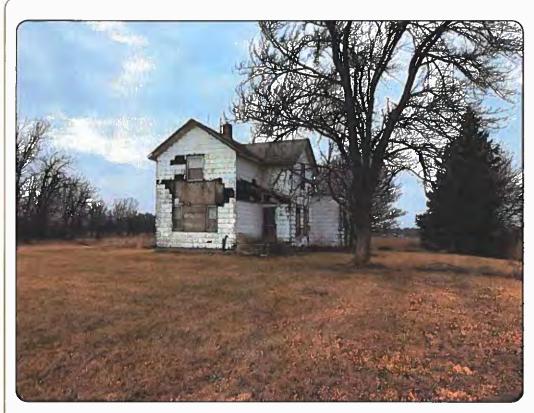
Sheet 347 of 355

Resource Name: A two-story vernacular residence.

Criteria: No

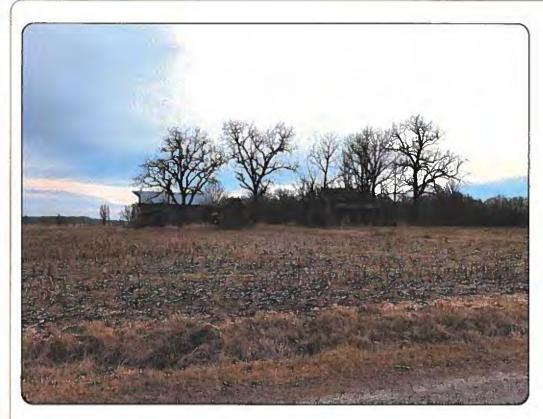
Sheet 348 of 355

Resource Name: A farmstead consisting of a corn crib, a poultry house, three sheds, and a one-and-one-half-story vernacular residence.

Criteria: No

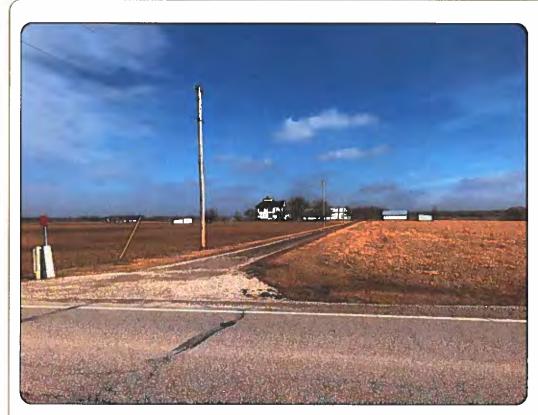
Sheet 349 of 355

Resource Name: A two-story Italianate residence.

Criteria: No

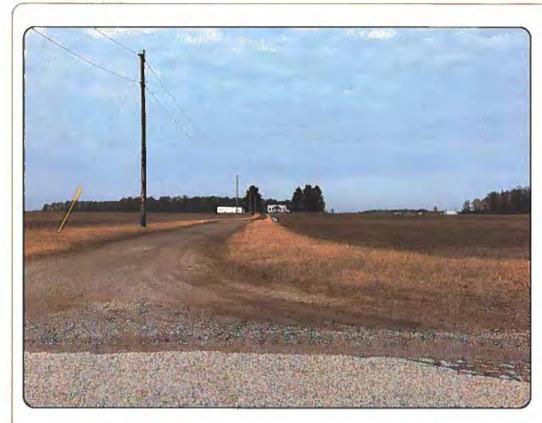
Sheet 350 of 355

Resource Name: A one-andone-half-story Greek Revivalstyle residence and garage.

Meets NRHP Eligibility
Criteria: Unable to determine
