Historic Resources Survey
October 2020
Environmental Design & Research
(Submitted to State Historic Preservation Office
January 5, 2021)

RE: Emerson Creek Wind Farm

Our office has reviewed the revised Historic Resources Survey Report, Emerson Creek Wind Farm, Groton and Oxford Townships, Erie County, Ohio, Lyme, Ridgefield, Sherman, Norwich, and Richmond Townships, Huron County, Ohio, prepared by Environmental Design and Research (EDR) in October 2020. The project is a 297.66-megawatt wind energy facility consisting of up to 87 wind turbine generators and associated infrastructure.

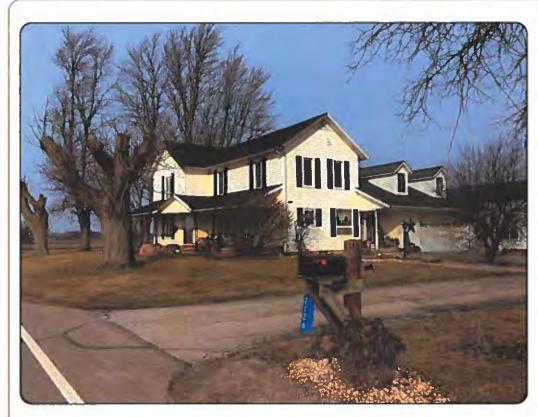
Sheet 351 of 355

Resource Name: A two-story vernacular residence.

Meets NRHP Eligibility Criteria: No

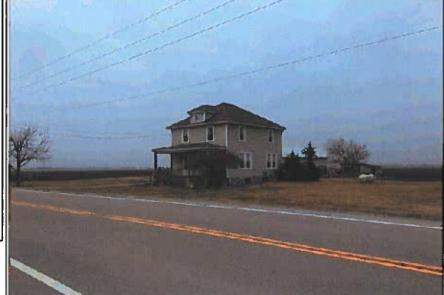
This is a two-story, wood-frame, Foursquare type house. It has a one-story, full-width, open porch on the front façade. The porch is constructed of unpainted, pressure-treated lumber. Other replacement materials include vinyl siding and windows.

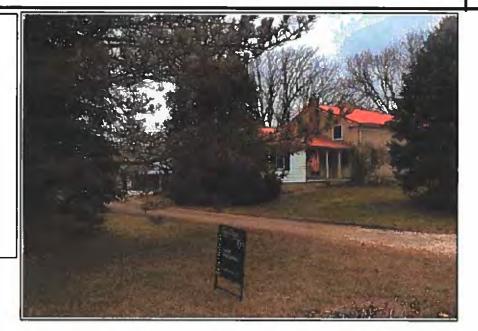
At just under six acres, the property is significantly smaller than it was historically. It appears on the 1874 Combination Atlas Map of Erie County, I lewart and Page as consisting of 268 acres, and on the 1896 Illustrated Atlas and Directory of Erie County, Ohio by the Atlas Publishing Co. as 28 yes (Stewart, 1874; Atlas Publishing Company, 1896). This house is a good example of the use of limestone construction common to Erie County ar retains a moderately high degree of integrity of location, materials, workmanship, and design. Coniferous limestone is noted as the most importate sological feature in Erie County. The upper portion of the limestone, which is formed in layers, is blue in color and known as "Sandusky stone" we appularly used for building and paving. The lower layer is lighter in color, composed largely of fossils and decomposing organic matter. Quarries are nekilns were prevalent in the city of Sandusky and the islands in Lake Erie during the nineteenth century. Many facilities are still in operation an nestone and crushed stone quarried in Erie County continue to be used for construction of buildings and roadways (Peeke, 1916; Sandusky Histor 1915).

The entirety of the property is paritally obscured by evergreens making it difficult to descern details. A large, modern, pole-barn and four wood-frame sheds are located west of the house. The barn is sided in metal and appears to date to circa 2000. The four sheds are sided in wood, with asphalt roofs, and are site on poured concrete foundations. There is also a small limestone outbuilding directly behind the house. The smaller buildings are arranged in a linear fashion along the souther property line.

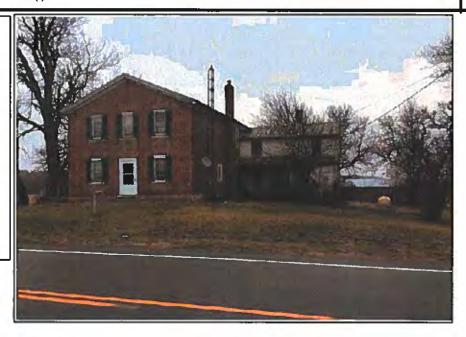
The massing and partial cornice return indicate Greek Revival influences, which is consistent with the construction date of 1820 provided on the property record and construction materials (Erie County, 2020). The house, and a barn that is no longer extant, are included on the 1874 Combination Atlas Map of Erie County, by Stewart and Page, shown within a 112-acre parcel that closely reflects the modern boundaries (Stewart, 1874). The property is notable as a vernacular example of the Greek Revival style. The house is in fair condition, but retains a high degree of integrity of materials, location, setting, and design. Retaining the majority of its original acreage and agricultural setting, the property is also a good example of a nineteenth-century rural farmstead grouping consisting of a house and outbuildings associated with the agricultural development of northern Ohio.

A wood-frame, gable-roofed barn is located south of the house. A second barn, located across the road and within a stand of trees, is in very poor condition and near collapse.

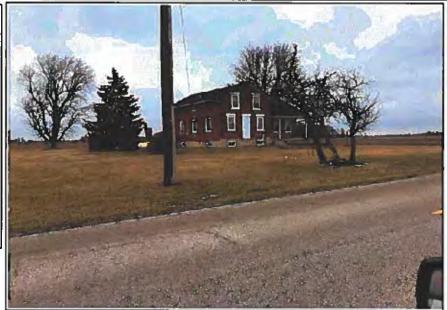
Door Selection: Two doors asymmetrical

Door Position: Flush

This is a one-and-one-half-story vernacular brick residence with a gable-and-ell form (Inset 22). The roof is clad in metal and the foundation is of parged masonry, with a stone water table on the principal façade only. The gable-front portion, to the west, contains a centered entry door on the first floor flanked by one-over-one windows, with a pair of one-over-one windows on the upper half-story. The door is not in use and stairs leading to it have been removed. A small, single-light window is tucked under the eave of the half-story on the west façade. The single-story, side-gabled portion to the east contains two one-over-one windows and an entry door within a porch supported by slender Doric columns resting on a stone or concrete masonry unit base. The windowsills and lintels are likely of stone but appear to be painted. Brick chimneys rise from the roof ridge near the south and east gable ends.
