CONSTRUCTION NOTICE FOR THE Seward Substation Transmission Line Relocation Project OPSB Case No. 22-0012-EL-BNR

Submitted to: The Ohio Power Siting Board Pursuant to O.A.C. 4906-06

> Submitted by: Duke Energy Ohio, Inc.

Duke Energy Ohio Seward Substation Transmission Line Relocation Project (Project)

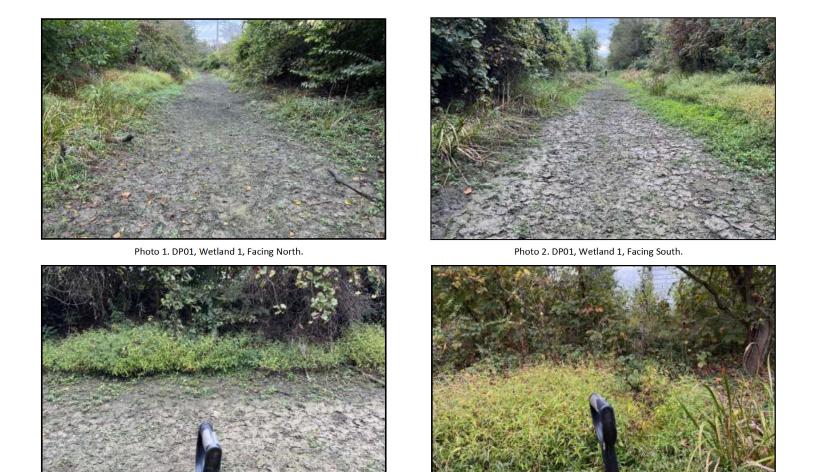
Photo 3. DP01, Wetland 1, Facing East.

Photo 4. DP01, Wetland 1, Facing West.

Wetland 1 was classified as an emergent wetland located within the remnant portion of the Miami-Erie Canal (Figure 4). The NWI Map identified Wetland 1 as a riverine wetland (R4SBC) (Figure 2). This wetland was located within the Miami-Erie Canal network which flows into Mill Creek, a Traditional Navigable Water (TNW). Due to the significant nexus the Miami Erie Canal, this wetland should be considered a jurisdictional "Waters of the U.S.". The ORAM score for wetland 1 was 24, categorizing the wetland as a Category 1, or low quality, wetland. A complete ORAM field data sheet is located in Appendix C.

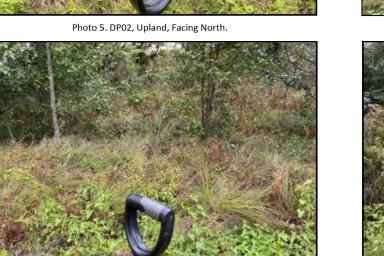
Photo 7. DP02, Upland, Facing East.

Dominant vegetation in the vicinity of DP02 included ash-leaf maple (*Acer negundo*, FAC), hedge false bindweed (*Calystegia sepium*, FAC), and common fox sedge (*Carex vulpinoidea*, FACW). In addition, non-dominant vegetation observed included mild water-pepper (*Persicaria hydropiper*, OBL), and blunt broom sedge (*Carex tribuloides*, OBL). The plants at this data point qualified as hydrophytic vegetation. The soil from 0 to 16 inches had a matrix soil color of 10YR 3/2 with a texture of Silt Loam. The soil at the data point was mapped as RvB2 (Russell-Miamian silt loams, 2 to 6 percent slopes, moderately eroded, and did not meet any hydric soil criteria. Secondary indicators of hydrology observed included Geomorphic Position (D2), and the FAC-Neutral Test (D5). This data point did not meet wetland criteria.
